Maintenance Alarms for Avaya Communication Manager 3.1.x, Media Gateways and Servers

03-300430
Issue 2.1
June 2006

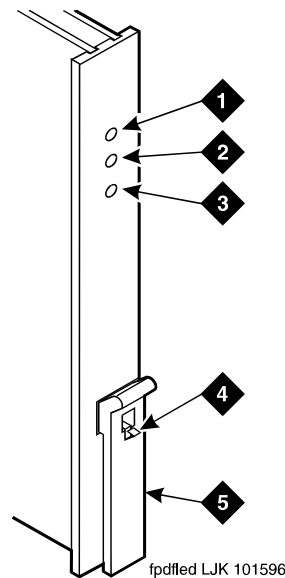
Figure 1: TN775 circuit pack LEDs on faceplate

These LEDs are illustrated [Figure 1: TN775 circuit pack LEDs on faceplate](#) on page 275.

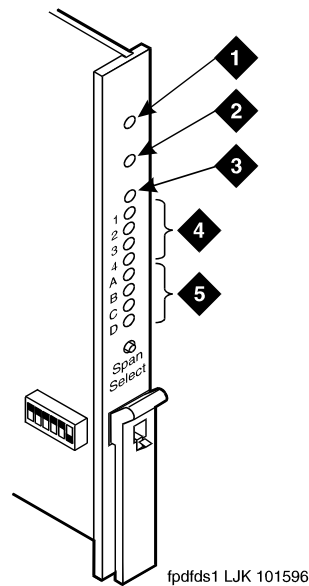
Figure 2: TN574 DS1 Converter circuit pack LEDs

Below the three standard LEDs on the DS1C circuit pack are four green LEDs that indicate whether a receive signal is present for each of the four DS1 facilities. [Figure 2: TN574 DS1 Converter circuit pack LEDs](#) on page 277 shows which facility (A, B, C, or D) corresponds to each LED. If a green LED is off, there is a Loss of Signal condition on the DS1 facility associated with that LED. The presence of a signal does not guarantee that the signal is using the correct framing format or line coding; an Alarm Indication Signal indicating that the opposite end of the DS1C complex is out of service may be present.

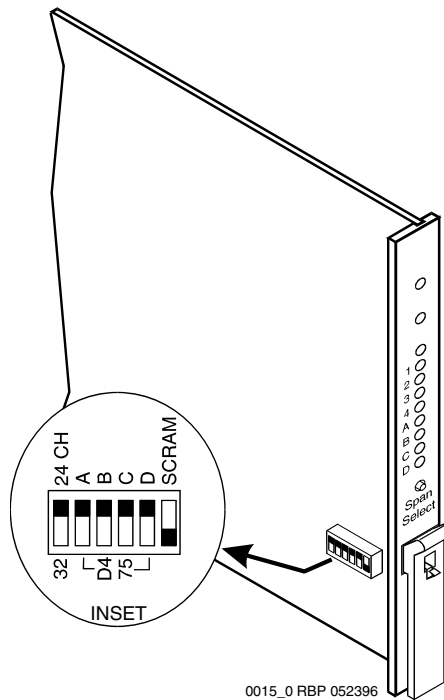
Figure 3: TN1654 DS1CONV circuit pack

The bottom four LEDs on the TN1654 board are labeled SPAN LEDs. These LEDs are under firmware control. If the facility is not administered, then the LED is not lit. The LED is lit amber if the facility is running alarm free. If the facility is detecting either a red alarm (loss-of-signal or loss-of-frame), a yellow alarm (remote frame alarm) or a blue alarm (AIS signal) then the LED is lit red. The SPAN SELECT switch on the TN1654 faceplate is for future use. Pushing the switch will have no effect on the board. See [Figure 3: TN1654 DS1CONV circuit pack](#) on page 279 for a view of the faceplate on the TN1654 DS1CONV circuit pack.

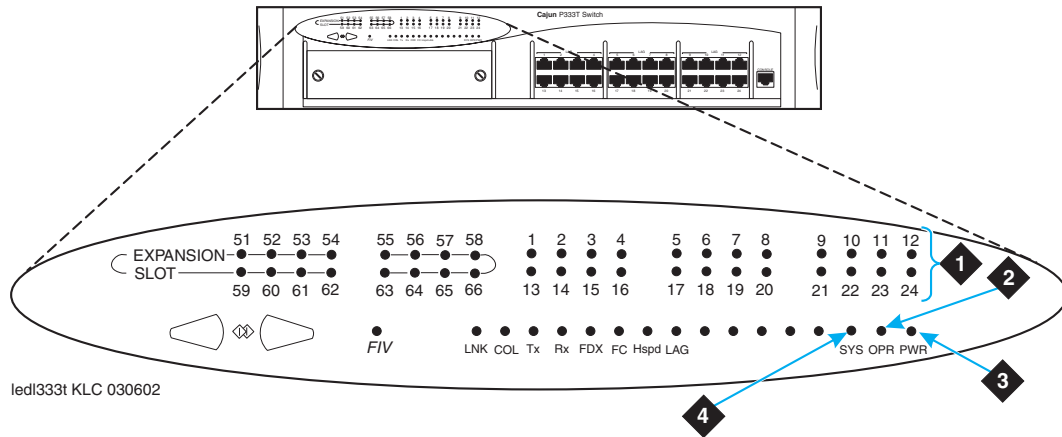
Figure 4: Avaya Ethernet switch LEDs

The Avaya Ethernet switch's LEDs are shown in [Figure 4: Avaya Ethernet switch LEDs](#).

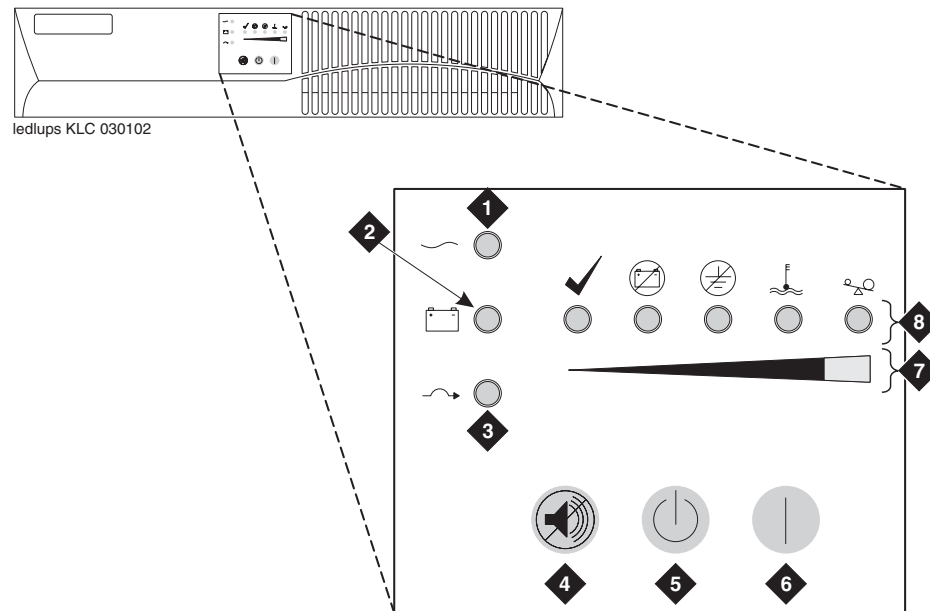
Figure 5: UPS LEDs

The Powerware front panel has the LEDs shown in [Figure 5: UPS LEDs](#).

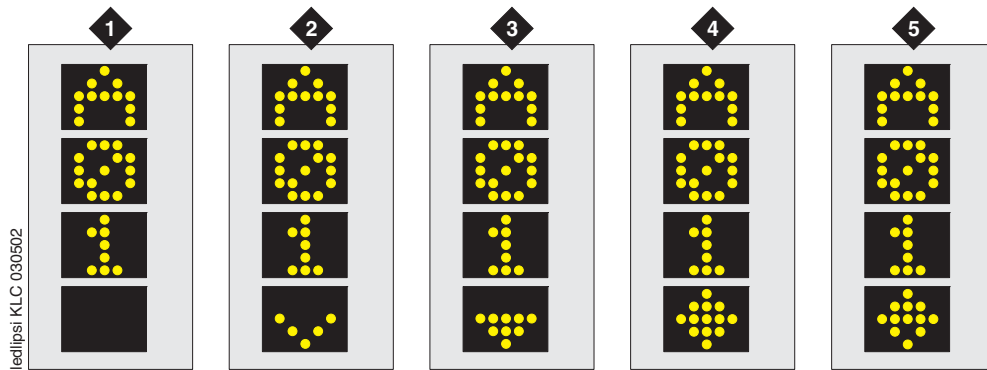
Figure 6: IPSI display showing connectivity status

There are four LEDs on the TN2312AP IPSI faceplate, and five LEDs on the TN2312BP IPSI faceplate. The top three LEDs are the standard ones found on most TN circuit packs. The fourth LED imitates the TN2182B Tone-Clock's amber LED. The archangel flashes the yellow LED when active, 2 seconds on and 200 msec off. In addition, the TN2312BP has a fifth LED that shows the emergency transfer control status.

Figure notes: IPSI connection status

Connectivity status	1	2	3	4	5
IPSI is connected to Avaya Ethernet switch	no	yes	yes	yes	yes
IPSI has an IP address	no	no	yes	yes	no
Laptop computer is connected to IPSI services port	no	no	no	yes	yes

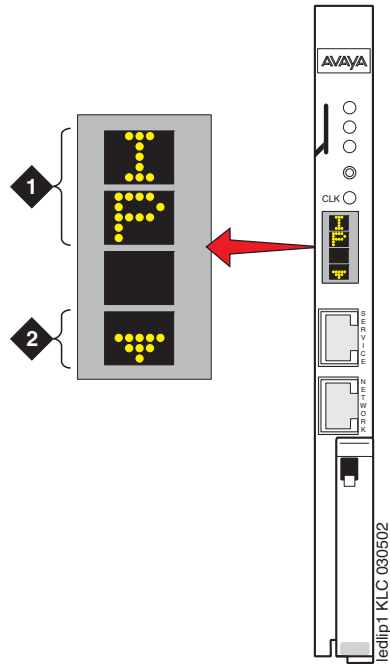
Figure 7: IPSI Display with static address

1. IPSI using DHCP
2. IPSI has connectivity and a static IP address

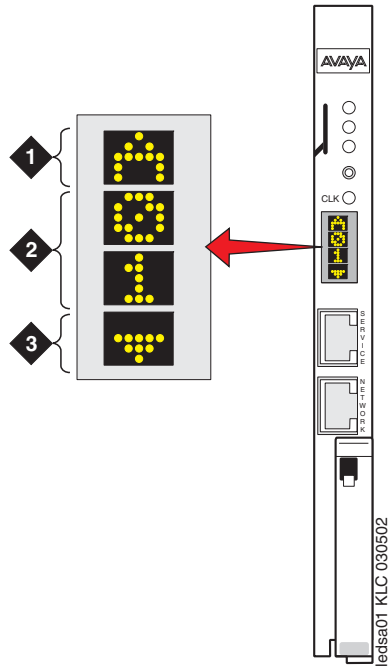
Figure 8: IPSI Board Display using DHCP addressing

- 1. Switch identifier
- 2. Cabinet number
- 3. IPSI has connectivity and a DHCP address

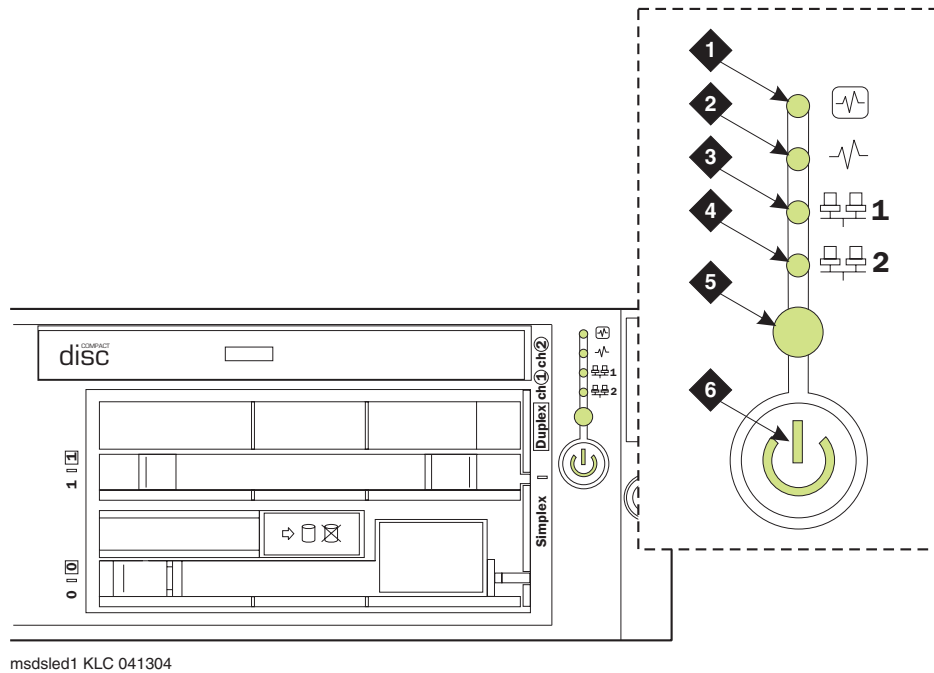
Figure 9: LEDs on front panel of S8710 Media Server

Figure notes: S8710 front panel LED interpretation

Number	Description	Status
1	Internal health	GREEN: normal AMBER: system degraded. See system board LEDs to identify component in degraded state. RED: system critical. See system board LEDs to identify component in critical state.
2	Power supply	GREEN: normal AMBER: power redundancy failure RED: Critical power supply failure
3	NIC 1 (Eth0) link/activity (GREEN)	STEADY ON: network link FLASHING: network link and activity Off: No link to network
4	NIC 2 (Eth1) link/activity (GREEN)	STEADY ON: network link FLASHING: network link and activity OFF: No link to network
5	Active/Standby mode (BLUE)	STEADY ON: in active mode FLASHING: in standby mode OFF: deactivated NOTE: If pressed, the LED is deactivated; wait 10 seconds and the LED comes back on.
6	Power on/ Standby button/ System power	GREEN: system on AMBER: system shut down but power still applied OFF: power supply failure

S8710 location	Diagram	LED interpretation
Front panel	Figure 9	Figure notes: S8710 front panel LED interpretation on page 291
Back panel	Figure 10	Figure notes: S8710 rear panel LED interpretation on page 292

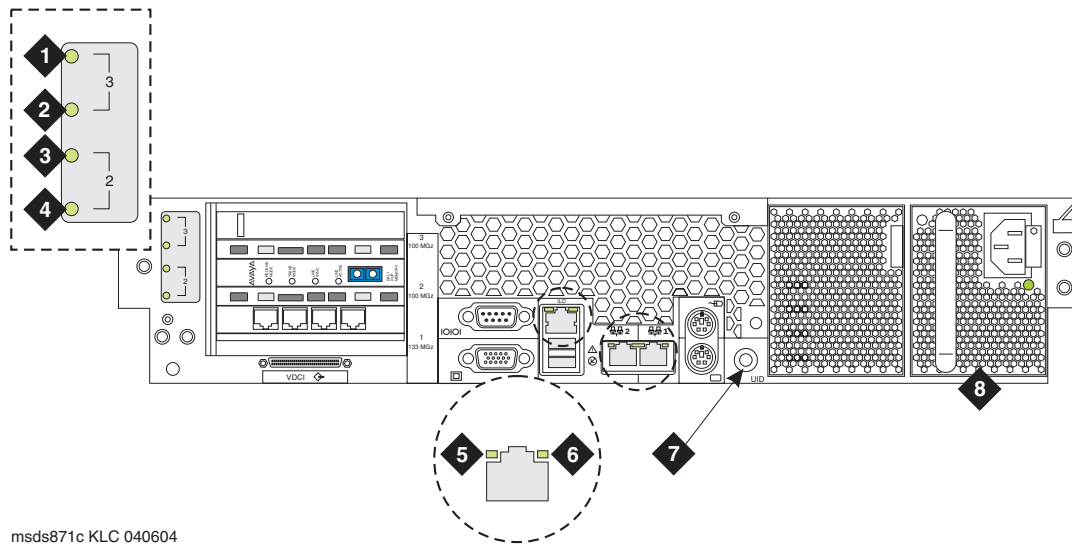
Figure 10: LEDs on back panel of S8710 Media Server

Figure notes: S8710 rear panel LED interpretation 1 of 2

Number	Description	Status
1	Not used	ON: expansion board failed. OFF: normal
2	Not used	STEADY ON: slot has power FLASHING: power is cycling OFF: no power
3	Quad-NIC fault (slot 2) (AMBER)	ON: expansion board failed. OFF: normal
4	Quad-NIC power (slot 2) (GREEN)	STEADY ON: slot has power FLASHING: power is cycling OFF: no power
5	RJ45 link (GREEN)	ON: linked to network OFF: not linked to network
6	RJ45 link (GREEN)	STEADY ON: network activity FLASHING: network activity OFF: no network activity
7	Active/standby mode (BLUE)	STEADY ON: in active mode FLASHING: in standby mode Off: deactivated NOTE: If pressed, the LED is deactivated; wait 10 seconds and the LED comes back on.

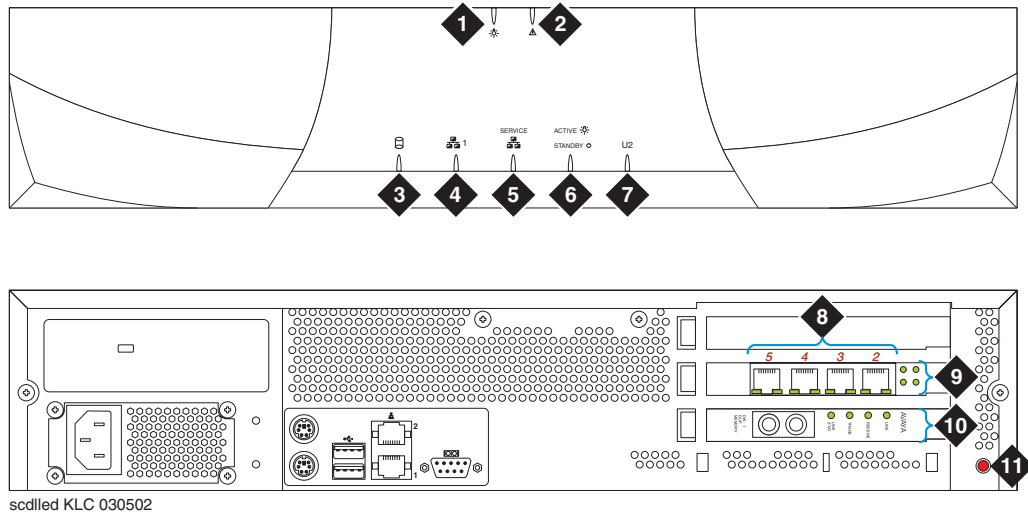
Figure 11: S8700 Media Server LEDs—Front and Back

The S8700 Media Server has an LED called Active/Standby that indicates whether the server is the active server or the standby server. The Active/Standby LED in the “on” state implies active and in the “flashing” state implies standby. It flashes at the rate of 400 ms “on” and 600 ms “off” when in standby mode.

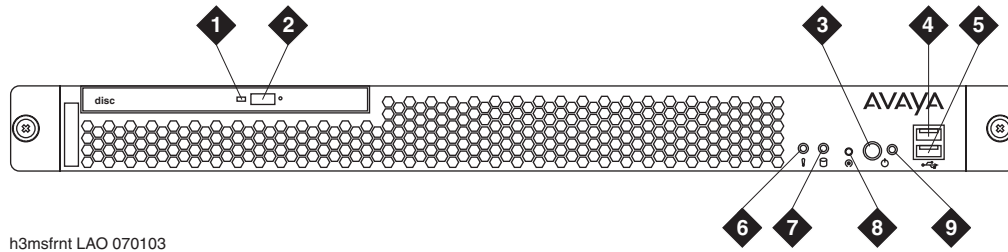
Figure 12: S8500 front panel

- Five (5) LEDs on the front panel ([Figure 12: S8500 front panel](#) on page 296)
- Four (4) LEDs on the back ([Figure 13: S8500 rear panel](#) on page 297)

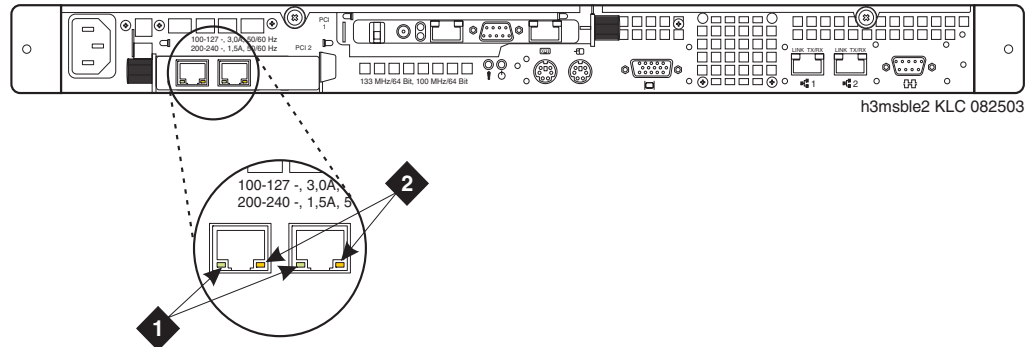
Figure 13: S8500 rear panel

The four LEDs on the S8500 back panel are shown in [Figure 13: S8500 rear panel](#) on page 297.

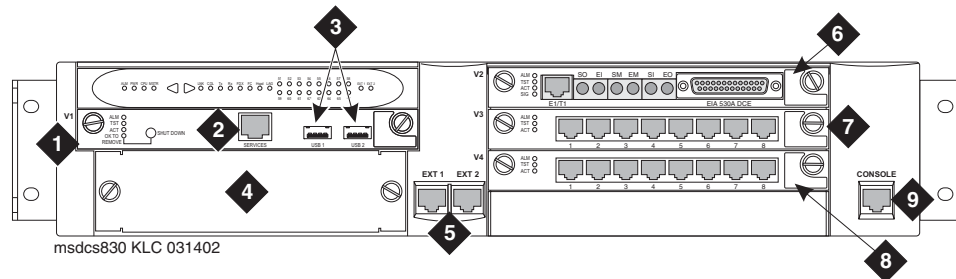
Figure 15: G700 LED Panel Location

As shown in [Figure 15: G700 LED Panel Location](#) on page 303, the LED panel is located on the top left corner of the G700. Directly below the LED panel is Media Module slot V1, which can be occupied by any type of Media Module. However, the S8300 Media Server can reside only in this particular slot because of height restrictions (for a specific discussion of the S8300 LEDs, see [S8300 Media Server LEDs](#) on page 297.

1. Media Module Slot #1 (V1)
2. S8300 Services Port (Used with cross-over ethernet cable)
3. S8300 USB Series Modem connection
4. Avaya Expansion Module Slot
5. 10/100 BaseT Ethernet Ports (Ext1, Ext2)
6. Media Module Slot #2 (V2)
7. Media Module Slot #3 (V3)
8. Media Module Slot #4 (V4)
9. Console Interface (use with serial cable)

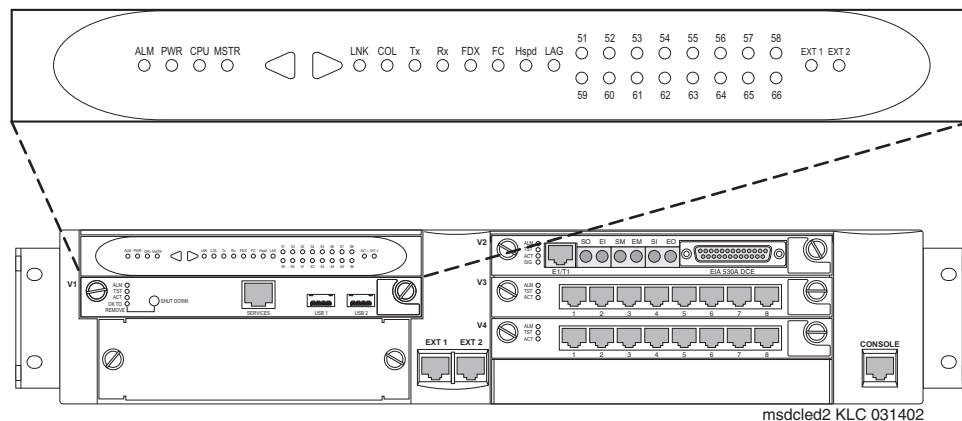
Figure 16: G700 LED Panel

[Figure 16: G700 LED Panel](#) shows an expanded view of the G700 LED panel.

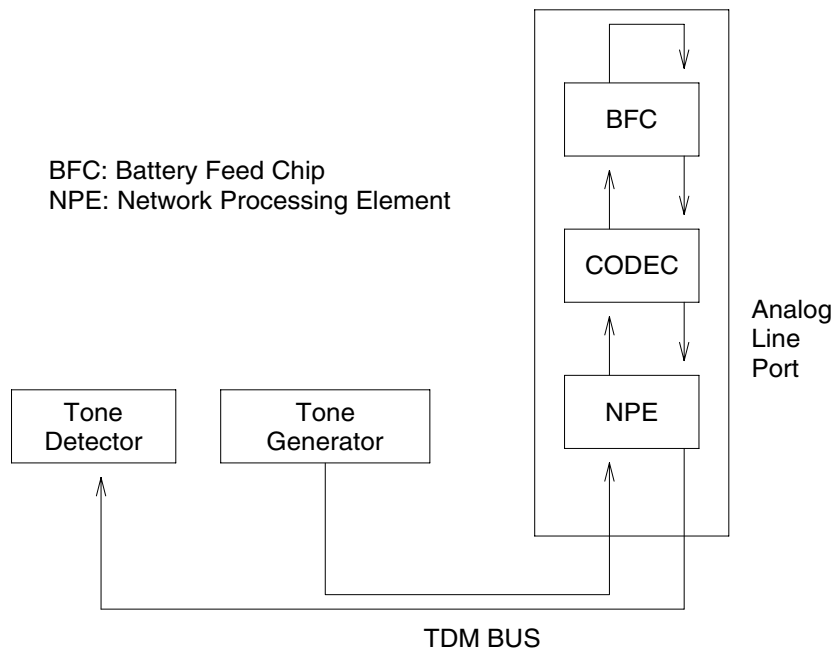
Figure 22: Analog Looparound and Conference Test

This test is designed to check the on-board transmission capabilities of the NPE, the codec, and the battery feed chip of the Analog port. A Tone Detector and a Tone Generator talk and listen on the same pair of time slots as the Analog port. The Analog port is then instructed to go into loop around mode (see [Figure 22: Analog Looparound and Conference Test](#) on page 433). The test passes if the signal measured by the Tone Detector is within acceptable limits.

This looparound test is sensitive to the length of the loop, the equipment in the loop, or the equipment terminating the loop, such as off-premises stations. If this test is causing a false alarm, use **change station** for this station and change the **Tests** field to **n**, to disable the test.

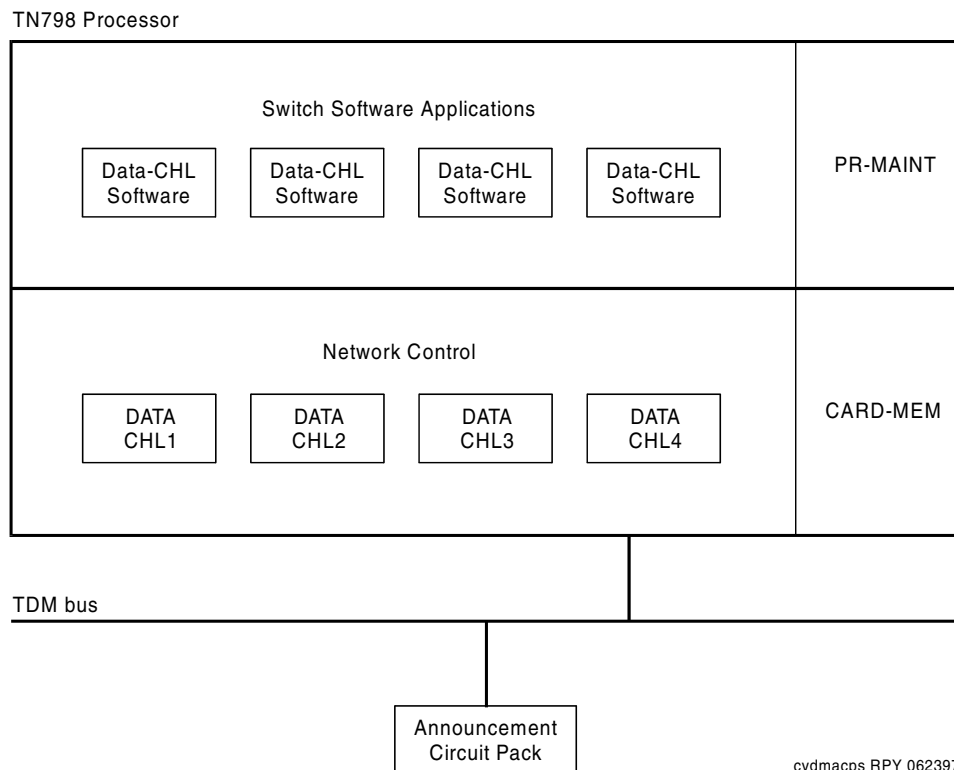
Figure 23: Connection of announcement circuit pack to the system

[Figure 23: Connection of announcement circuit pack to the system](#) on page 495 shows the connection of the Announcement Circuit Pack to the system. To save or restore announcements, an ANNOUNCEMENT Data Extension must be administered, and at least one DATA-CHL (Network Control Data Channel) must be in the in-service/idle state.

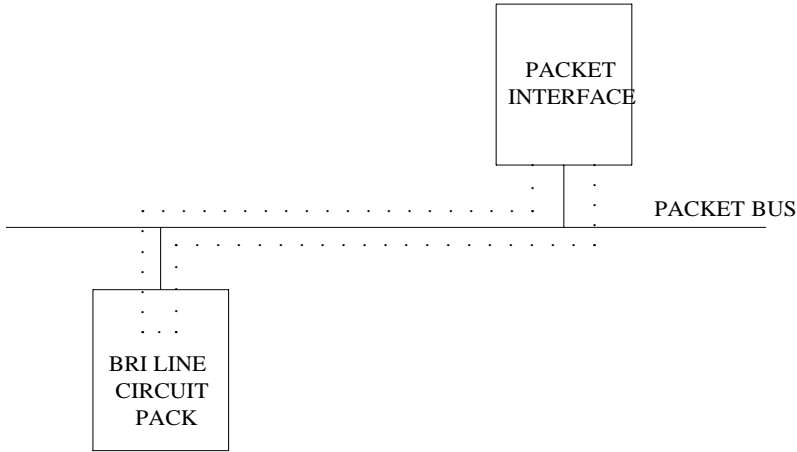
Figure 24: BRI Port Local LAN Loop-Around Path

The dotted lines in [Figure 24: BRI Port Local LAN Loop-Around Path](#) on page 515 show how a loop-around test is performed across the packet bus for the D channel.

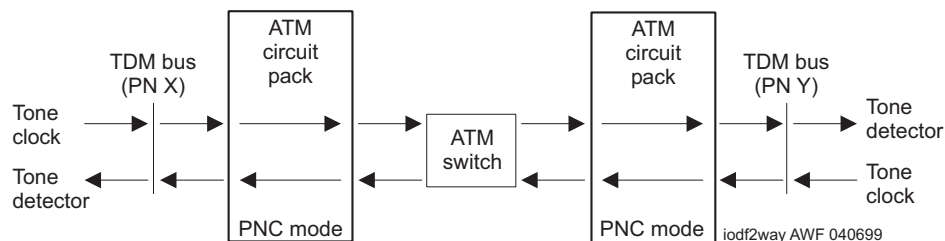
Figure 25: Expansion Interface 2-Way Transmit Test #241
PN X and PN Y represent any of 44 possible PNs.

The test results indicate if the test failed in one or both directions. The test aborts if the ATM-EIs do not exist on both ends (for example, the EIs are not administered correctly). If the test passes, the TDM and ATM framer interfaces of both ATM-EIs are functioning properly. If the test fails, a series of tests are run on the board. [Figure 25: Expansion Interface 2-Way Transmit Test #241 PN X and PN Y represent any of 44 possible PNs.](#) on page 563 shows a schematic of this test.

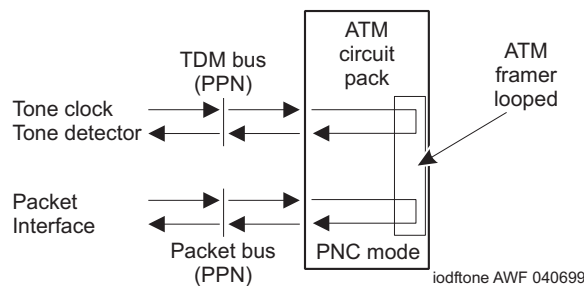
Figure 27: ATM Board Framer Loop-Around Test (#1260)

- **Circuit (TDM) path:** one of the Tone Generators sends a bit pattern through a TDM bus time slot to the ATM framer. The pattern is converted into ATM cells and is looped back to the ATM-EI board, which converts the cell back into the bit pattern and puts it on a pre-determined time slot. A Tone Detector tests for the bit pattern and reports the test result. This test verifies that a large portion of the ATM-EIs circuit paths are functioning correctly. [Figure 27: ATM Board Framer Loop-Around Test \(#1260\)](#) on page 580 shows a diagram of the test.

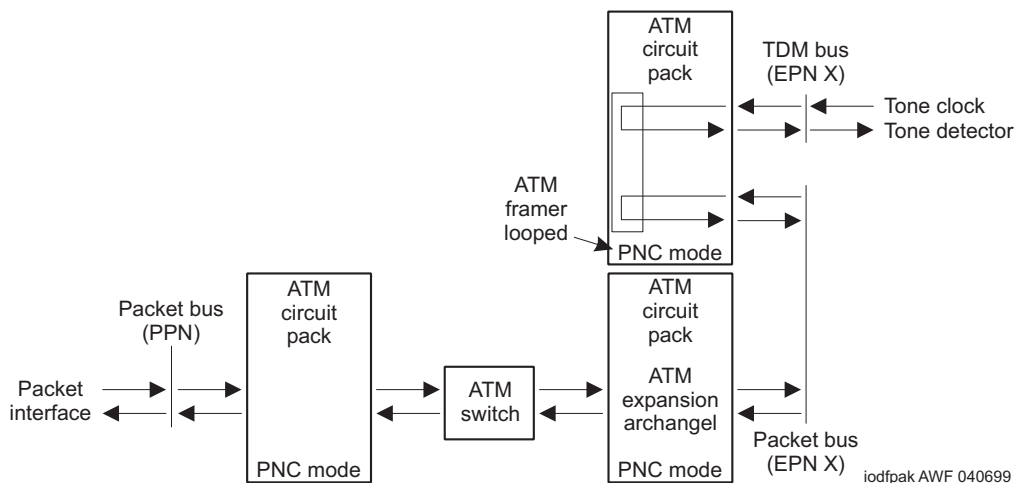
Figure 28: ATM Board Framer Loop-Around Test (#1260) (non-EAA, Packet Path)

- **Packet path:** the Packet Interface circuit pack sends packet data to the ATM framer interface, where it is mapped into ATM cells and then looped around internally. The cells are converted back to packet data after it has been looped. This portion of the test verifies correct operation of the ATM-EI's packet-bus interface and a large portion of the ATM-EI's packet paths. [Figure 28: ATM Board Framer Loop-Around Test \(#1260\) \(non-EAA, Packet Path\)](#) on page 581 shows the packet switched signal path for the ATM circuit pack.

This test verifies the operation of a large portion of the ATM-EI circuit and packet paths, but does not verify the optical portion of the lightwave transceiver. If this test passes, the ATM-EI circuit pack is functioning correctly, but faults can exist in the lightwave transceiver. If the test fails, the fault can be on the board.

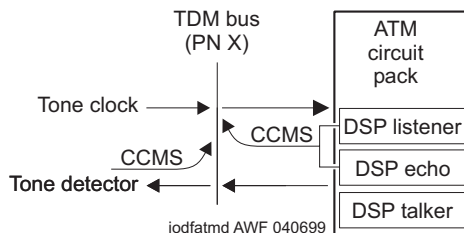
Figure 29: ATM Board DSP Test (#1293)

This test applies to TN2305 and TN2306 ATM-EIs, both active and standby, and is run as part of craft short and long testing, periodic, scheduled, initialization, and error analysis testing. Refer to [Figure 29: ATM Board DSP Test \(#1293\)](#) on page 587 for a diagram of this loop-around test.

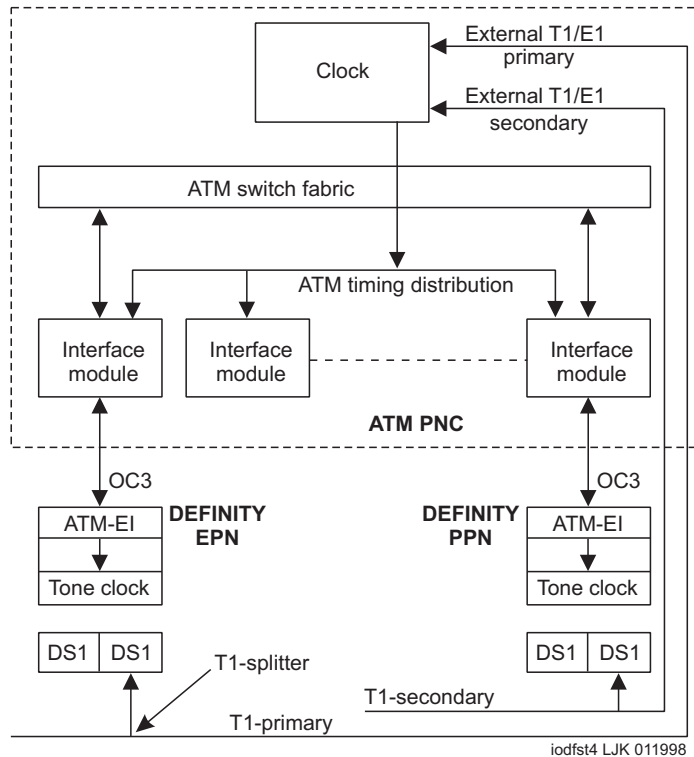
Figure 32: Stratum-4 Synchronization with Unduplicated ATM PNC

If the primary synchronization reference in [Figure 32: Stratum-4 Synchronization with Unduplicated ATM PNC](#) on page 632 is providing a valid timing signal, then the flow of system synchronization would travel from the DS1 interface circuit pack in the PN to the ATM switch. The primary DS1 interface circuit pack provides a timing signal for the ATM switch clock circuitry. This synchronization source is then distributed to all of its OC3 Interface Modules. Each ATM Expansion Interface circuit pack uses the received data stream from the ATM switch to generate a timing signal. The Tone-Clock circuits in the PNs use this signal to generate timing for every circuit pack in their respective PNs. All PNs, in the above mentioned scenario are designated the *slave* PNs. The ATM switch is the *master* that contains the system synchronization source. If the primary synchronization reference does not provide a valid timing signal, ATM synchronization maintenance infers a switch to the secondary reference.

[Figure 32: Stratum-4 Synchronization with Unduplicated ATM PNC](#) on page 632 depicts a simplex ATM PNC with T1/OC3 synchronization reference into the ATM switch.

The TN722 DS1 Interface circuit pack does not provide a synchronization reference as reliably as the TN767 or TN464 circuit packs. Therefore, administer the TN767 or TN464 circuit packs as the primary or secondary sources.

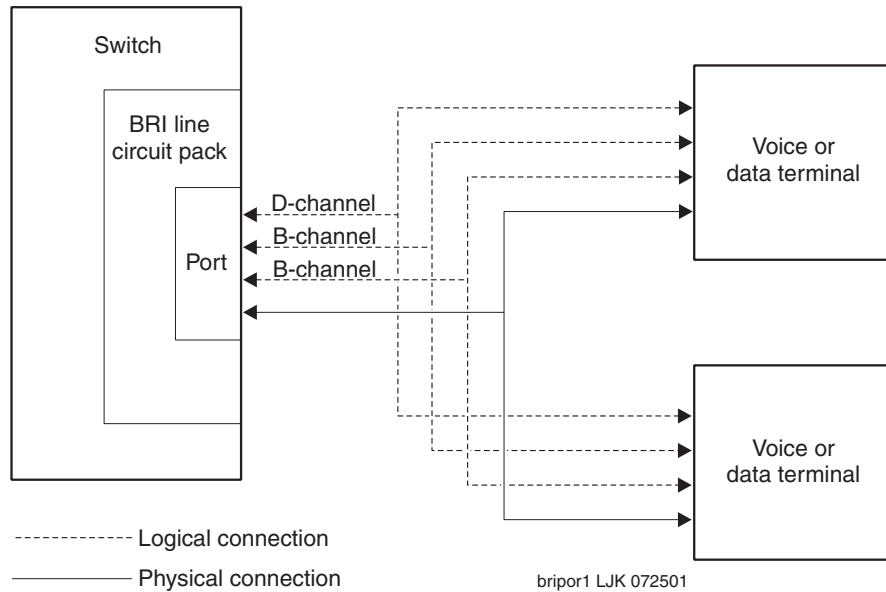
Figure 33: ISDN-BRI Port Interactions

[Figure 33: ISDN-BRI Port Interactions](#) on page 702 illustrates the physical connection (solid line) between an ISDN-BRI port and its associated ISDN-BRI set(s). Each physical connection allows for two B channels and one D channel. Each ISDN-BRI circuit pack can support up to 12 of these *physical* connections to different voice and voice/data sets or ASAI or Avaya adjuncts. On a TN2198 each ISDN-BRI circuit pack can support up to 12 *physical* connections to a NT1 which in turn connects to 2 terminals.

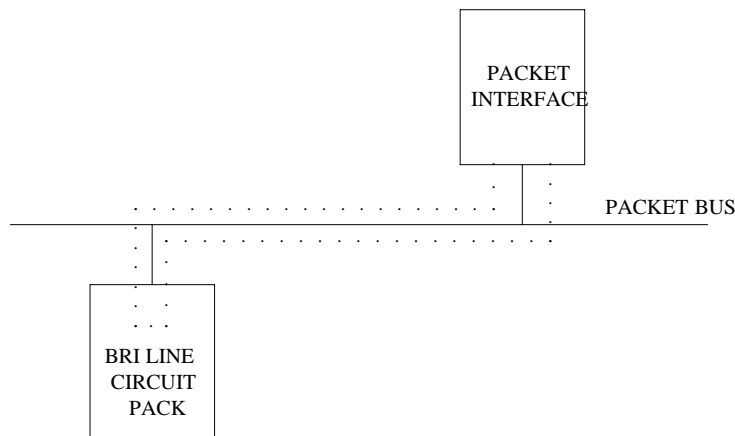
Figure 34: Path of the BRI Port Local LAN Loop Around

The dotted lines in [Figure 34: Path of the BRI Port Local LAN Loop Around](#) on page 708 show how a Loop Around test is performed across the packet bus for the D channel.

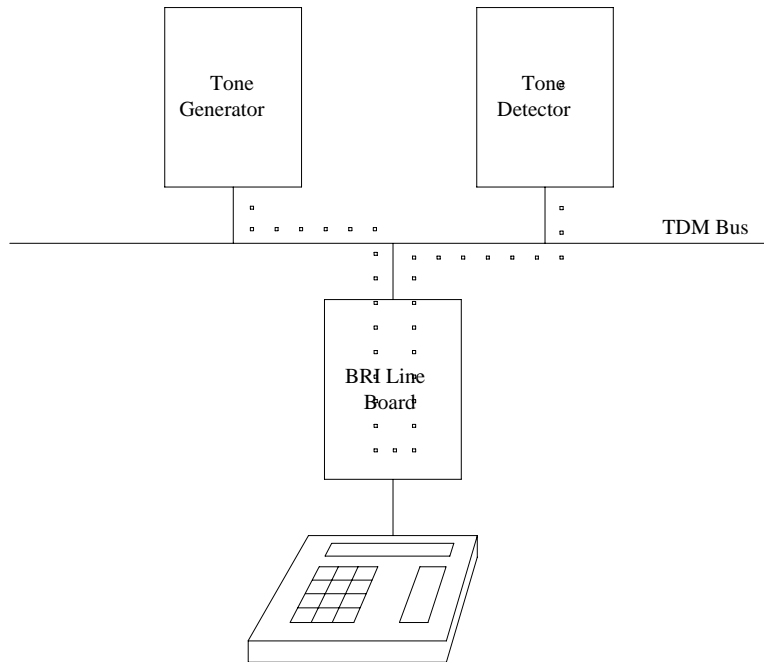
Figure 35: Path of the BRI Port Local TDM Loop Around

The dotted lines in [Figure 35: Path of the BRI Port Local TDM Loop Around](#) on page 711 show how a Loop Around test is performed for the B channels. The figure shows a terminal connected to a BRI line board using a TN556. If a TN2198 is used the terminal would be connected to a NT1, and the NT1 to the BRI board.

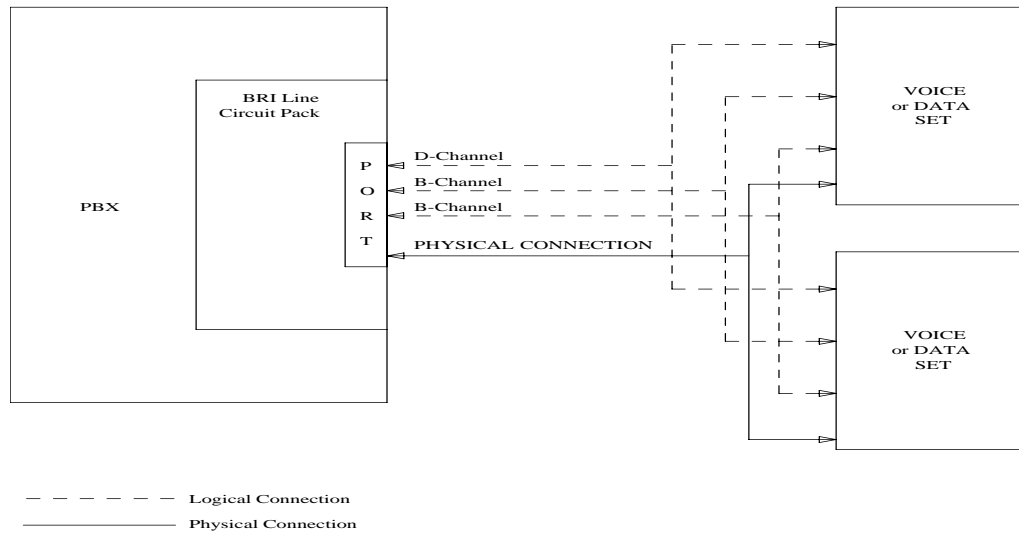
[Figure 36: ISDN-BRI Set Interactions](#) on page 725 illustrates the physical connection (solid line) between an ISDN-BRI circuit pack and a voice or voice/data set. Each physical connection allows for two B channels, as stated above, plus one D channel. Each ISDN-BRI circuit pack can support up to 12 of these PHYSICAL connections to different voice and voice/data sets or ASAI and Avaya adjuncts.

Figure 36: ISDN-BRI Set Interactions

This section contains the ISDN-BRI Set, ASAI Adjunct and Avaya Adjunct Maintenance documentation. Some of the results of maintenance testing of the ISDN-BRI Set or the ASAI and Avaya Adjunct may be affected by the health of the ISDN-BRI circuit pack and port. These interactions should be kept in mind when investigating the cause of ISDN-BRI Set problems.

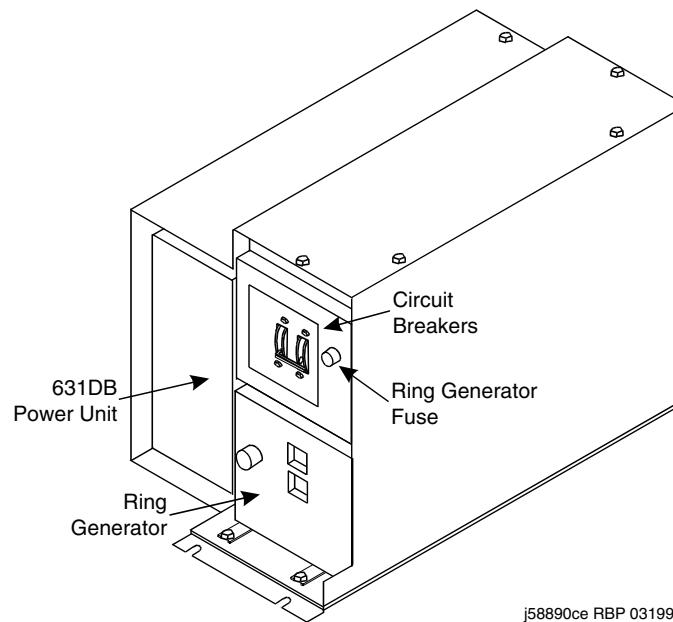
[Figure 37: AC Power-Distribution Unit \(J58890CE-2\): Front](#) on page 786 shows an AC power-distribution unit (List 9 or List 10). This unit sits at the bottom of some multicarrier cabinets.

Figure 37: AC Power-Distribution Unit (J58890CE-2): Front

The AC power-distribution unit contains the following components:

- Circuit breaker
- Electromagnetic Interference (EMI) filter
- Ring generator
- AC input fuse
- 20-Amp fuses
- Signal connector
- -48 VDC fan power

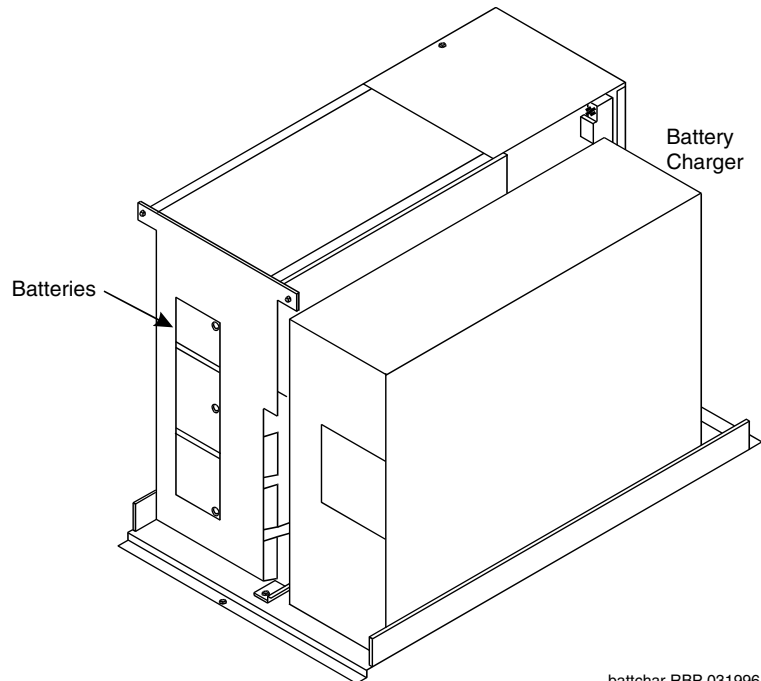
battchar RBP 031996

The optional battery charger (List 11) sits at the bottom of some multicarrier cabinets. See [Figure 38: Battery Charger \(Optional Part of J58890CE-2\): Front](#) on page 787.

Figure 38: Battery Charger (Optional Part of J58890CE-2): Front

The charger is used only without an uninterruptible power supply (UPS). The charger contains:

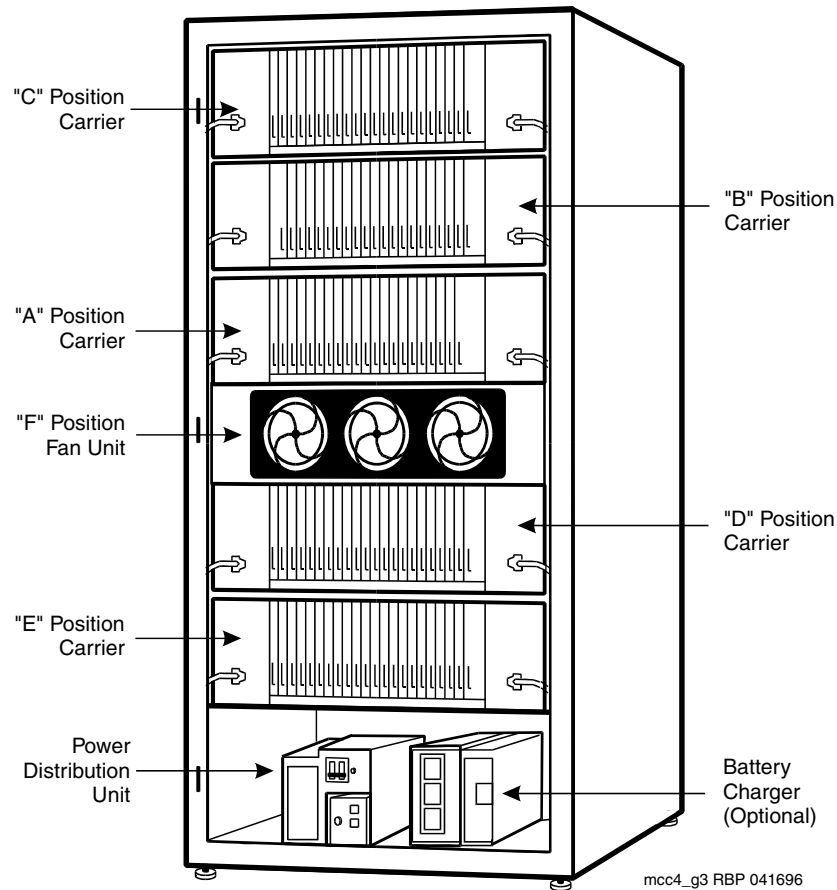
[Figure 39: AC Power Distribution in Multicarrier Cabinets](#) on page 788 shows AC power distribution in some multicarrier cabinets. The DC power-distribution cables are on both sides of the cabinet. **These cables supply power to each of the carriers.** The optional battery charger is at the right side of the power-distribution unit.

Figure 39: AC Power Distribution in Multicarrier Cabinets

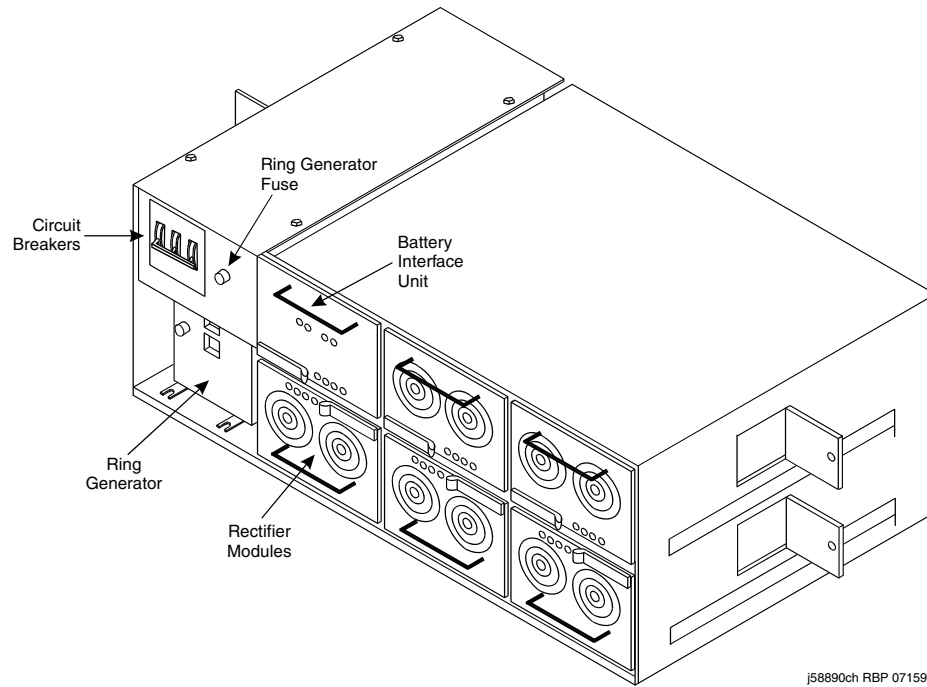
In AC-powered cabinets, the power-distribution unit (J58890CH-1), distributes 170 to 264 VAC from a wall outlet to a set of BU3200A Battery Interface Units (BIU). See [Figure 40: AC Power-Distribution Unit \(J58890CH-1\): Front](#) on page 789 and [Figure 41: Power-Distribution Unit \(J58890CH-1\)](#) on page 790.

Figure 40: AC Power-Distribution Unit (J58890CH-1): Front

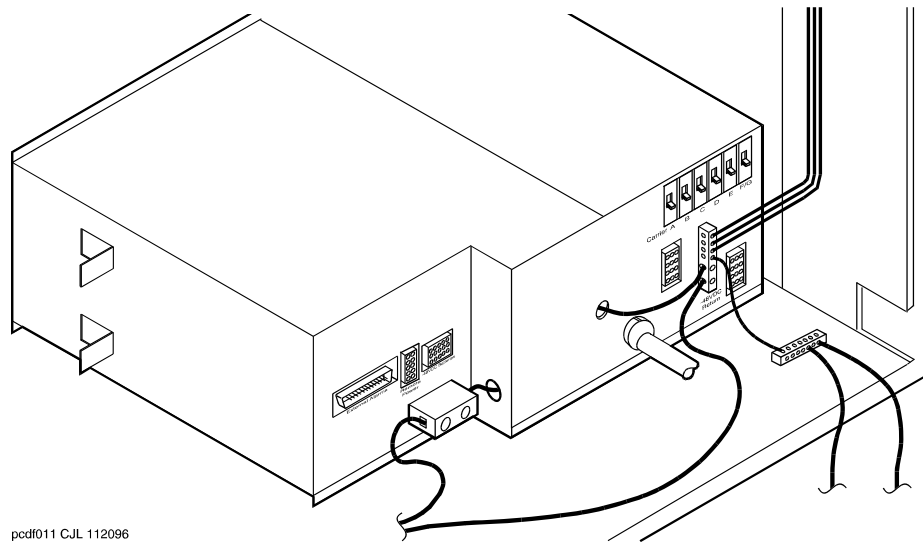
Figure 41: Power-Distribution Unit (J58890CH-1)

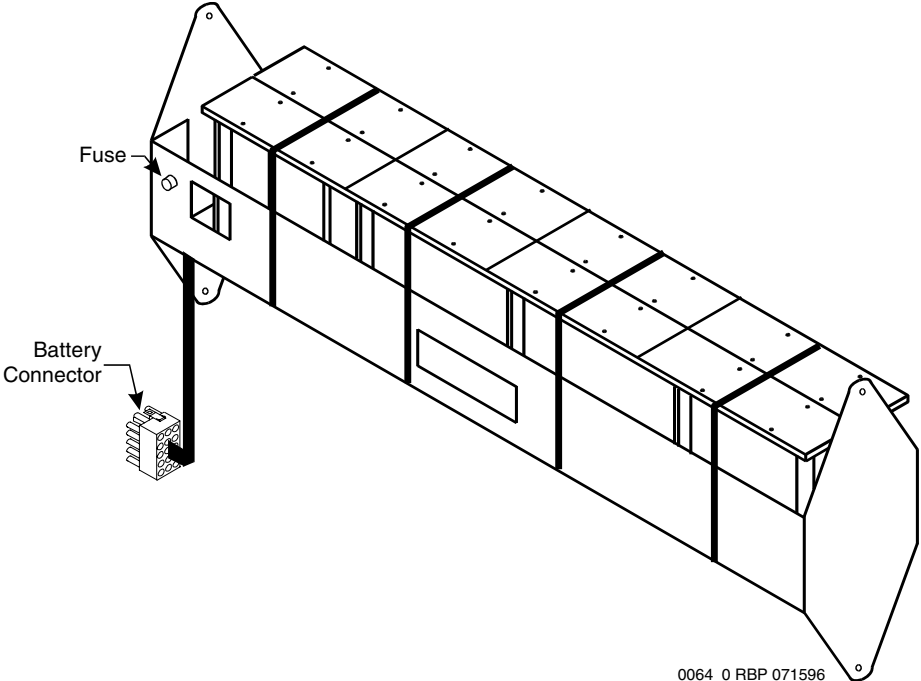
[Figure 42: Small Battery Assembly](#) on page 791 shows the small battery assembly.

Figure 42: Small Battery Assembly

The small battery is at the center rear of the multicarrier cabinet. This 8-AH (Amp Hour) battery is fused for short circuit protection and is charged by the J58890CH-1. The batteries also contain a thermal sensor that changes the charging voltage depending on battery temperature.

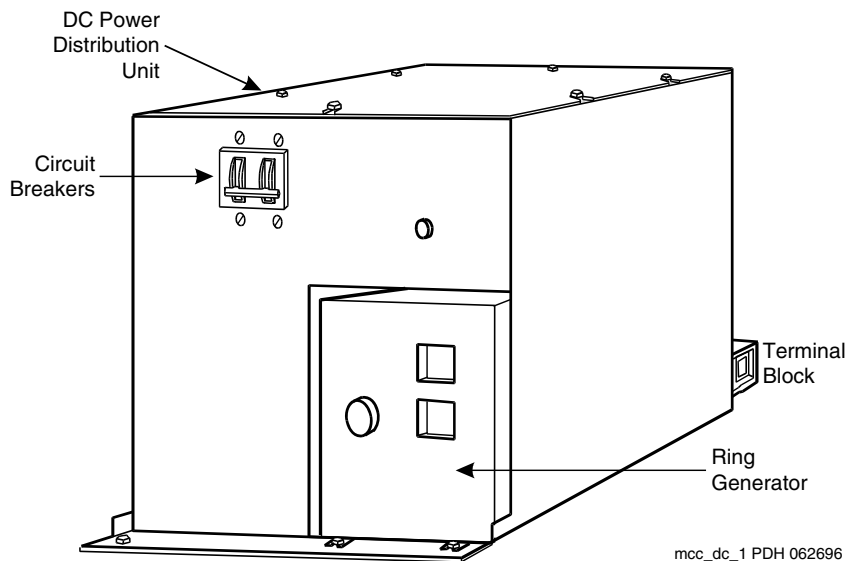
[Figure 43: DC Power-Distribution Unit \(J58890CF-2\): Front](#) on page 792 shows a power-distribution unit in some DC-powered multicarrier cabinets. The unit sits at the bottom of the cabinet and contains the ring generator, 20-Amp circuit breakers, terminal blocks, and system fan power.

Figure 43: DC Power-Distribution Unit (J58890CF-2): Front

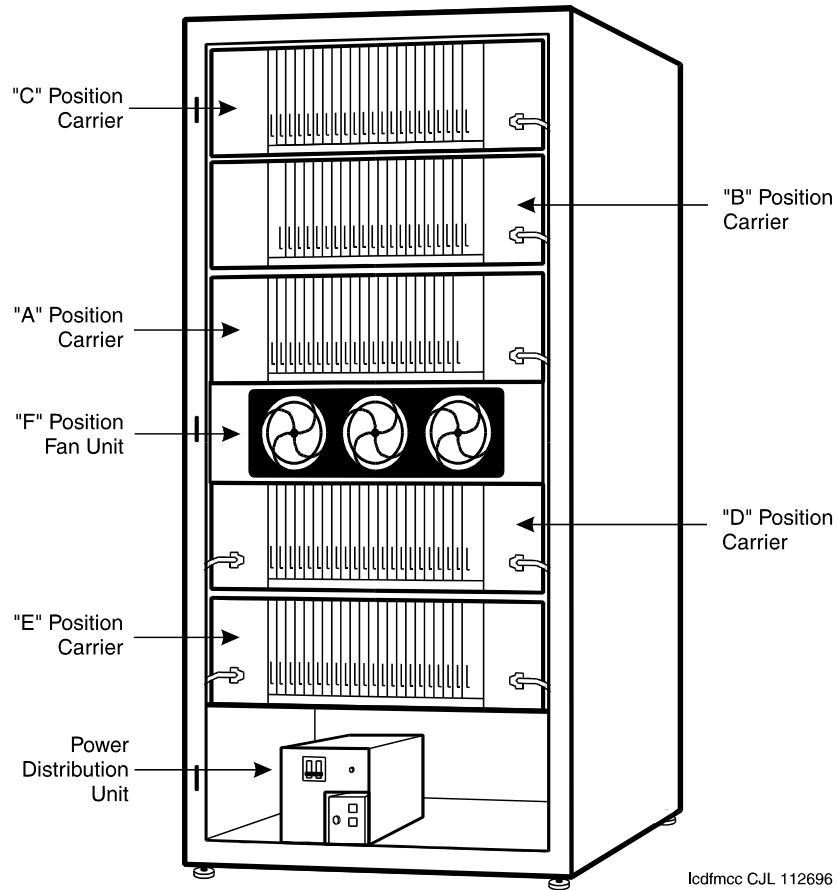
[Figure 44: Typical Multicarrier Cabinet with 649A Power Units](#) on page 793 shows a typical AC-powered multicarrier cabinet.

Figure 44: Typical Multicarrier Cabinet with 649A Power Units

Some carriers may contain two power supplies, the 644A and the 645B, that together supply the required voltages to the carrier. Other carriers may contain one 649A power supply located on the right side of the carrier. In these systems, an additional 649A is located on the right of the optional switch node carriers.

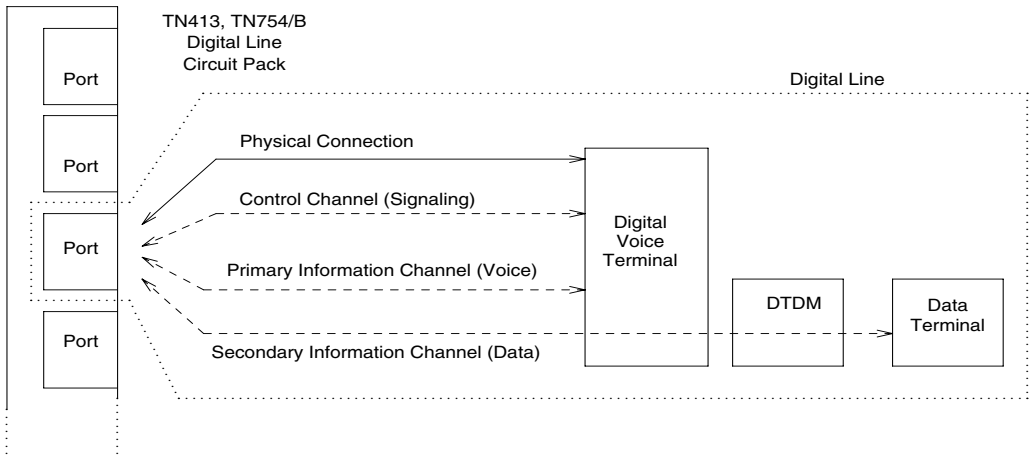
Figure 45: Digital Line Connectivity

Each digital line port supports two 64 kbps information channels (primary and secondary) and one 8kbps signaling channel. Digital voice terminals always use the primary information channel, and only one voice terminal can be connected to each port. The secondary information channel can be used to connect a data terminal via a Digital Terminal Data Module (DTDM) or a Data Adaptor (DA). All other devices currently supported by Digital Line circuit packs communicate on the primary information channel. [Figure 45: Digital Line Connectivity](#) on page 937 shows examples of digital line connectivity.

The TN2181 and TN2224B/CP support both modes as shown in [Figure 45: Digital Line Connectivity](#) on page 937 and [Figure 46: Digital Line Connections](#) on page 937.

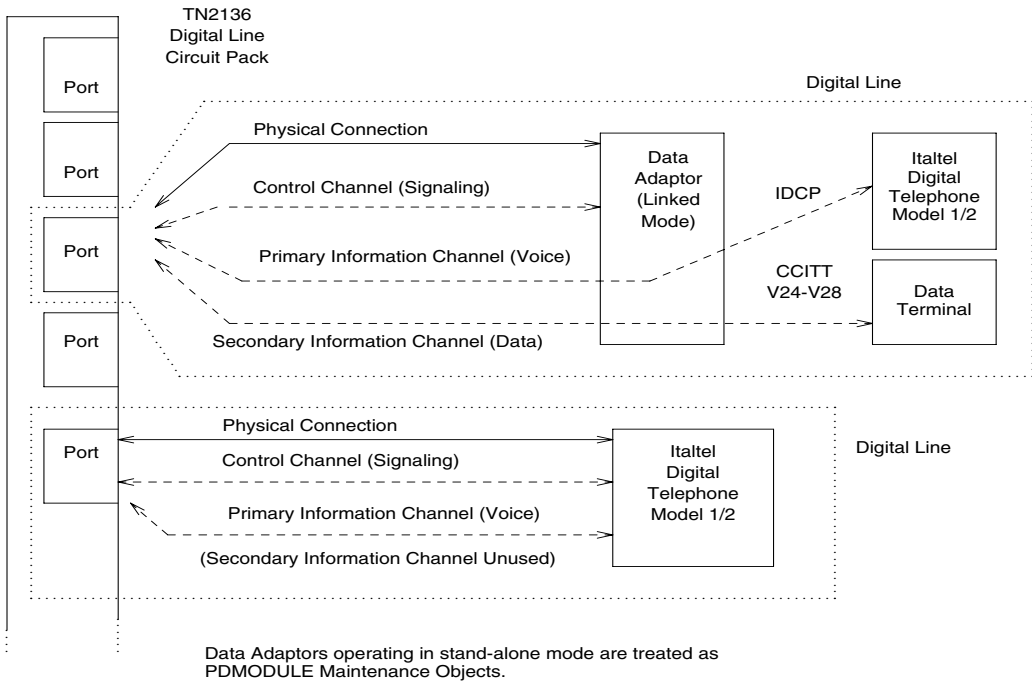
Figure 46: Digital Line Connections

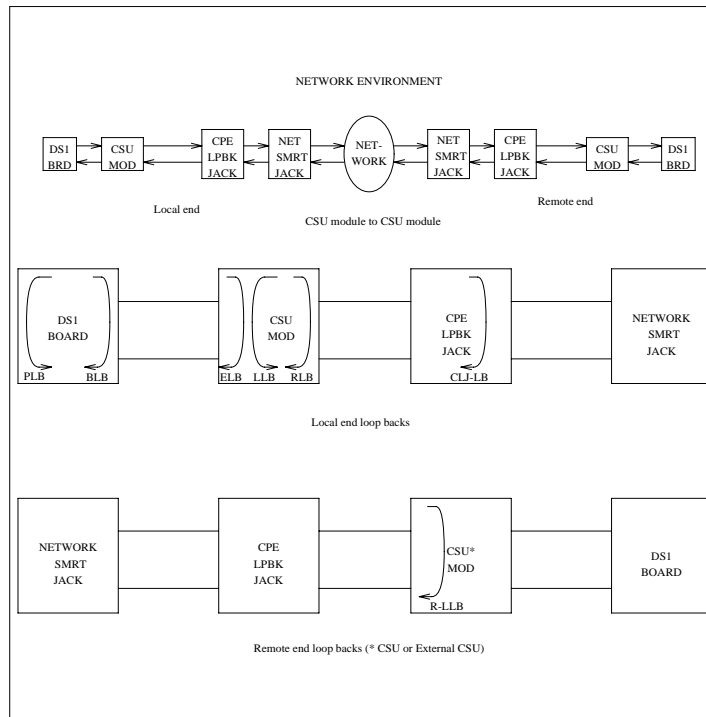
Figure 49: High-Level Overview Of Loop-Back Points

These loop-back tests are explained in detail later in this DS1-BD section, but [Figure 49: High-Level Overview Of Loop-Back Points](#) on page 991 gives a high-level overview of the loop-back points.

The following list of acronym definitions are for [Figure 49: High-Level Overview Of Loop-Back Points](#) on page 991:

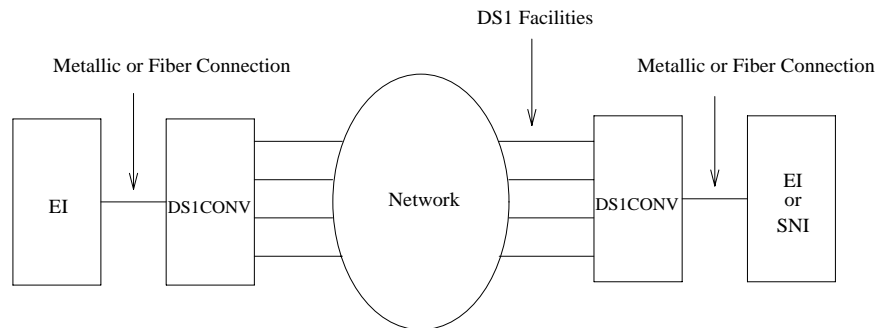
DS1 converter circuit packs are connected to the Expansion Interface (EI) circuit packs (TN570) and the Switch Node Interface (SNI) circuit packs (TN573) as shown in [Figure 50: DS1 Converter Complex and the DS1 Facilities](#) on page 1065.

Figure 50: DS1 Converter Complex and the DS1 Facilities

The DS1 converter complex can replace fiber links between two EIs and fiber links between an PN's EI and an SNI. Fiber links between two SNIs and fiber links between the and the Center Stage Switch (CSS) cannot be replaced by a DS1 converter complex.
