Maintenance Alarms for Avaya Communication Manager 3.1.x, Media Gateways and Servers

03-300430
Issue 2.1
June 2006

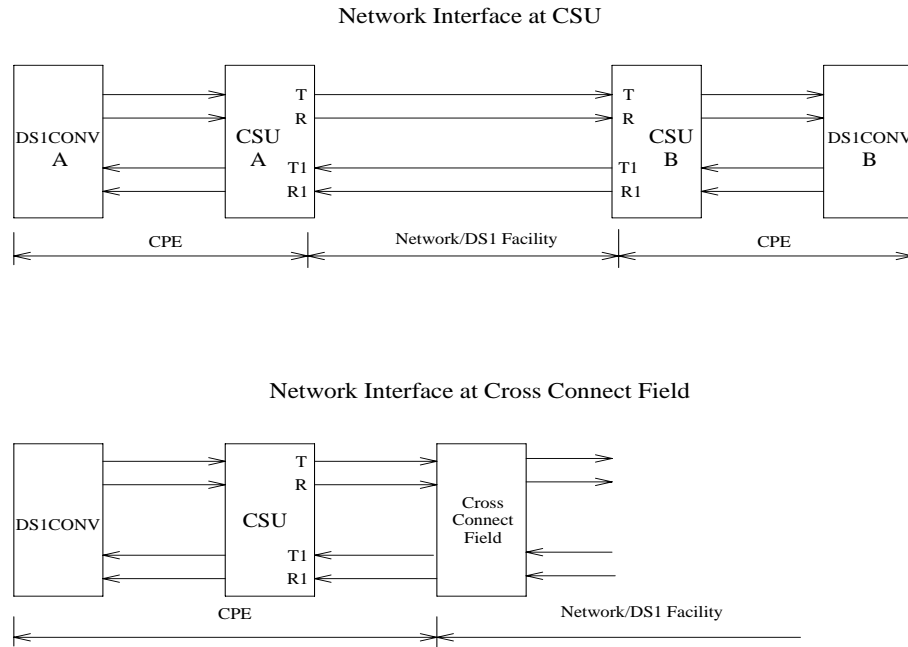
Figure 51: DS1 Facility Connections

For the following repair procedure, see to [Figure 51: DS1 Facility Connections](#) on page 1079 and the diagrams in the related test descriptions.

For the following repair procedure, see [Figure 51: DS1 Facility Connections](#) on page 1079 and the diagrams in the related test descriptions.

1. Check the loop-back LEDs on both CSU A and CSU B as shown in [Figure 51: DS1 Facility Connections](#) on page 1079 to see if a CSU is in a loop-back mode. Also check to see if the CSUs have been manually hard-wired into a loop-back mode. Remove detected loop backs.

To isolate a problem, set the loop back first at the loop-back point LB 1, and then at the loop-back point LB 2, see [Figure 54: Loopback Points for Test #799](#) on page 1085 and [Figure 51: DS1 Facility Connections](#) on page 1079. Place the loop backs at as many points as your CSU capabilities will allow. Hard-wired loop backs at the far end are not desirable, because the equalization-level adjustments may cause problems.

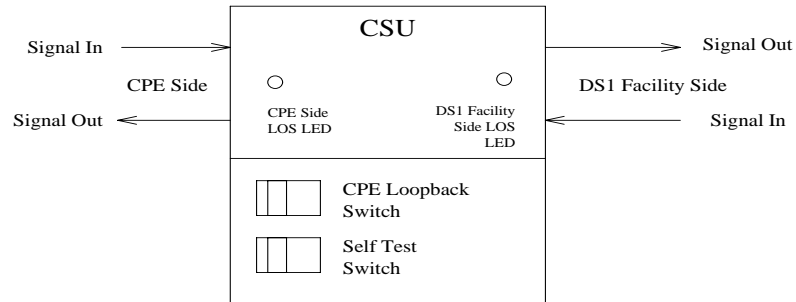
Figure 52: Typical CSU Maintenance Capabilities

Fault isolation for this problem may be different depending on the capabilities of the CSU device that is being used. Typically, CSUs provides an LED that is useful for fault isolation (see [Figure 52: Typical CSU Maintenance Capabilities](#) on page 1079). This is the “16 Zeros” LED. This LED is momentarily lit when a string of 16 consecutive zeros is detected in the DS1 signal from the DS1 converter. Zeros on a DS1 link are represented by an absence of a pulse. Thus, an active 16 Zeros LED indicates a LOS alarm from the DS1 converter.

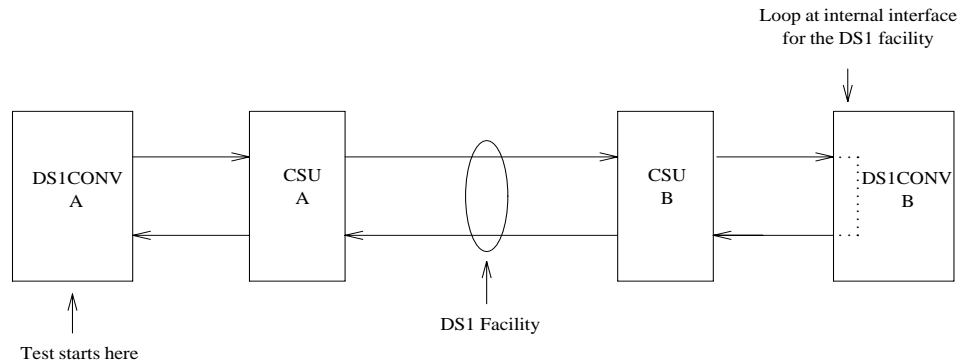
Figure 53: Far-End Internal Loop-Back Test (#797)

If the test passes on a TN1654 DS1 facility, the *round trip delay time* appears in milliseconds in the `Error Code` field. The round trip delay time is the length of time in milliseconds it takes for the firmware to receive the test pattern after it has been sent.

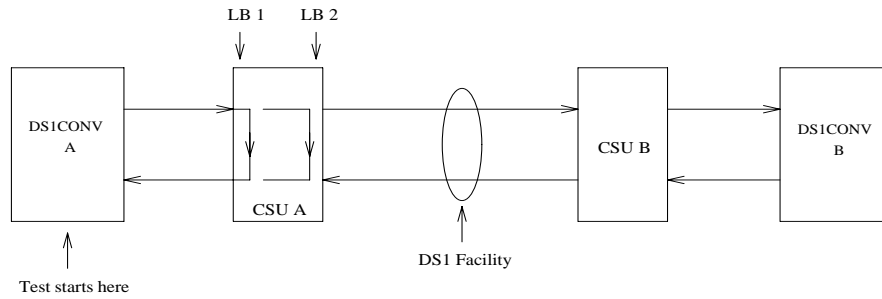
Figure 54: Loopback Points for Test #799

If the test passes on a TN1654 DS1 facility, the *round trip delay time* will be displayed in milliseconds in the `ERROR Code` field. The round trip delay time is defined as the length of time in milliseconds it takes for the firmware to receive the test pattern after it has been sent. This measurement is taken on the last DS1 channel tested.

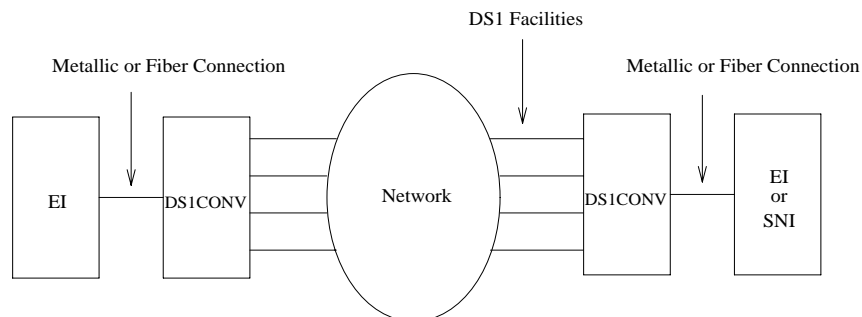
Figure 55: DS1 converter connection to EIs and SNIs

DS1 converter circuit packs connect to TN570 Expansion Interface (EI) circuit packs and TN573 Switch Node Interface (SNI) circuit packs via metallic cables as shown in [Figure 55: DS1 converter connection to EIs and SNIs](#) on page 1089. A fiber link cable can be used instead of the metallic cable if it is necessary to locate the DS1 converter far from the connected EI or SNI circuit pack, for example, in an adjacent cabinet.

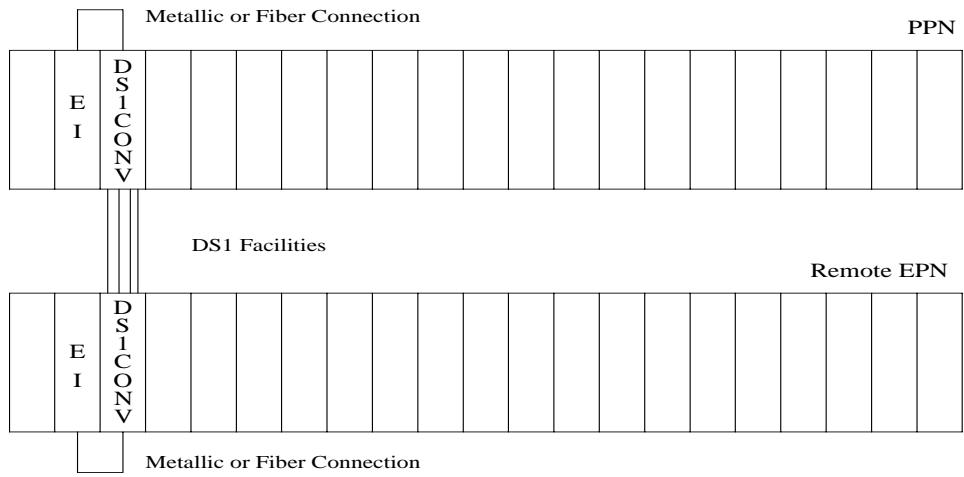
Figure 56: DS1 converter Complex in Direct Connect PNC

[Figure 56: DS1 converter Complex in Direct Connect PNC](#) on page 1090 and [Figure 57: DS1 Converter Complex in Duplicated PNC with 1 SN](#) on page 1091 show DS1 converter connections in a direct-connect PNC configuration and between the CSS and an PN in a critical-reliability system configuration (duplicated PNC).

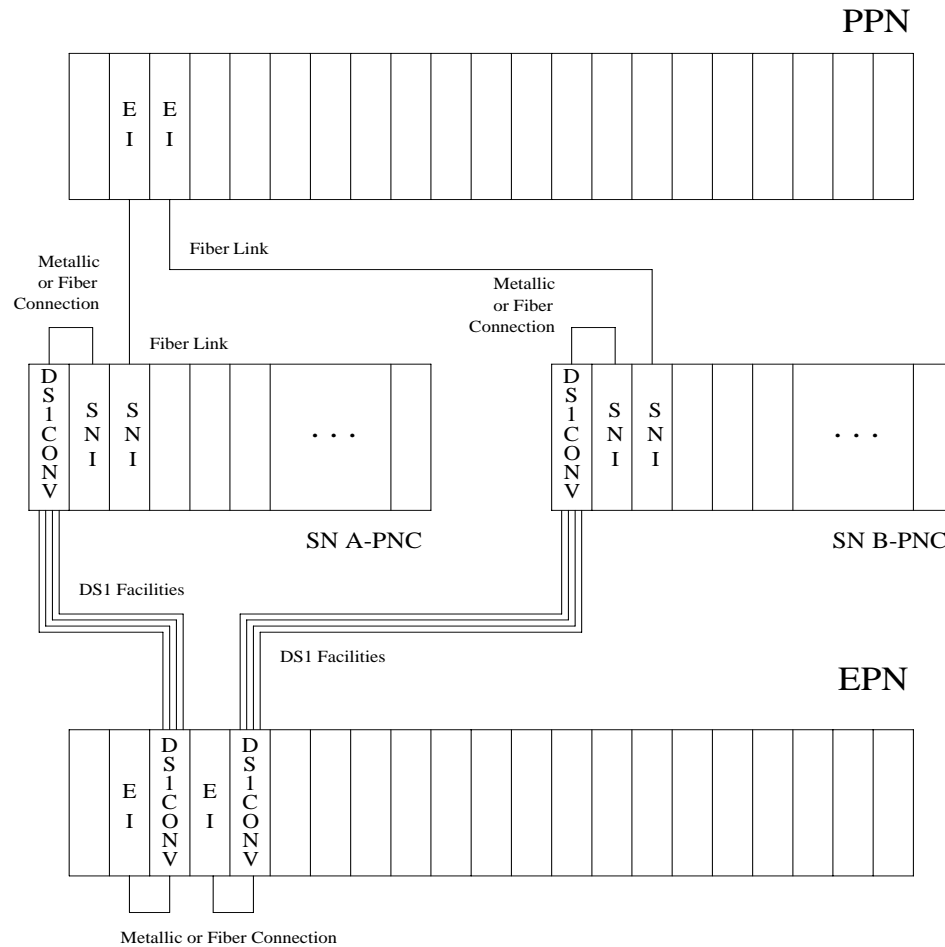
Figure 57: DS1 Converter Complex in Duplicated PNC with 1 SN

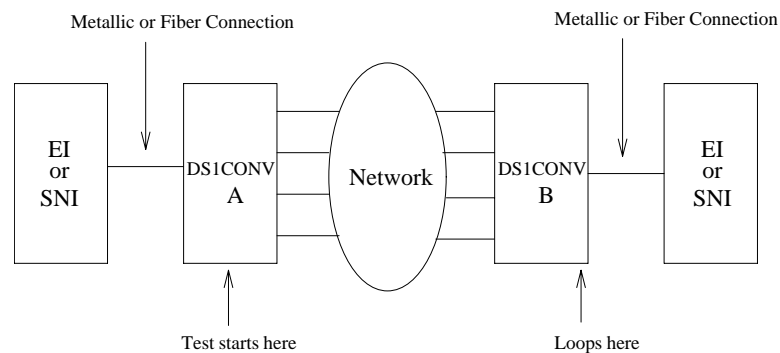
Figure 58: Far-End DS1 Converter Loop-Back Test (#788)

This test starts at the DS1 converter circuit pack whose equipment location was entered, and loops all fiber time slots at the far edge Fiber Optic Interface of the DS1 converter circuit pack at the other end of the DS1 converter complex. See [Figure 58: Far-End DS1 Converter Loop-Back Test \(#788\)](#) on page 1114.

For a standard-, duplex-, or high-reliability system (no PNC duplication), this test can only be executed at the endpoint that is closer to the media server relative to the neighbor DS1 converter circuit pack, because of its impacts on the system control links. The completion of the test is delayed in this configuration to wait for the recovery of the system control links. For a critical-reliability system (PNC duplication), test can be executed at any DS1 converter circuit pack.

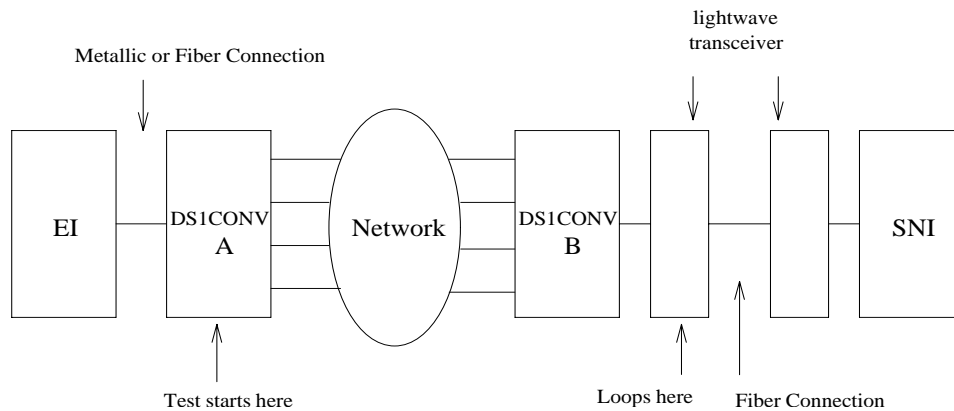
Figure 59: Far-End Lightwave Transceiver Loop-Back Test

For a standard-, duplex-, or high-reliability system (no PNC duplication), this test can only be executed at the endpoint that is closer to the media server relative to the neighbor DS1 converter circuit pack because of its impacts on the system control links, also the completion of the test will be delayed in this configuration to wait for the recovery of the system control links. For a critical-reliability system (PNC duplication), the test can be executed at any DS1 converter circuit pack.

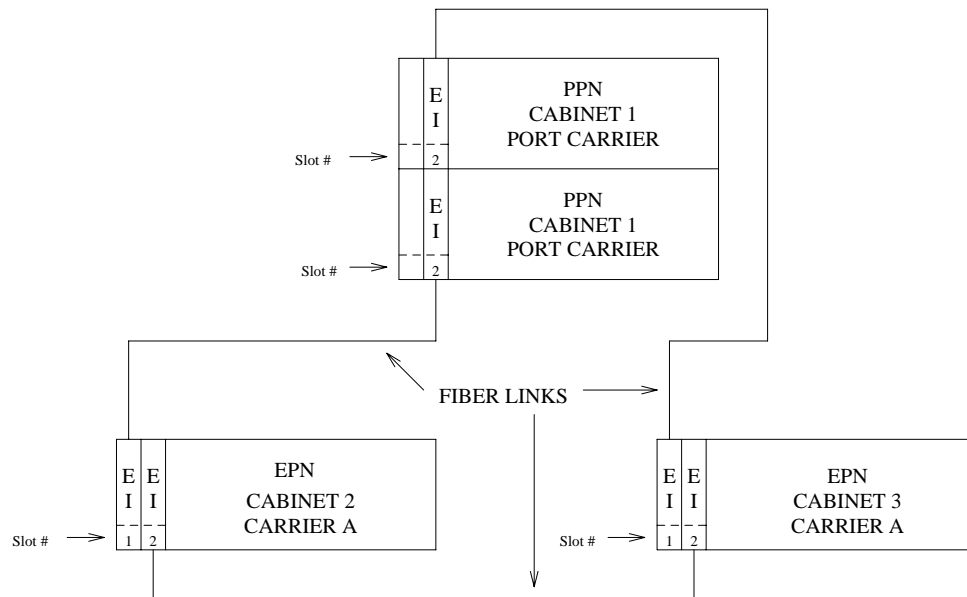
[Figure 61](#) shows the location of the EI circuit packs in a typical unduplicated PNC, direct connect configuration.

Figure 61: Direct Connect Configuration with Unduplicated PNC

Each PN in a direct-connect configuration must be connected to the other PNs through a fiber link. Each PN has one EI that functions as an Archangel. This EI must be connected with fiber to an EI. If an EI is functioning as an Archangel (bus master), its amber LED will be flashing at a rate of 2 seconds on and 200 ms off.

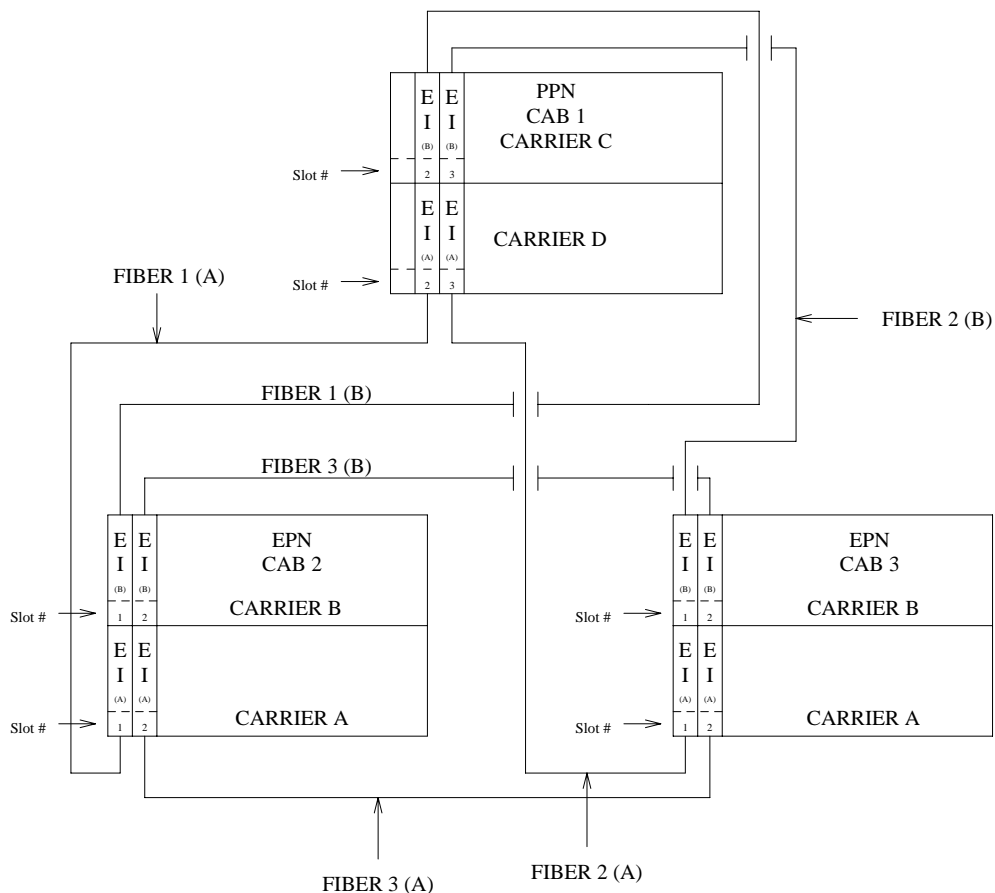
[Figure 62](#) shows the location of EI circuit packs in a typical duplicated PNC, direct-connect configuration.

Figure 62: Direct Connect Configuration with Duplicated PNC

In a duplicated PNC there is an A-side and a B-side PNC. Every EI in this diagram is labeled with an A or a B designating to which PNC it belongs. Note that a PNC's designation (A or B) does not relate directly to the carrier where its EIS reside. Again, only one of a PN's EIs can function as the Archangel (TDM-bus master). A PN's EI that is:

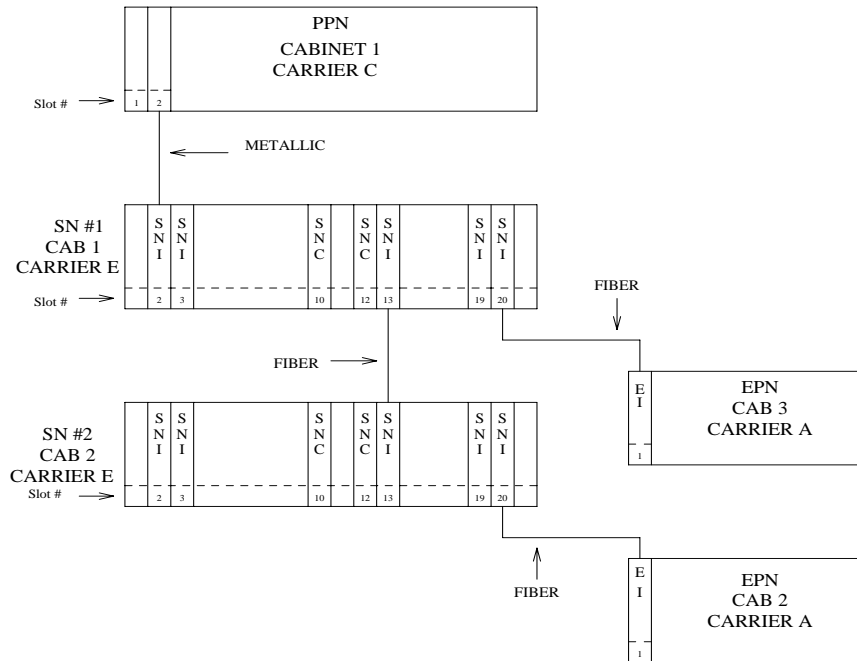
Figure 63 shows the location of EIs in a typical center stage switch configuration with unduplicated PNC.

Figure 63: Center Stage Switch Configuration with Unduplicated PNC

For an unduplicated center stage switch configuration, only one EI is needed in each PN. Notice that there is no direct connection between the PNs, rather every inter-PN connection is made through the center stage switch. Each SNI in the switch node carriers can be connected to a PN through an EI circuit pack.

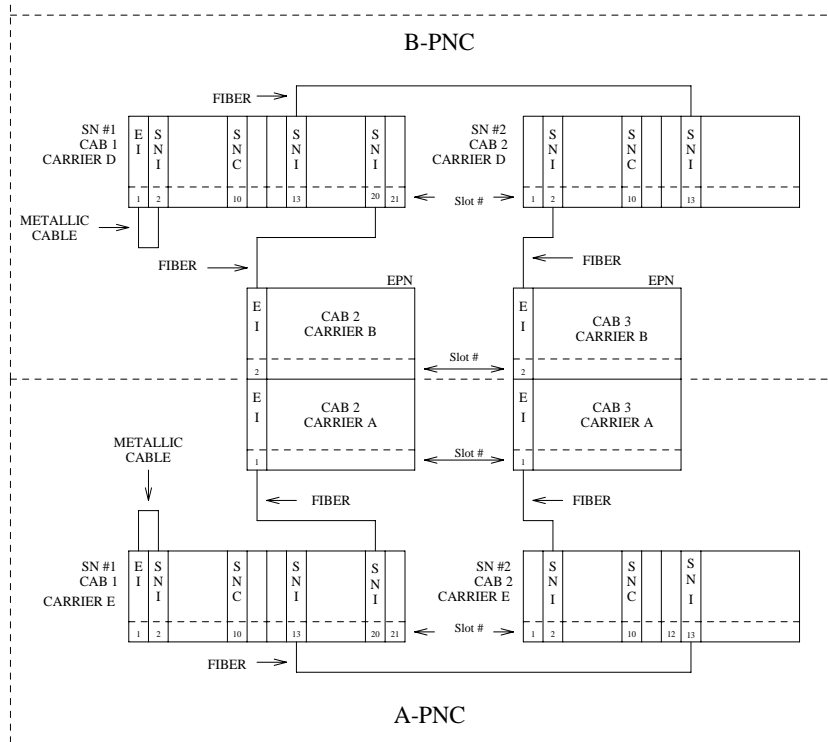
Figure 64: Center Stage Switch Configuration with Duplicated PNC

In a duplicated center stage switch configuration, two EIs are needed in each PN. One resides in the PNC's A side and one in the B side. Note that a PNC designation (A or B) does not directly designate the carrier where an EI resides. The active PNC's EI is the one acting as the PN's Archangel (TDM bus master). This EI's amber LED should be blinking at a rate of 2 seconds on and 200 ms off. Whereas, the amber LED on standby PNC's EI should be off.

Figure 64: [Center Stage Switch Configuration with Duplicated PNC](#) on page 1188 shows the location of EIs in a typical two Switch Node Center Stage Switch configuration with duplicated PNC.

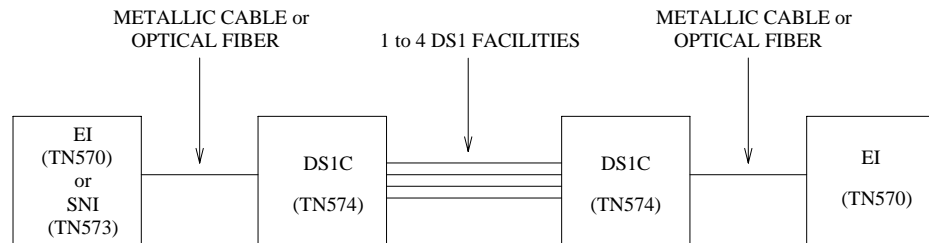
A PN (and thus, the EIs contained within it) can be remoted via a DS1 Converter complex. This requires that a fiber link (providing connectivity to the remoted PN) be administered with an associated DS1 Converter complex. This complex consists of two TN574 DS1 Converter (DS1C-BD) circuit packs connected by from 1 to 4 DS1 facilities. [Figure 65: Fiber Link with DS1 Converter Complex](#) on page 1189 shows where the DS1 converter complex fits into an EI-to-SNI or EI-to-EI fiber link. For more information, see [DS1C-BD](#) on page 1088.

Figure 65: Fiber Link with DS1 Converter Complex

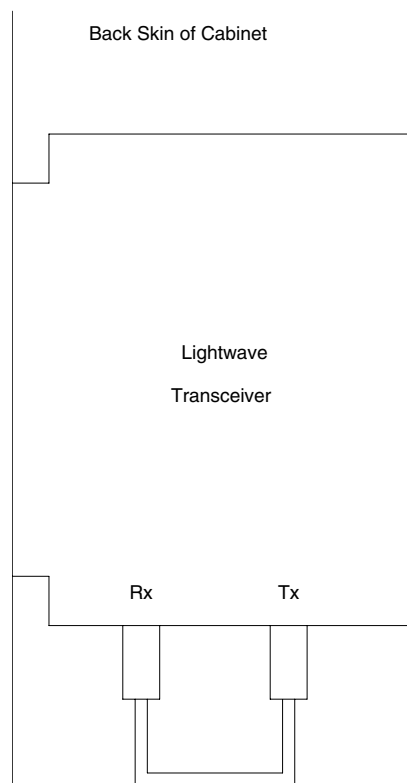
Figure 66: Interconnection of Lightwave Transceiver Transmit/Receive Jacks

3. Using a fiber jumper cable, interconnect the transmit and receive jacks of the lightwave transceiver as shown in [Figure 66: Interconnection of Lightwave Transceiver Transmit/Receive Jacks](#) on page 1200.

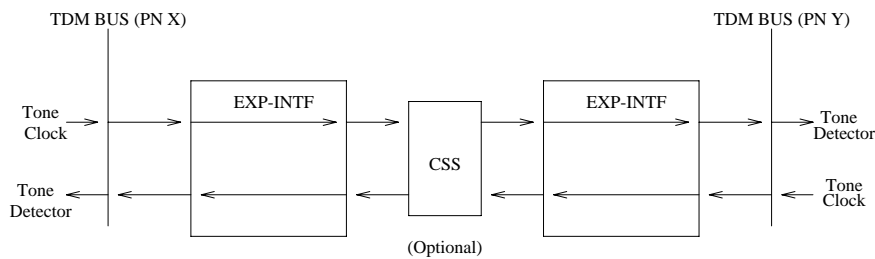
Figure 67: Two-Way Circuit Switch Transmission Test

The path used in this test is represented in [Figure 67: Two-Way Circuit Switch Transmission Test](#).

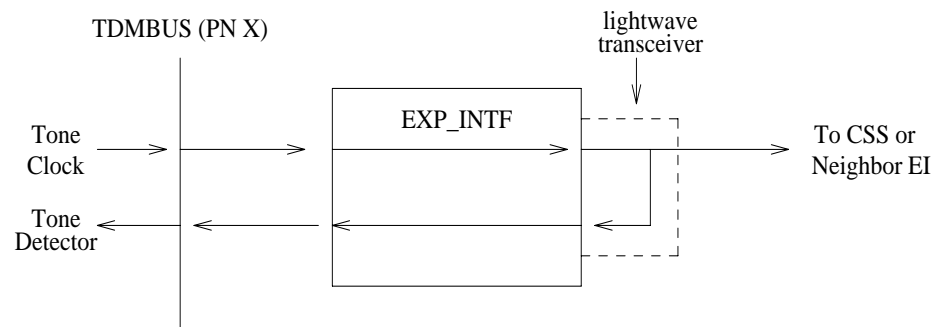
Figure 68: TDM BUS Lightwave Transceiver Looparound

This is a 2-part connectivity test. In the first part of the test, a digital count is transmitted from the cabinet of the EI circuit pack under test, through the EI circuit pack under test, out to its lightwave transceiver. The connection then loops back into the lightwave transceiver, through the same EI circuit pack again, and into the originating cabinet. If the test tone is detected by a tone detector, the first part of the test passes. The path used for this part of the test is represented in [Figure 68: TDM BUS Lightwave Transceiver Looparound](#) on page 1219.

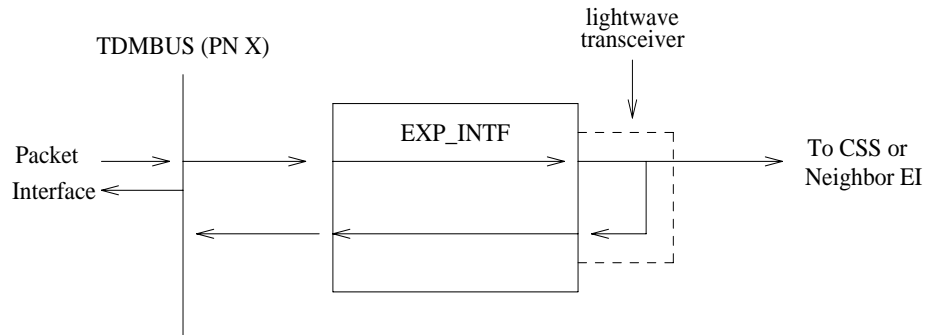
Figure 69: Packet Bus Lightwave Transceiver Looparound—PN only

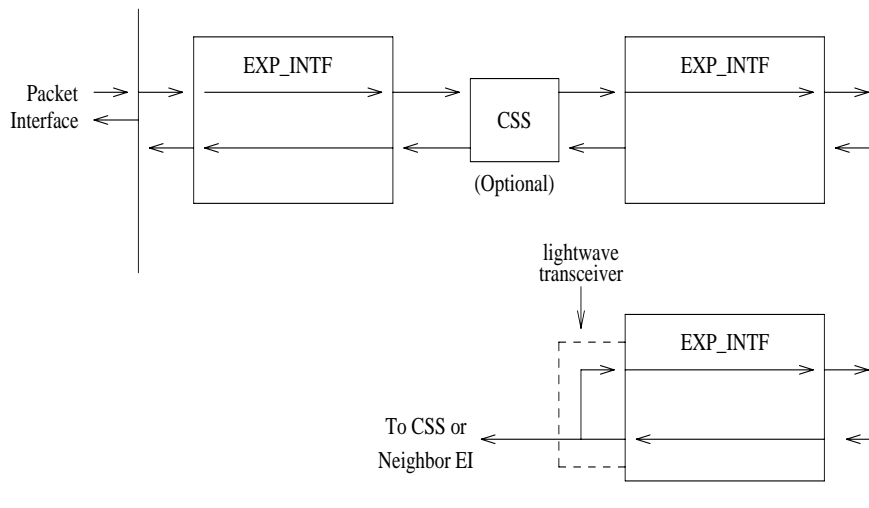
Figure 70: Packet Bus Lightwave Transceiver Looparound—CSS and PN

In the second part of the test, a data packet is sent from the TN1655 Packet Interface circuit pack to the EI circuit pack under test, the packet is looped back through the lightwave transceiver and is sent back to the Packet Interface circuit pack. If the Packet Interface circuit pack receives the same packet it transmitted, the second part of the test passes. If the entire test has passed, the EI circuit pack, its backplane wiring, and the electrical portion of the lightwave transceiver are healthy. The path used for this test is represented in [Figure 69: Packet Bus Lightwave Transceiver Looparound—PN only](#) on page 1220. The path used for this test if the EI resides in a PN is represented in [Figure 70: Packet Bus Lightwave Transceiver Looparound—CSS and PN](#) on page 1220.

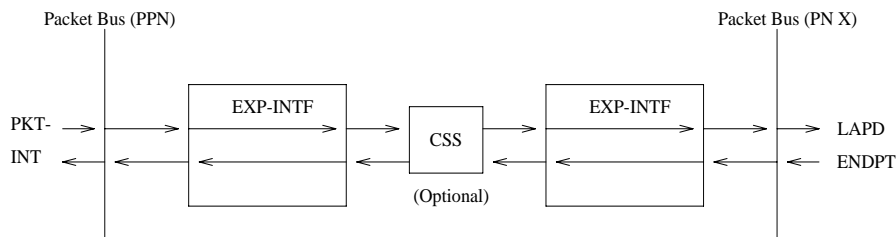
Figure 71: Expansion Interface Packet Interface Test—Packet Endpoint Loop

The path shown in [Figure 71: Expansion Interface Packet Interface Test—Packet Endpoint Loop](#) on page 1230 is used when testing a PN EI that is on the active PNC.

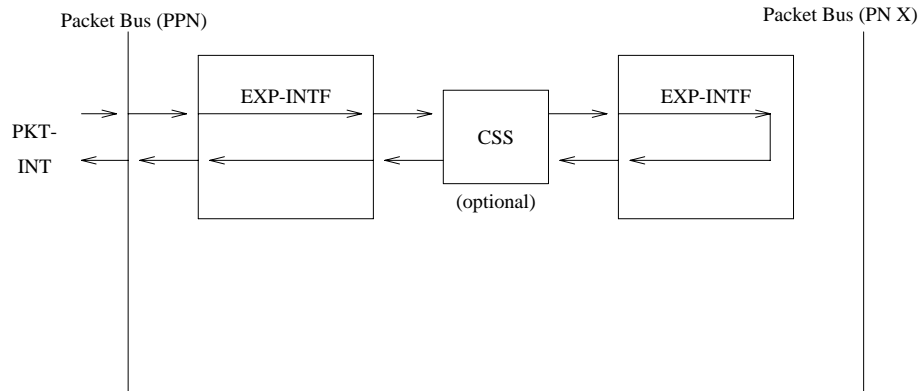
Figure 72: Expansion Interface Packet Interface Test, PN-to-PN loop

In a Center Stage configuration the path shown in [Figure 72: Expansion Interface Packet Interface Test, PN-to-PN loop](#) on page 1231 is used when testing a PN EI that is on the standby PNC. In a Direct Connect configuration, this path is used on any PN EI or on a PN EI that is on the standby PNC.

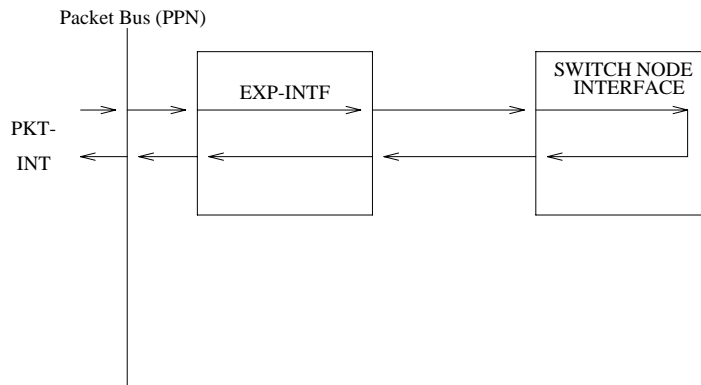
Figure 73: Expansion Interface Packet Interface Test—PN to CSS Loop

The path shown in [Figure 73: Expansion Interface Packet Interface Test—PN to CSS Loop](#) on page 1231 is used when running the test on a PN EI in a Center Stage configuration.

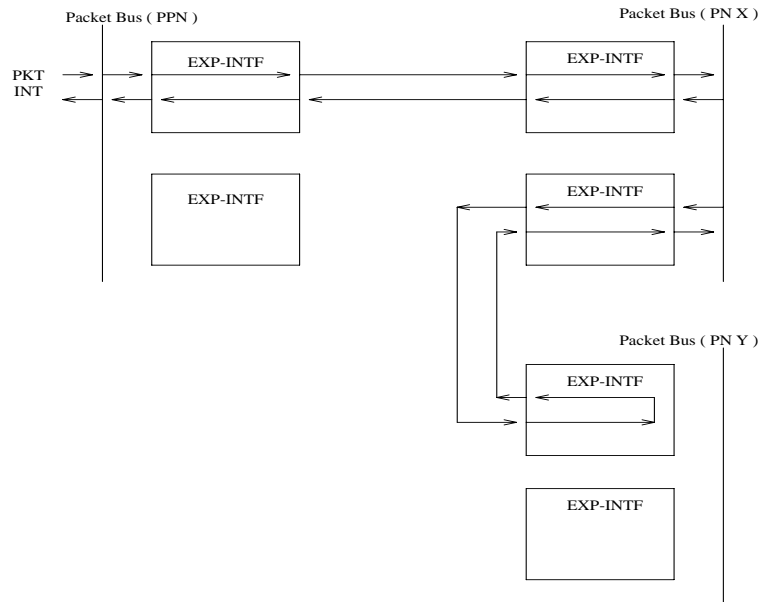
Figure 74: Expansion Interface Packet Interface Test, PN-to-PN link

The path shown in [Figure 74](#) is used when the EI under test is one that provides connectivity between the two PNs in a Direct Connect configuration.

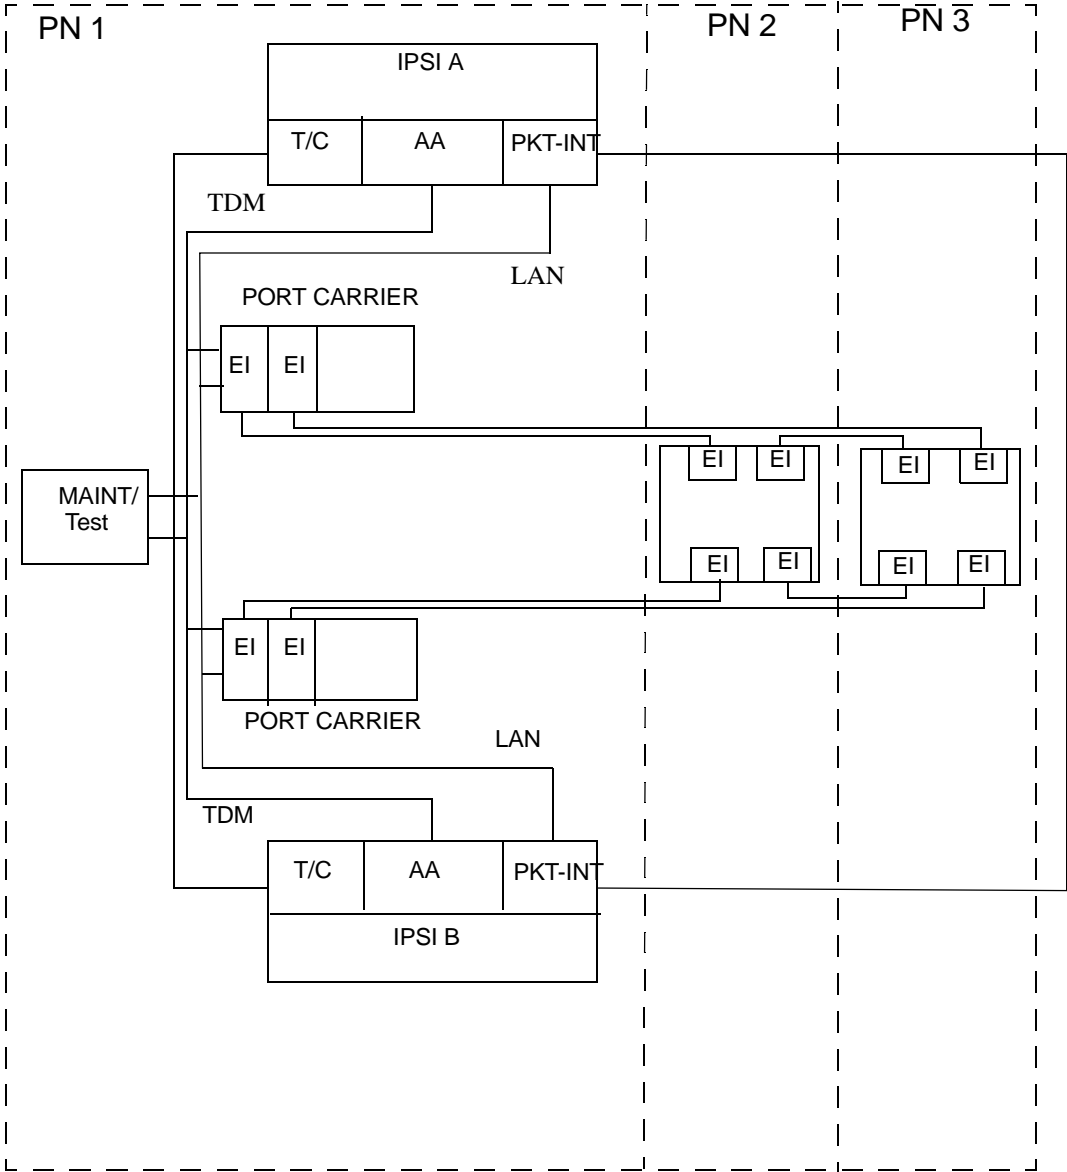
Figure 76: Duplicated IPSI Duplicated Direct Connect PNC Connectivity

[Figure 76](#) shows a critical-reliability system with duplicated IPSIs and directly connected PNCs. [Figure 77: Duplicated IPSI Duplicated PNC with Center Stage Switch Connectivity](#) on page 1436 shows a critical-reliability system with duplicated IPSIs and CSS-connected PNCs. [Table 494: Cabinets that support IPSI and IPSI duplication](#) on page 1437 shows a complete list of cabinets.

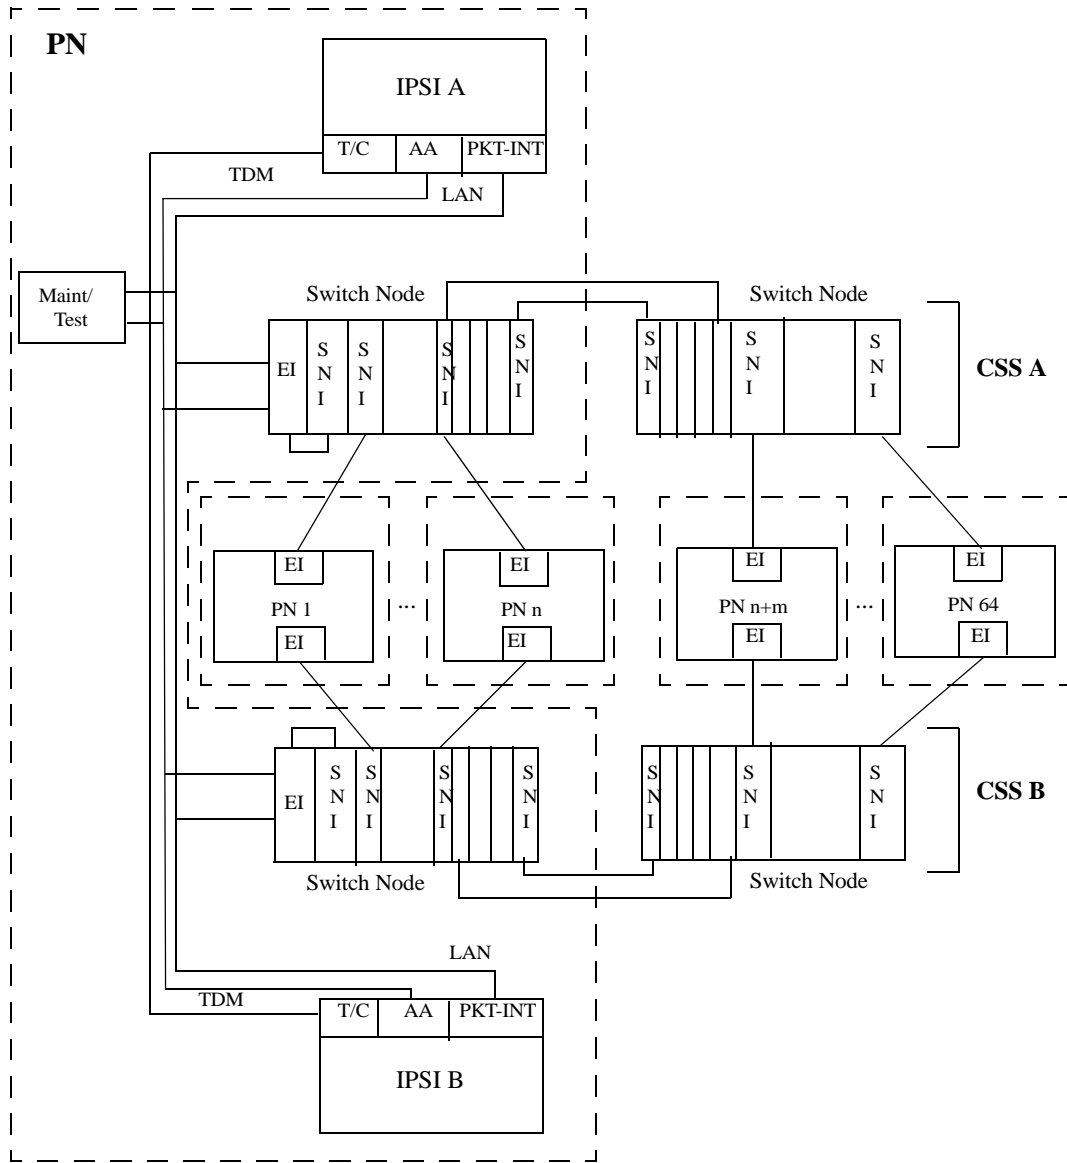
Figure 77: Duplicated IPSI Duplicated PNC with Center Stage Switch Connectivity

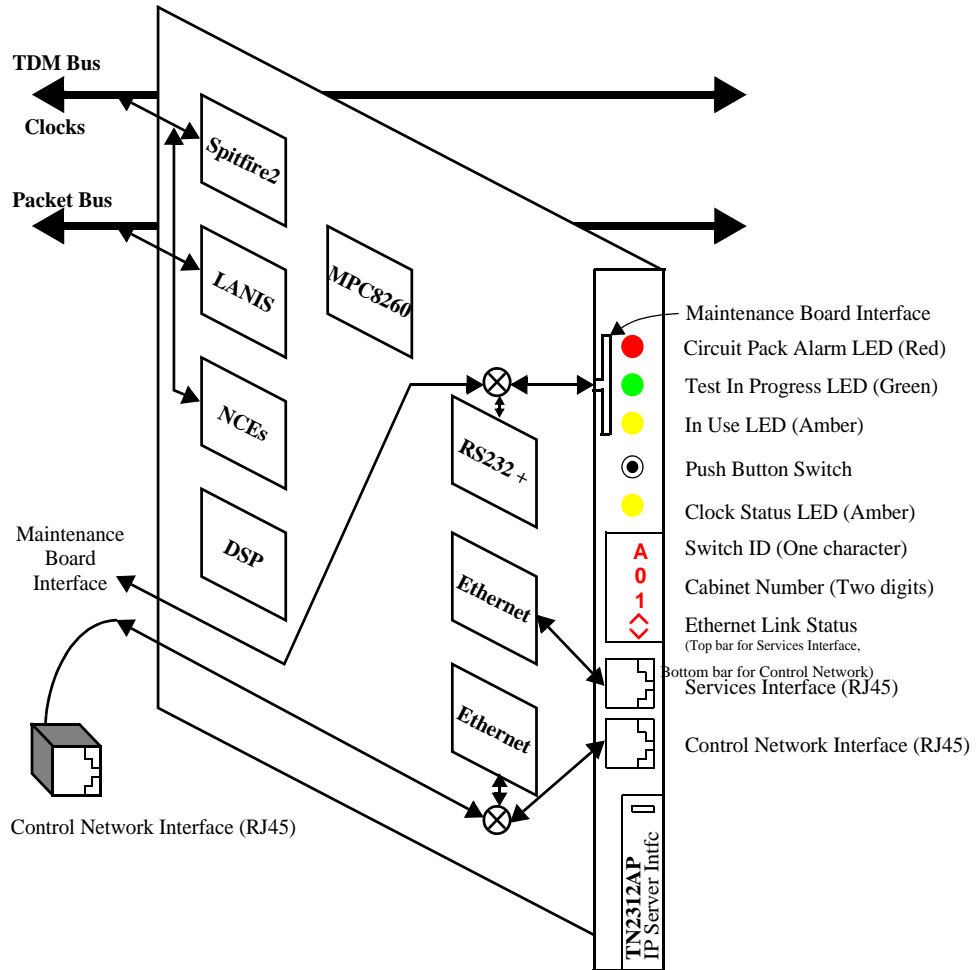
Figure 78: TN2312AP IPSI

This is a 10/100 BaseT Ethernet interface used to connect to the Control network. This interface is available through the backplane I/O as well as through the faceplate. When the IPSI I/O adapter is plugged onto the Amphenol connector, located on the rear of the carrier, the backplane connections will be selected, otherwise, connectivity to the faceplate will be selected. For the PN control carriers, the backplane connections are available only when the new PN control carriers are used.

The faceplate view of the TN2312AP IPSI is shown in [Figure 78: TN2312AP IPSI](#) on page 1444 and described in the following sections.

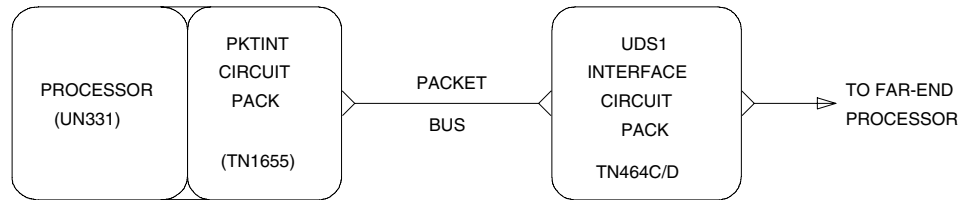
Figure 79: Remote Layer 3 Query Test (#637)

For systems supporting circuit packs, [Figure 79](#) illustrates a UDS1 Interface circuit pack located in the PN. When the UDS1 board resides in a PN, there is additional PNC hardware connecting the packet buses of the IPSI PN and PN. Examples of such hardware are the Center Stage Switch and fiber-optic cables.

Tests #639 and #636 check the health of the D channels and DS1/UDS1 Interface circuit packs or MM710 DS1 Interface Media Module. As shown in [Figure 79: Remote Layer 3 Query Test \(#637\)](#) on page 1467, this test goes one step further by checking the communication path from the processor, through the TDM/packet bus and DS1/UDS1 Interface circuit pack, or through the MM710 Media Module, and on to the far-end switch or terminal adapter. A special ISDN message is sent to the far-end switch or terminal adapter, which must respond within a specified amount of time. This test is designed to ensure that the communication path between the switch and the far end is up and operational, and that the two endpoints can properly exchange ISDN control messages.

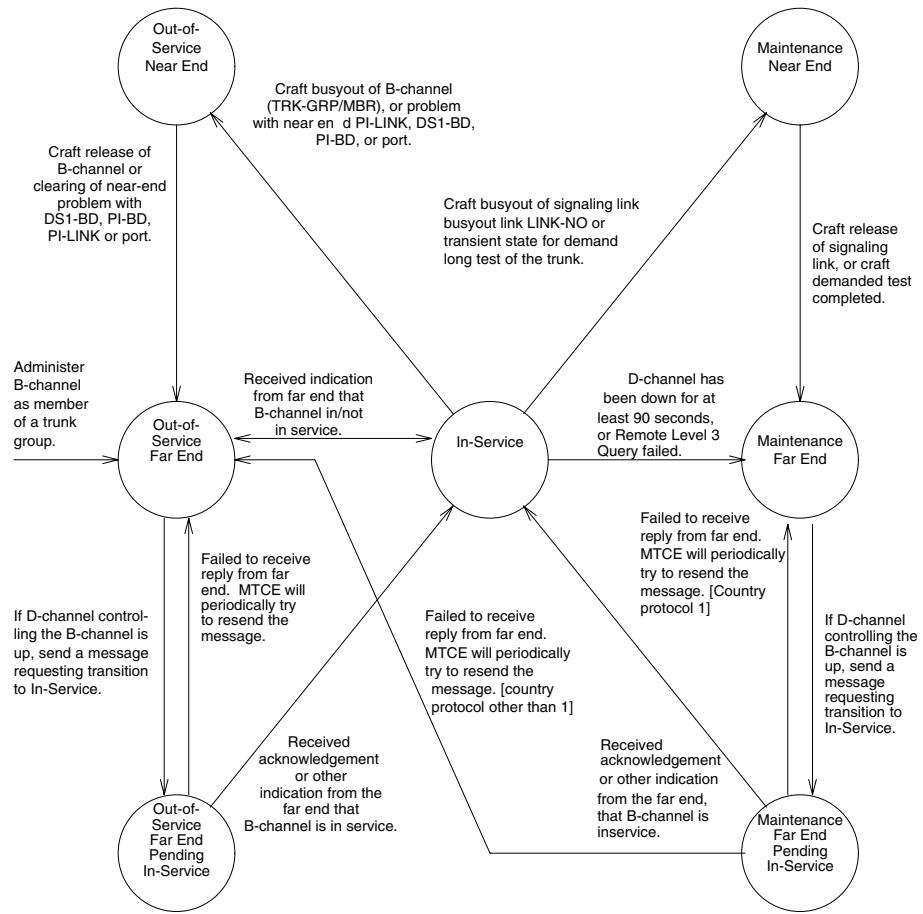
Figure 80: Common Progressions in Service States

The following diagram of the DS1 ISDN Trunk service states shows the common progression from one service state to another and the event that caused the change of state.

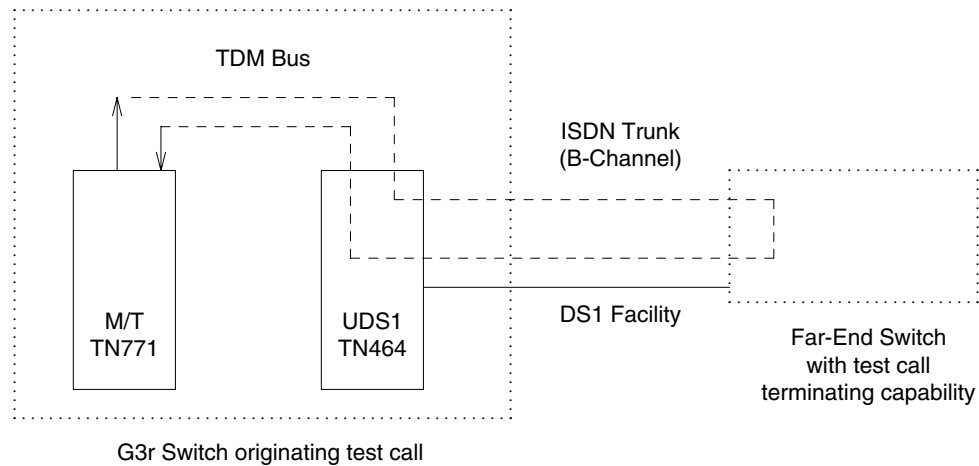
Figure 81: Outgoing ISDN-PRI Test Call

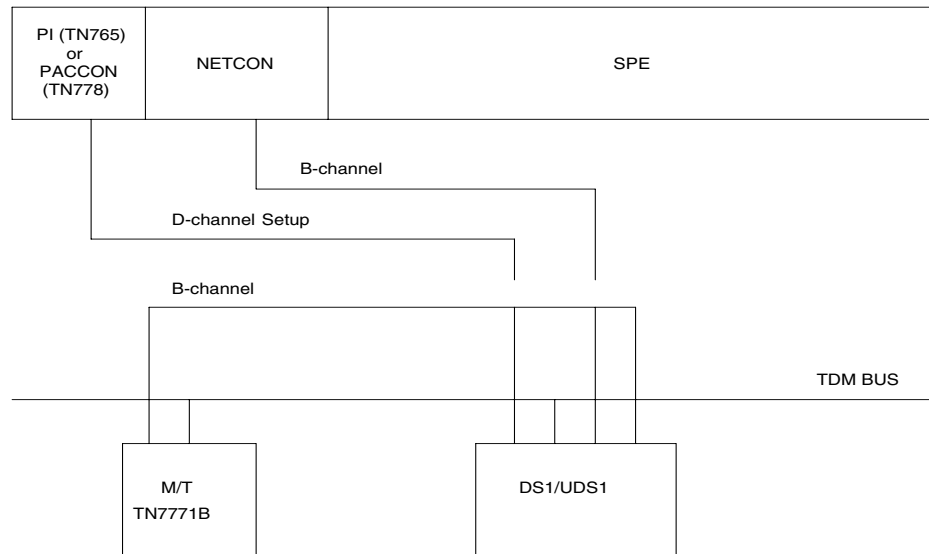
Figure 82: ISDN-PRI Outgoing Test Call

In the second method, the test call connection is established over the TDM Bus of the transmit and receive sides of the ISDN-PRI trunk to a digital trunk testing port on the Maintenance/Test circuit pack. The Maintenance/Test Digital Port generates a pseudo bit stream. A pictorial description of the outgoing ISDN-PRI test call connectivity is contained in [Figure 82: ISDN-PRI Outgoing Test Call](#) on page 1496.

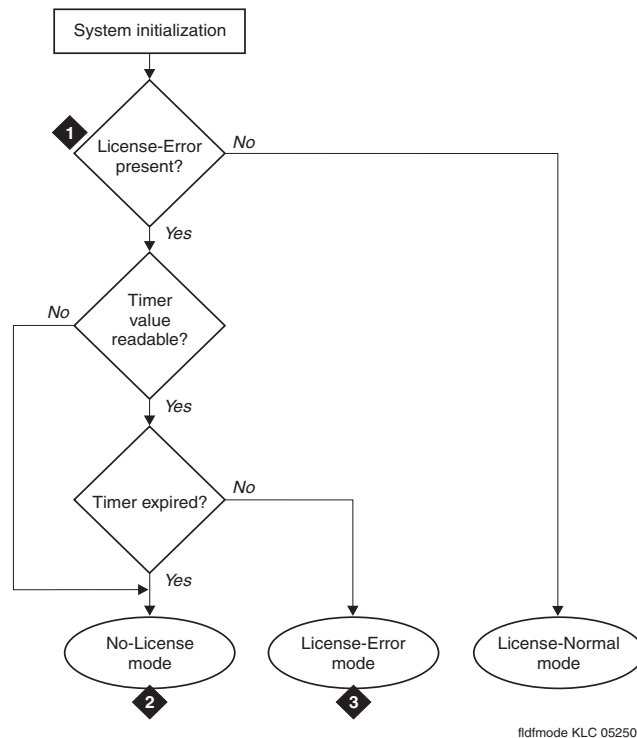
Figure 83: License mode algorithm

Entry into License Error mode starts a timer that, when expired, causes the system to enter No-License mode (see [Figure 83: License mode algorithm](#)).

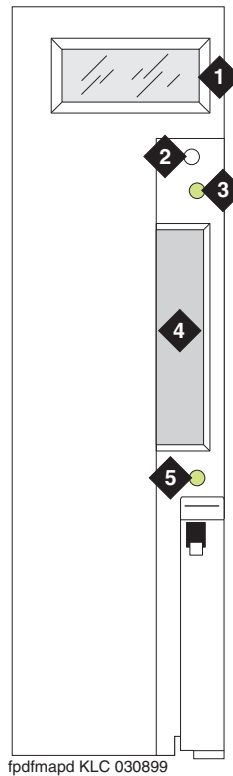
Figure 84: TN802 faceplate

Step	Description	Comments
1.	Restore IP Trunk administration	At the Windows 2000 desktop, double-click on the IP Trunk Backup/ Restore icon. The IP Trunk Backup/Restore Utility screen appears.
2.	Select utility	In the IP Trunk Backup/Restore Utility dialog screen, click Files> Restore . The IP Trunk Backup screen appears.
3.	Select restore	In the IP Trunk Backup screen, click on the Restore button.
4.	Wait	Wait until the amber Disk-In-Use LED (Note 5 in Figure 84: TN802 faceplate on page 1540) light is out.

[Figure 84: TN802 faceplate](#) on page 1540 shows the TN802 faceplate.

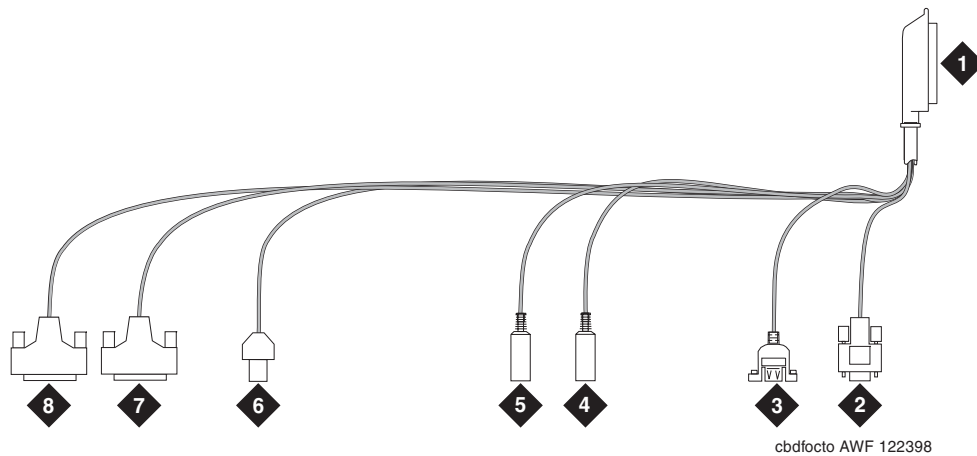
Figure 85: TN802 external cable assembly

1. Attach a male-to-male serial cable and a NULL modem connector (if not built into the cable you use) to the COM2 connector (Note 8 in [Figure 85: TN802 external cable assembly](#) on page 1542). Attach the other end to the serial port of your laptop.
2. Launch the pcANYWHERE application.
3. Click on Add Remote Control Item.
4. In the Properties window, choose the communication port to which you connected the cable in Step 1.
5. Click on Details and configure the settings ([Table 538: Remote connection settings](#) on page 1541):

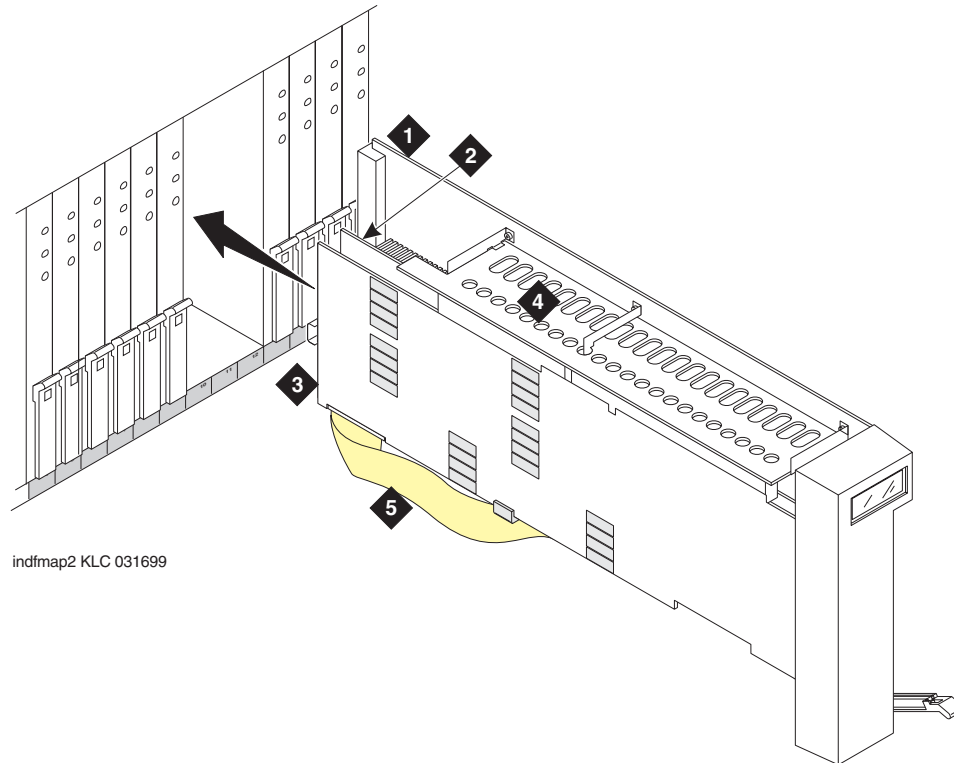
Figure 86: TN802 board assembly

[Figure 86](#) shows the circuit pack with the two additional boards connected through the side plane.

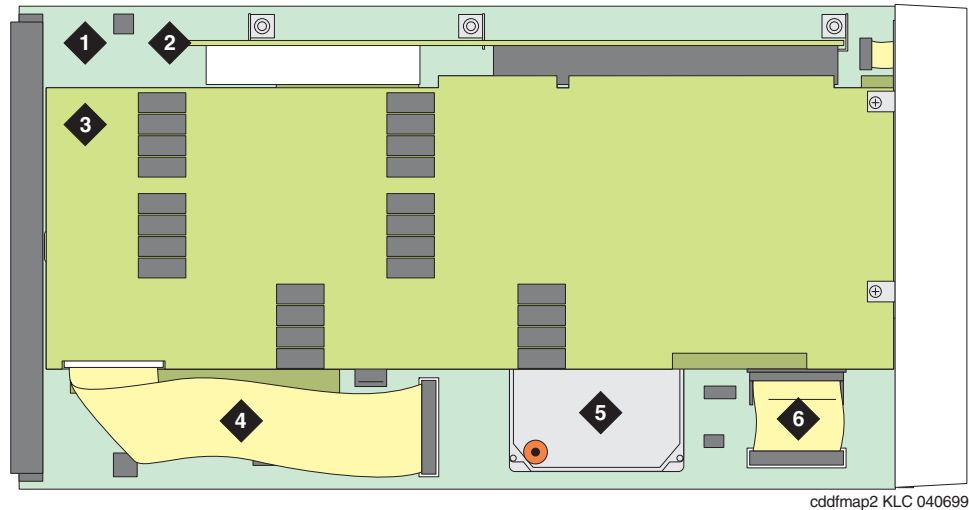
Figure 87: TN802 board assembly and cables (side view)

- a. Verify the IP address.
 - b. Check the physical connections to and from the TN802 circuit pack.
 - c. Check the internal cables on the TN802 circuit pack (Notes 4 and 6 in [Figure 87: TN802 board assembly and cables \(side view\)](#) on page 1547).
 - d. Try pinging another device in the same subnet.
 - e. Try pinging the gateway to the rest of the network from the subnet.
 - f. Try pinging a device outside the local subnet but inside the network or another subnet.
5. When finished, type **exit** at the command prompt, and press **Enter**.

[Figure 87: TN802 board assembly and cables \(side view\)](#) on page 1547 shows a side view of the three boards and interconnecting cables that make up the TN802.

The TN802 hard drive (Note 5 in [Figure 87: TN802 board assembly and cables \(side view\)](#) on page 1547) can be replaced in the field.

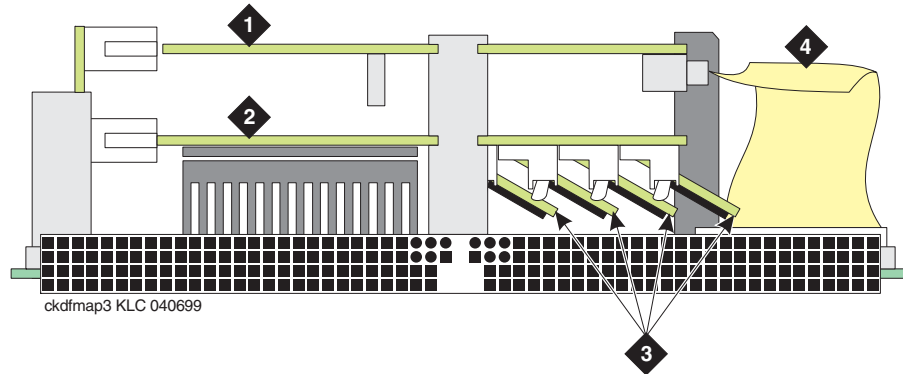
Figure 88: TN802 board assembly and cables (end view)

[Figure 88: TN802 board assembly and cables \(end view\)](#) shows the end view of the three boards and interconnecting cables on the TN802.
