Maintenance Alarms for Avaya Communication Manager 3.1.x, Media Gateways and Servers

03-300430
Issue 2.1
June 2006

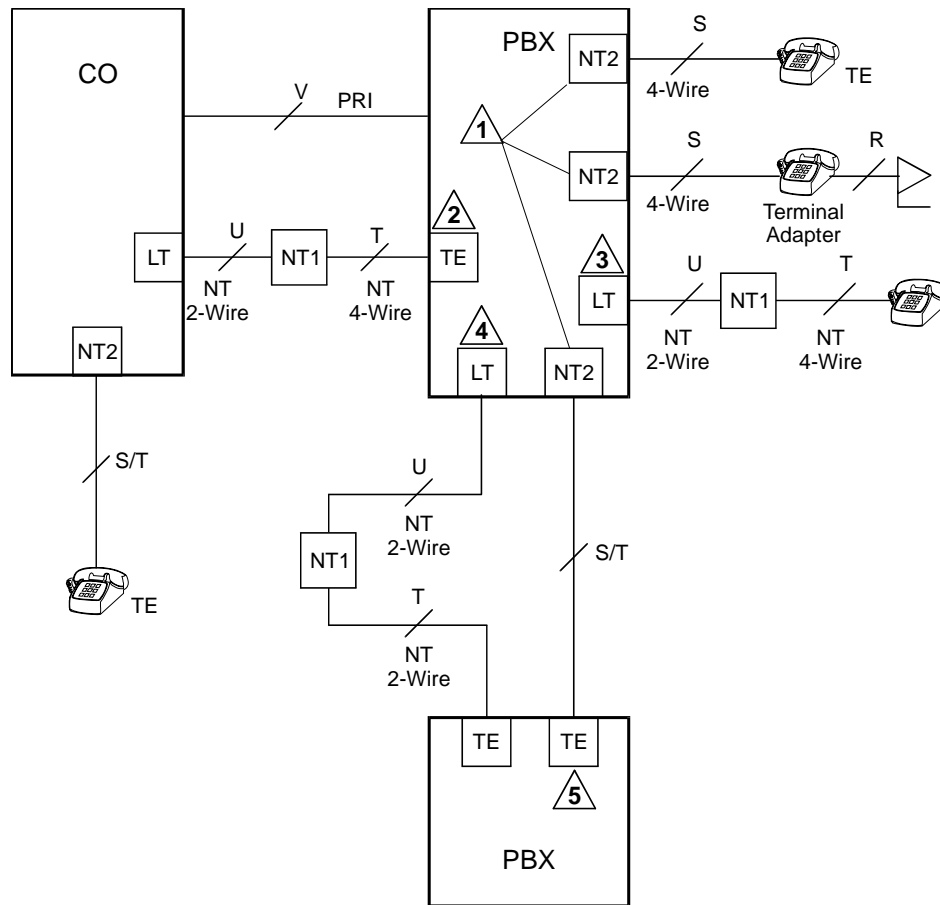
Figure 89: Integrated Trunk-Side BRI, ISDN Interface Reference Points

[Figure 89: Integrated Trunk-Side BRI, ISDN Interface Reference Points](#) on page 1614 shows, for a generic integrated trunk-side BRI, the ISDN Interface Reference Points. [Figure notes: ISDN Interface Reference Point definitions](#) on page 1615 gives definitions for the generic ISDN Interface Reference Points.

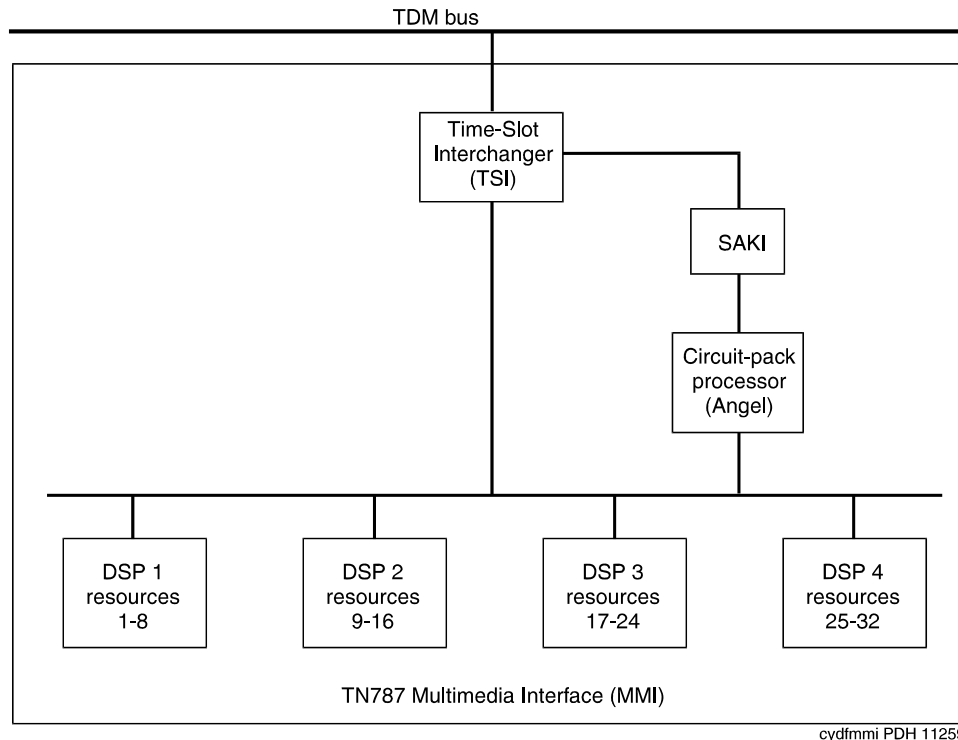
The MMI circuit pack contains 4 digital signal processors that manage the 32 resources.

Figure 90: TN787 Multimedia Interface (MMI) Circuit Pack

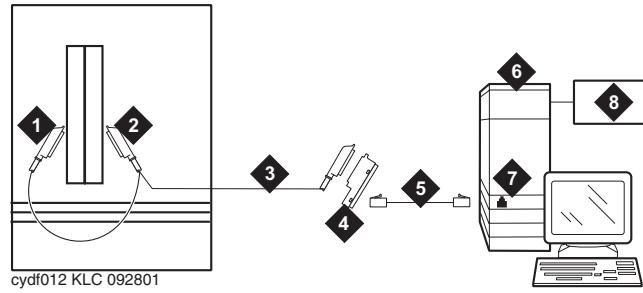
Figure 91: Typical ESM connections

1. Port B Y-cable connector to a TN787 MMI (Multimedia Interface) circuit pack
2. Port A Y-cable connector to a TN2207 PRI circuit pack
3. 25-pair Y-cable
4. 356A adapter
5. D8W cord connected to 356A adapter port 1
6. Expansion Service Module (ESM)
7. Port B on compatible PRI (primary rate interface) card

The TN2207 circuit pack permits connecting an ESM (Expansion Services Module). See [Figure 91: Typical ESM connections](#) on page 1682 for connectivity.

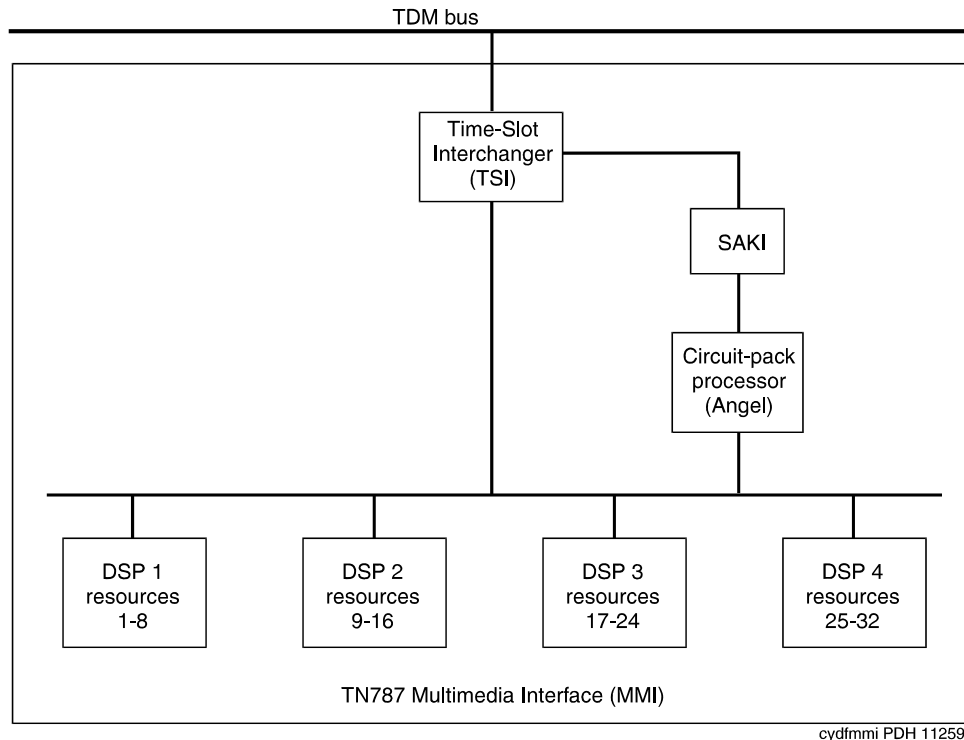
Figure 92: TN787 MMI (MULTIMEDIA INTERFACE) CIRCUIT PACK

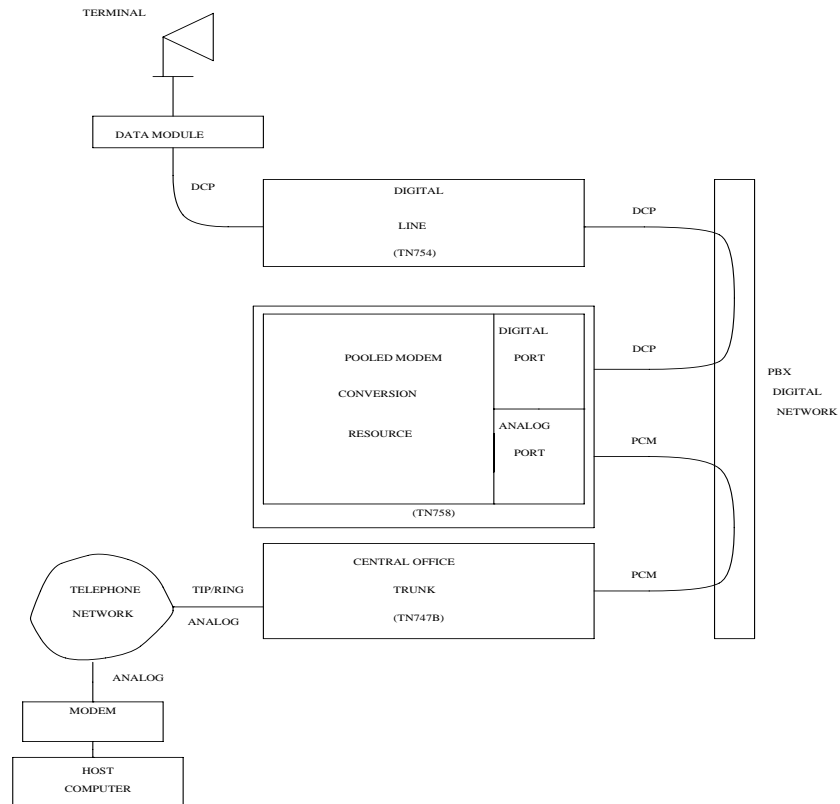
Figure 93: Typical Modem Pool Switched Connection with Integrated Pooled Modem

There are two primary types of Modem Pool conversion resources available: an Integrated Pooled Modem and a Combined Modem Pool. The integrated TN758 Pooled Modem circuit pack contains two independent 300- or 1200-bps conversion resources. Each conversion resource contains two interfaces to the PBX digital network: an analog port and a digital port. The analog port is connected through the PBX network to the analog line or trunk port containing the analog modem signals. The digital port connects through the PBX network to the digital line or trunk port in the call. [Figure 93: Typical Modem Pool Switched Connection with Integrated Pooled Modem](#) on page 1703 shows a typical end-to-end connection using a conversion resource on the integrated Pooled Modem circuit pack.

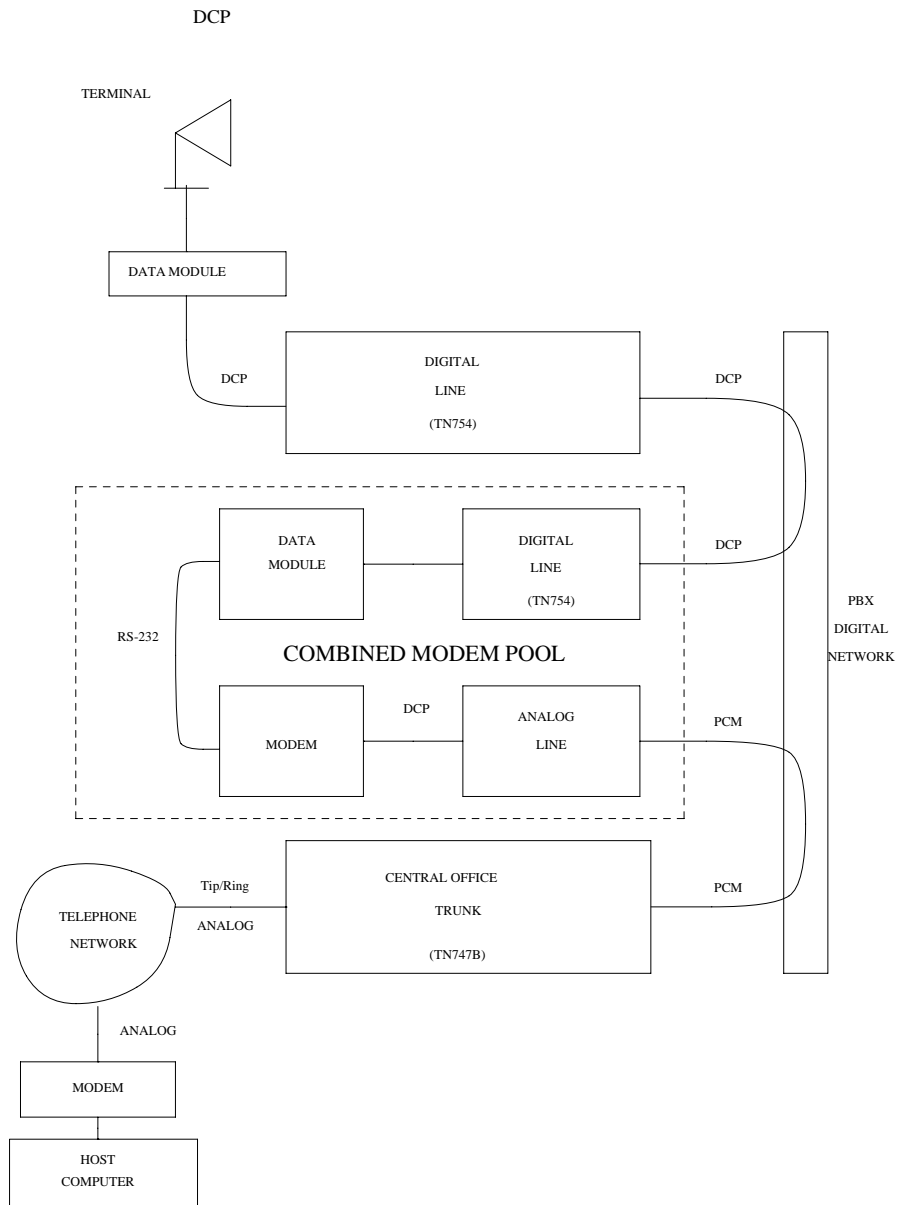
The Combined Modem Pool conversion resource is the second type available. The function served by the Combined Modem Pool is similar to that of the integrated Pooled Modem circuit pack, but the physical implementation is much different. It has the advantage of supporting any speed the external modem can support. The integrated Pooled Modem circuit pack can only support 300- or 1200-bps transmission rates. The Combined Modem Pool conversion resource consists of a port on an Analog Line circuit pack, an external modem, a Data Module, and a port on a TN754 Digital Line circuit pack. The tip and ring interface of the Analog Line is connected to the modem, the RS-232C interface of the modem connects to the Data Module, and the DCP interface on the Data Module is connected to the Digital Line port.

The analog modem signals pass through the Analog Line port to the modem. The modem converts these to RS-232C signals which are passed on to the Data Module. The Data Module further converts the signals to the DCP protocol for the Digital Line port which passes the signals on to the PBX network.

Figure 94: Typical Modem Pool Switched Connection with Combined Modem Pool

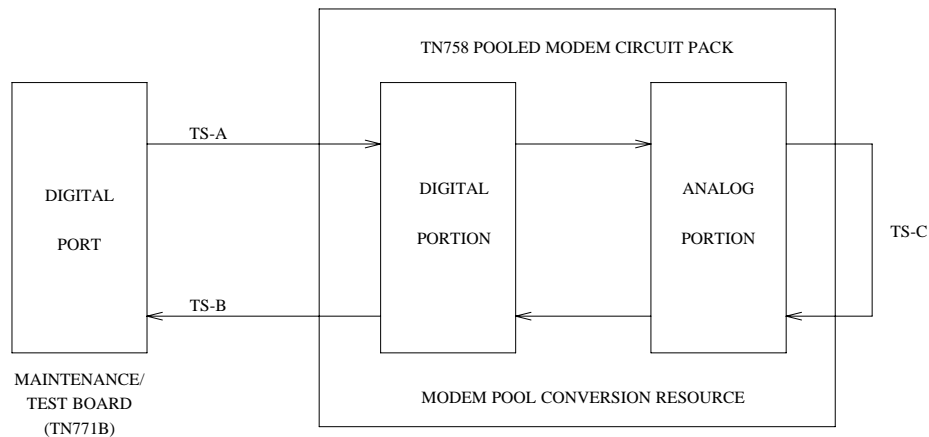
Figure 95: Modem Pool Conversion Resource Loop-Around

The Modem Pool Conversion Resource Loop-Around test is set up as follows:

Test data patterns are transmitted from a Maintenance/Test board's digital port over network time slot A through the digital port on the conversion resource, looped around through the analog port via time slot C back to the Maintenance/Test board's digital port circuit via time slot B where the patterns are checked for accuracy. Finally, the test forces a disconnect by breaking the connection between the Maintenance/Test board's digital port and the Modem Pool port (time slot A) and verifying that the Maintenance/Test board's digital port and Modem Pool port go on-hook within the proper time. This test attempts to allocate a Maintenance/Test board's digital port, Modem Pool port, and other internal resources. If any of these allocation attempts fail, the test cannot be completed, and a specific abort error is reported.

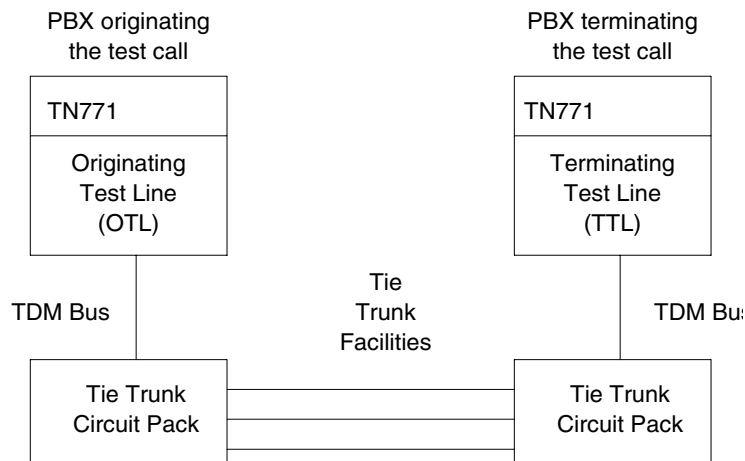
Figure 96: ATMS Tie Trunk Test Call

The Maintenance/Test analog port is port number 1 on the TN771D Maintenance/ Test circuit pack. This port is used by the Automatic Transmission Measurement System (ATMS) as an Originating Test Line (OTL) or Terminating Test Line (TTL) for test calls over analog trunks. For more details, see [Automatic Transmission Measurement System](#) in *Maintenance Procedures for Avaya Communication Manager 3.1, Media Gateways and Servers, 03-300432*. [Figure 96](#) shows a typical ATMS configuration.

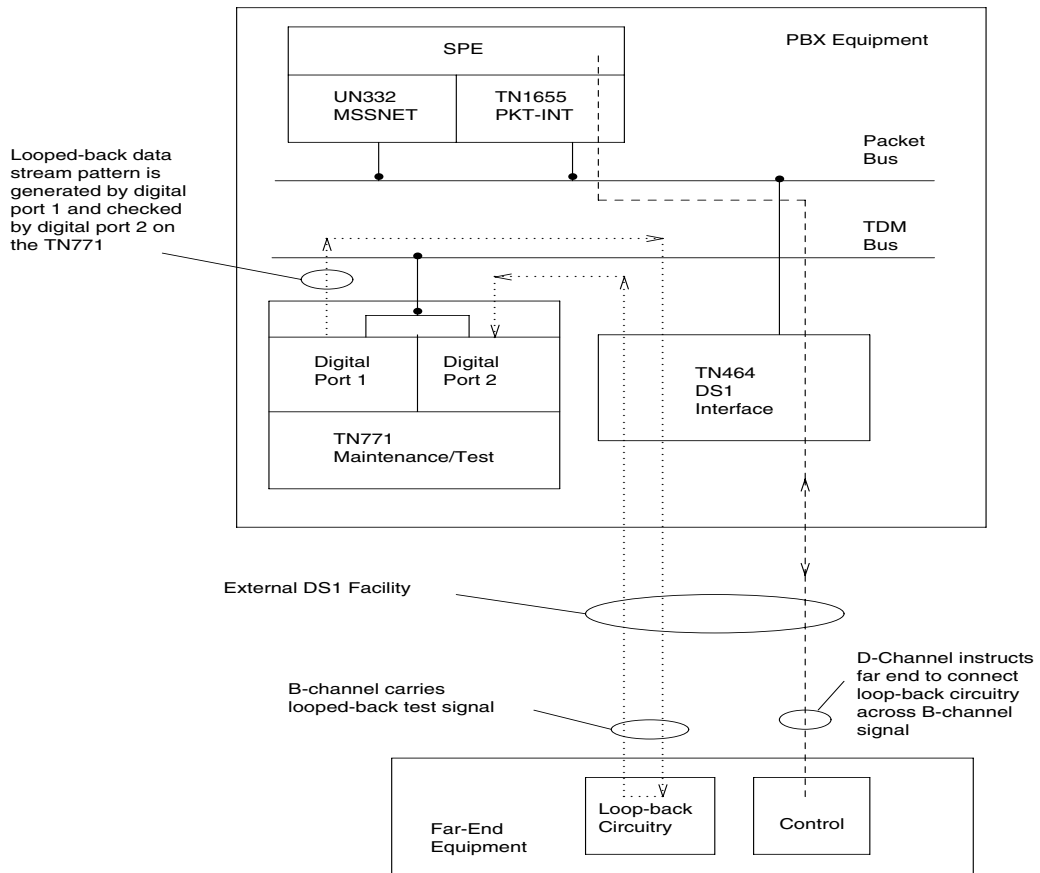
Figure 97: ISDN-PRI Outgoing Test Call

The Maintenance/Test digital port is a port on the TN771D circuit pack. Ports 2 and 3 are digital ports. The Maintenance/Test digital port provides the ability to perform digital (i.e., ISDN-PRI) trunk testing via the TDM bus. For an ISDN-PRI test call, connections are set up in the system as shown in [Figure 97: ISDN-PRI Outgoing Test Call](#) on page 1734.

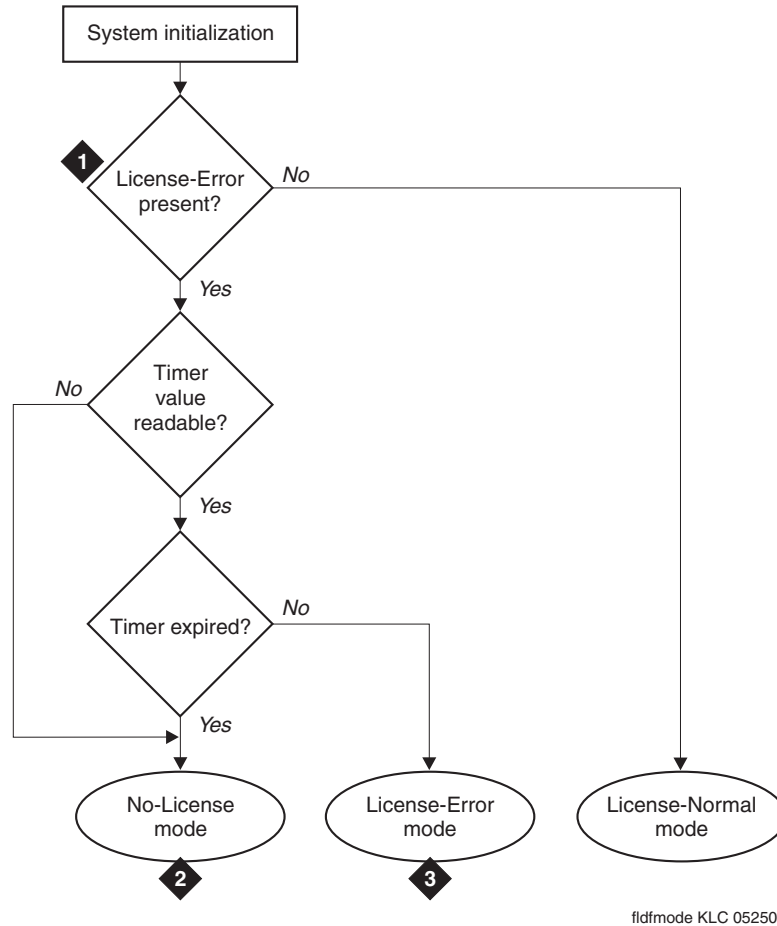
Figure 98: License mode algorithm

Entry into License-Error mode starts a timer that, when expired, causes the system to enter No-License mode (see [Figure 98: License mode algorithm](#) on page 1752). When Communication Manager enters No-License mode, the following SAT warning message displays:

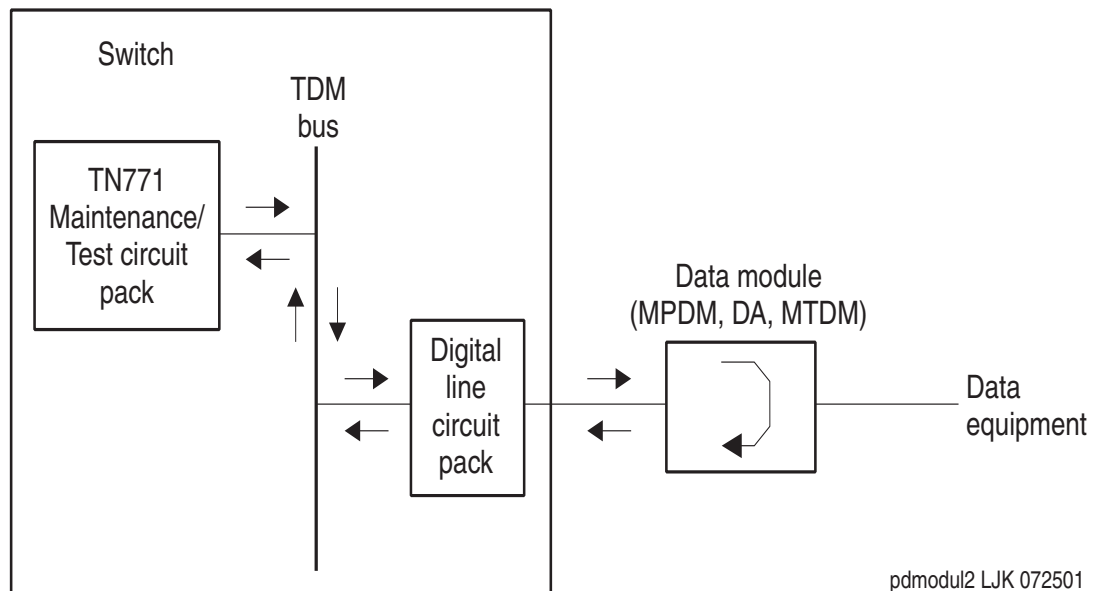
Figure 101: Internal Loop-Around Test

A signaling message is sent through the digital port circuit pack to the data module, requesting it to enter loop-around mode. A test pattern is then sent from the TN771D Maintenance/Test circuit pack, over the path illustrated above, and back to the TN771D where it is checked for consistency.

The test aborts if any of the following local PBX resources are not available: a digital port on the TN771D (there are two such digital ports, but only one may be used at a time), two TDM time slots and an idle digital port connected to the data module.

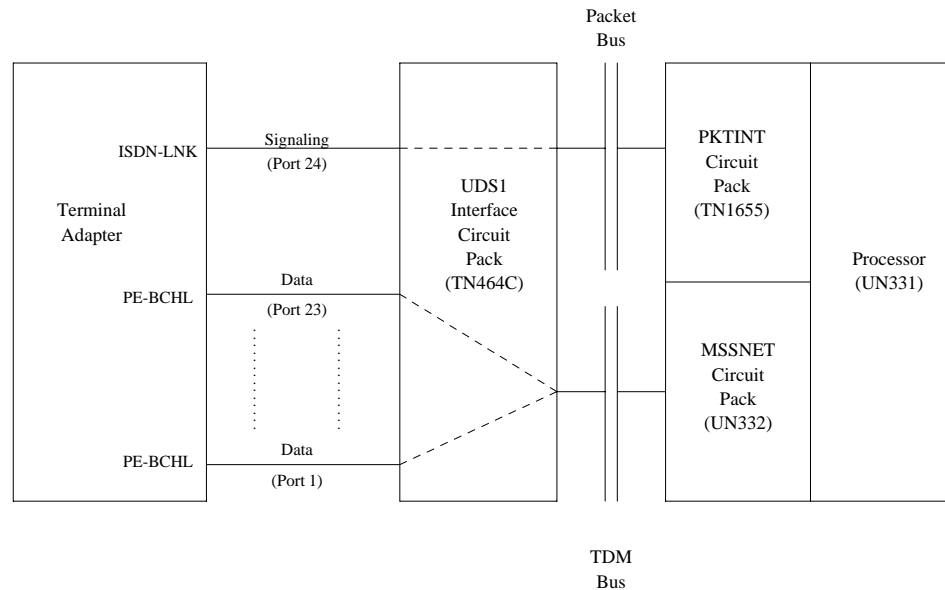
Figure 102: PRI Endpoint Port Interactions

A PRI endpoint port is a port on a UDS1 interface circuit pack and thus depends on the health of the circuit pack for proper operation (see the following figure). A problem on the associated ISDN-LNK's (ISDN-PRI signaling-link port's) D channel can also affect the PRI endpoint. In turn, the ISDN-LNK depends on the SYS-LINK (system link) to the packet interface. Keep this hierarchy of dependencies in mind when diagnosing problems.

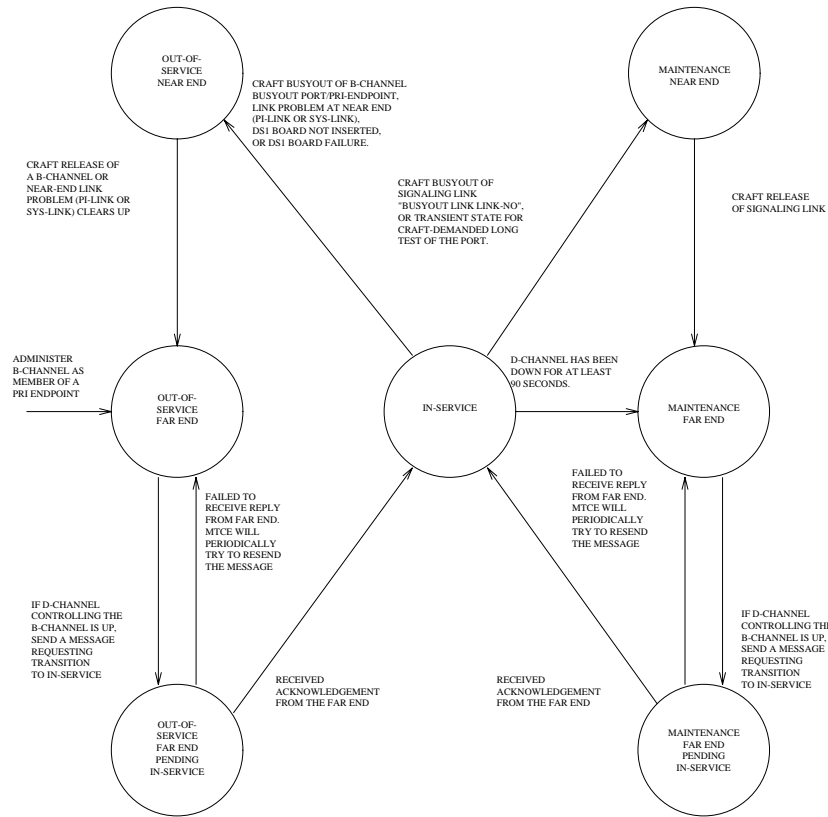
Figure 103: Common Progressions in PRI Endpoint Service States

The `status pri-endpoint extension` command displays the following possible service states for PRI endpoint ports. The table that follows gives recommended procedures for each state. The figure following that shows typical progressions from one service state to another. Refer also to [Troubleshooting ISDN-PRI endpoints \(wideband\)](#) in *Maintenance Procedures for Avaya Communication Manager 3.1, Media Gateways and Servers, 03-300432* for a layered approach to addressing PRI endpoint problems.

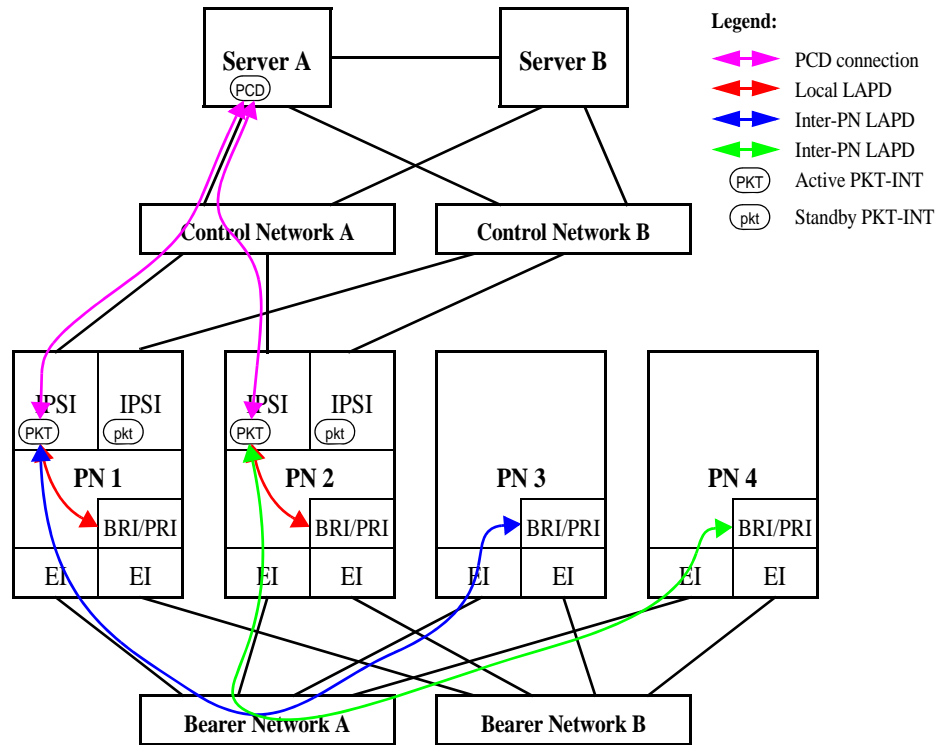
Figure 104: Distributed PKT-INTs

S8700 Fiber-PNC: As shown in [Figure 104: Distributed PKT-INTs](#) on page 1826, PNs 1 and 2 have IPSIs that terminate LAPD links. PNs 3 and 4 do not have local IPSIs, so their LAPD links are terminated by IPSIs in PNs 1 and 2.

The Packet Interface module is a single point of failure in a standard- or duplex-reliability system, with unduplicated IPSIs. If not acceptable, an S8700 customer can upgrade to a high- or critical-reliability system with duplicated IPSIs. [Figure 104: Distributed PKT-INTs](#) on page 1826 shows an S8700 Fiber-PNC configuration with duplicated IPSIs. The following concepts apply to duplicated IPSIs:

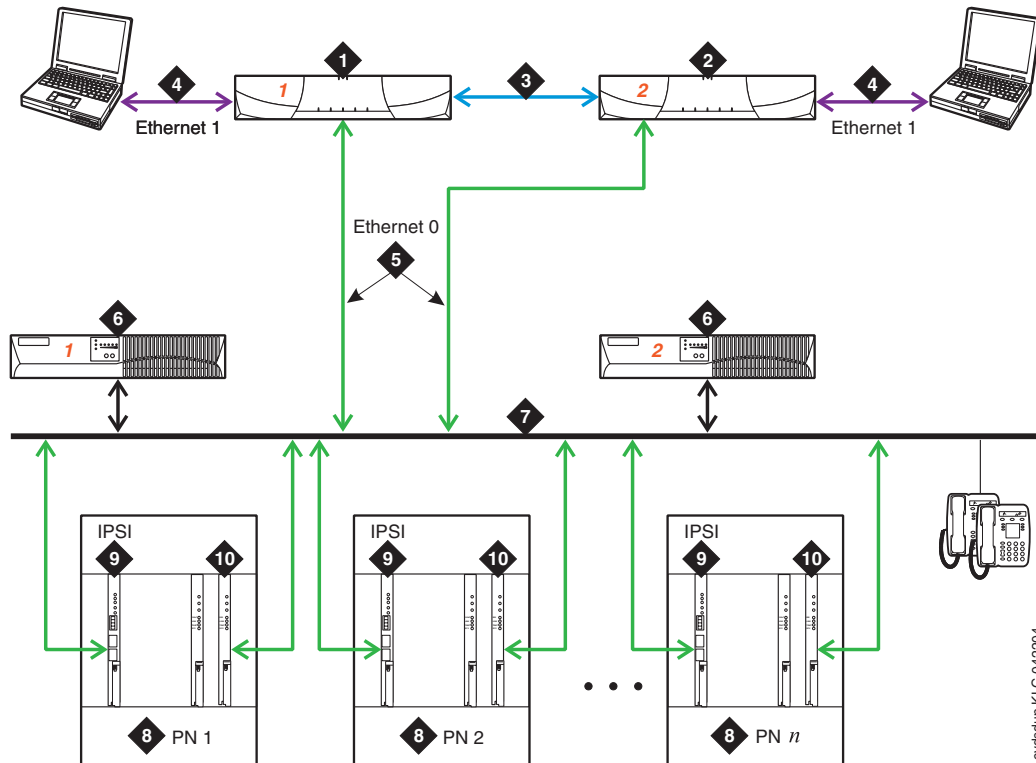
Figure 105: IP-PNC Duplex Reliability - Simplex Control Network

A PKT-INT module resides on each IPSI board. On an S8700 IP-PNC system, there is a duplicated server. One server is in active mode and one server is on standby. The control network(s) may be implemented in a simplex, see [Figure 105: IP-PNC Duplex Reliability - Simplex Control Network](#) on page 1829, or a optional duplicated configuration. There is only one PKT-INT per port network.

Duplicated control networks require G650 media gateways (not G600) because the G600 does not support duplicated clocks. The clock is a component of the TN2312 IPSI.

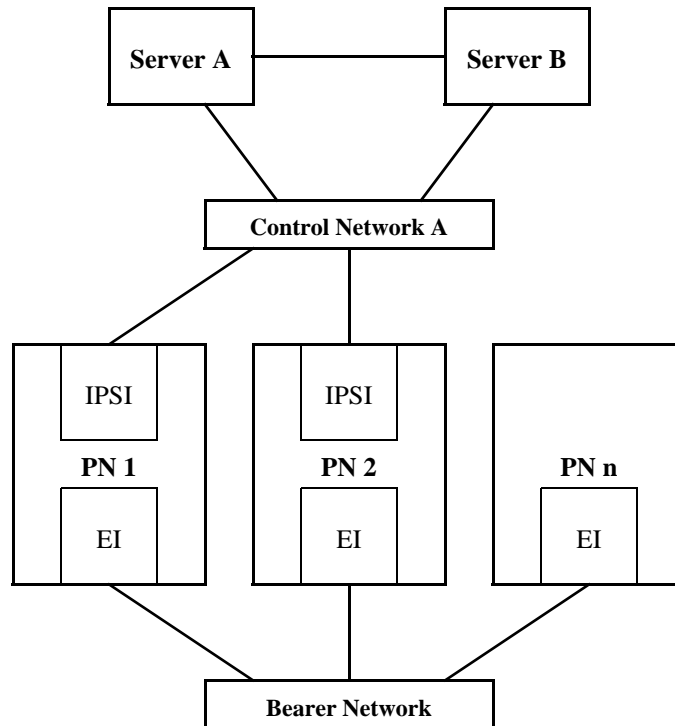
Figure 106: Duplex-Reliability Configuration

The duplex-reliability configuration shown in [Figure 106: Duplex-Reliability Configuration](#) on page 1831 has duplicated media servers, an unduplicated control network, unduplicated IPSIs in the IPSI connected PNs, and an unduplicated bearer network. Because the IPSIs are not duplicated, the PKT-INT modules contained within them are not duplicated.

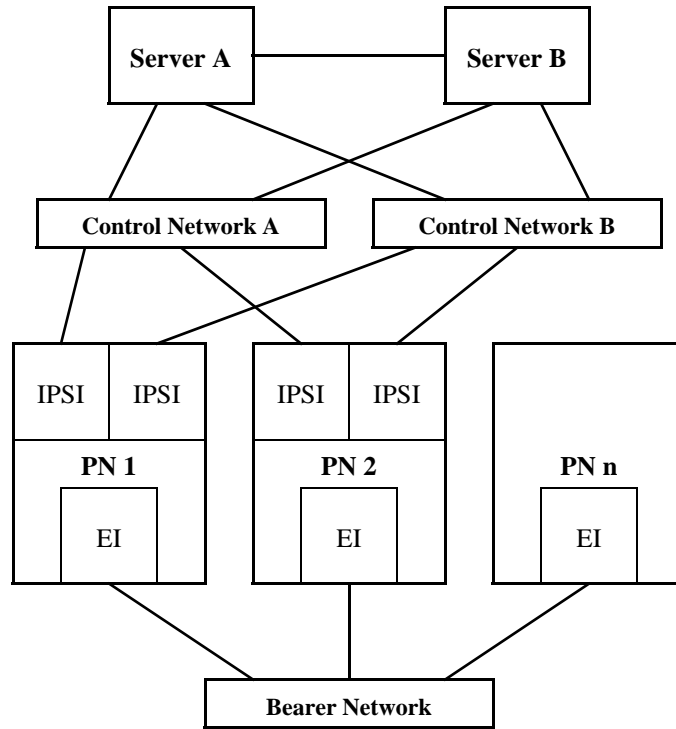
Figure 107: High-Reliability Configuration - Fiber-PNC

The high-reliability configuration shown in [Figure 107: High-Reliability Configuration - Fiber-PNC](#) on page 1832 has duplicated media servers, duplicated control networks, and duplicated IPSIs in the IPSI connected PNs. With this configuration, every IPSI connected PN must have duplicated IPSIs. The duplicated control network prevents a single fault in the control network, such as a bad Ethernet switch, from bringing the whole system down. Because the IPSIs are duplicated in this configuration, the PKT-INT modules are duplicated.

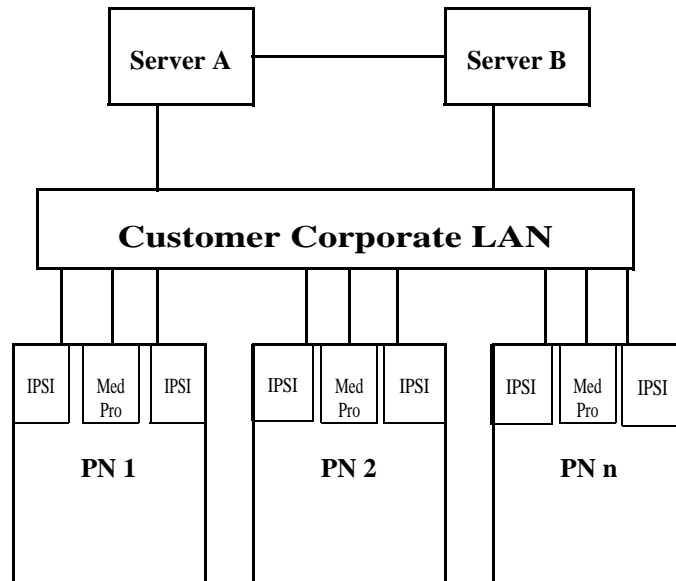
Figure 108: High-Reliability Configuration - IP-PNC

The IP-PNC high reliability configuration is similar to the Fiber-PNC configuration. There are no expansion interface circuit packs in the IP-PNC configuration. There are duplicated IPSI circuit packs in each port network. Port networks must use the G650 rack mounted carrier to accommodate the duplicated clock circuits located on the IPSI circuit packs. See [Figure 108: High-Reliability Configuration - IP-PNC](#) on page 1832.

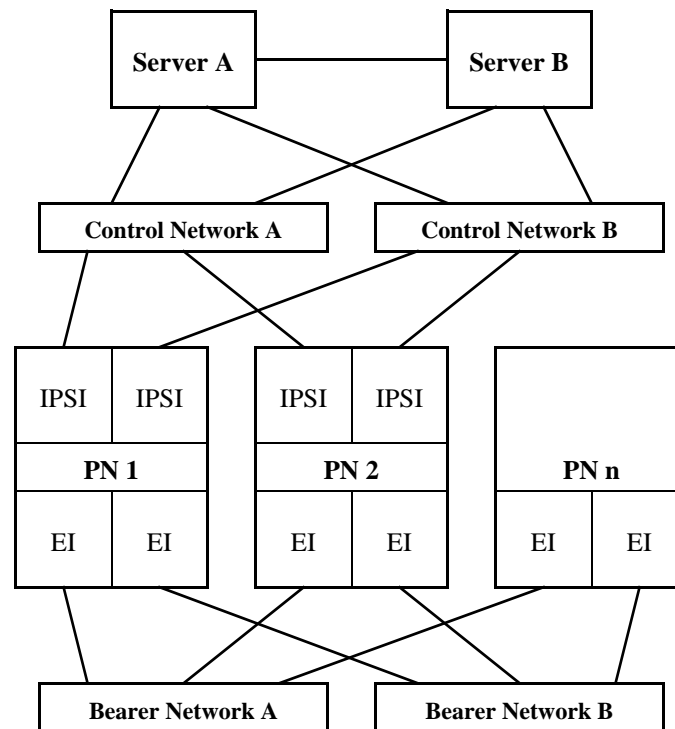
Figure 109: Critical-Reliability Configuration - Fiber-PNC

The critical-reliability configuration shown in [Figure 109: Critical-Reliability Configuration - Fiber-PNC](#) on page 1833 has full duplication of the following options: media servers, control networks, IPSIs and PNCs (bearer networks). As with the high-reliability configuration, this configuration requires that IPSI connected PNs have duplicated IPSIs. Because the IPSIs are duplicated in this configuration, the PKT-INT modules are duplicated.

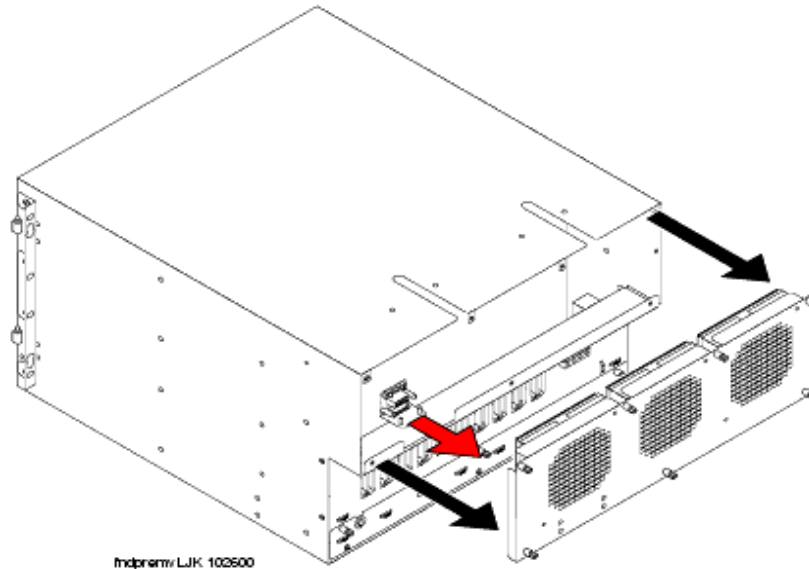
Figure 113: Fan Removal

1. Place the new fan assembly close to the G600.
2. Loosen the thumb screws on the fan assembly, and pull it straight out (unplug it) as shown in [Figure 113: Fan Removal](#) on page 1982. The power for the fan automatically disconnects when the assembly is unplugged.
3. Plug in the new fan assembly. The power for the fan automatically connects when the fan assembly is plugged in.
4. Tighten every thumb screw on the fan assembly.

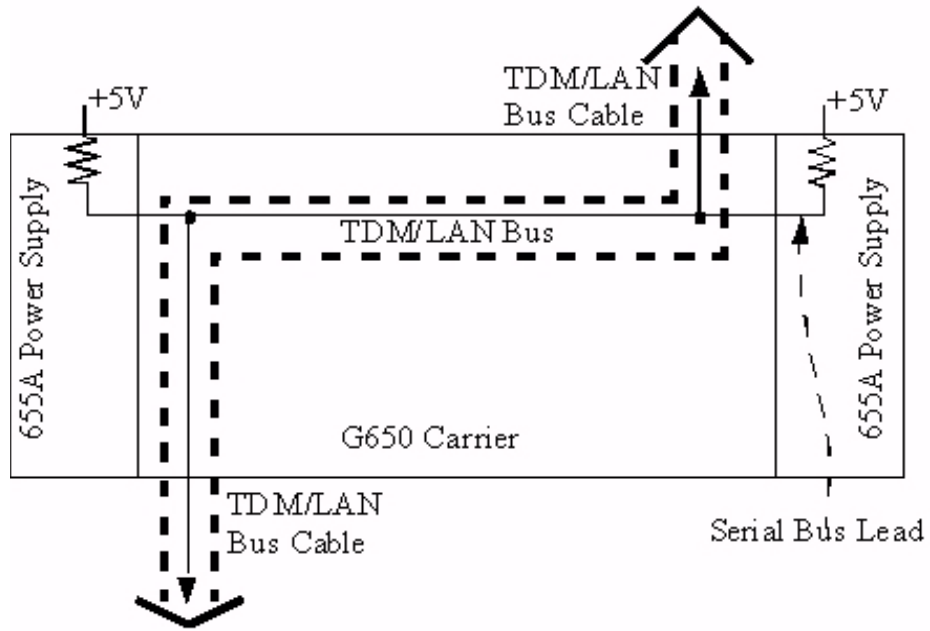
Figure 114: Wiring diagram for serial bus data and clock leads

The TN2312BP IPSI in the A carrier will act as master of the serial bus and poll each of the power supplies based on their board address. Only a TN2312BP IPSI in the A carrier can be a bus master, even if a TN2312BP in carrier B is used for port network connectivity. Therefore, setting the TN2312BP in the A carrier or B carrier to be active will not clear a problem if the TN2312BP itself is the reason for the failure. The power supply's board address is derived from 4 board address leads in the power slot of the backplane. The G650 carrier addressing paddle card sets 3 of these 4 address leads for the power slot. A G650 can have a maximum of ten 655A power supplies on the serial bus (See [Figure 114: Wiring diagram for serial bus data and clock leads](#) on page 1988).

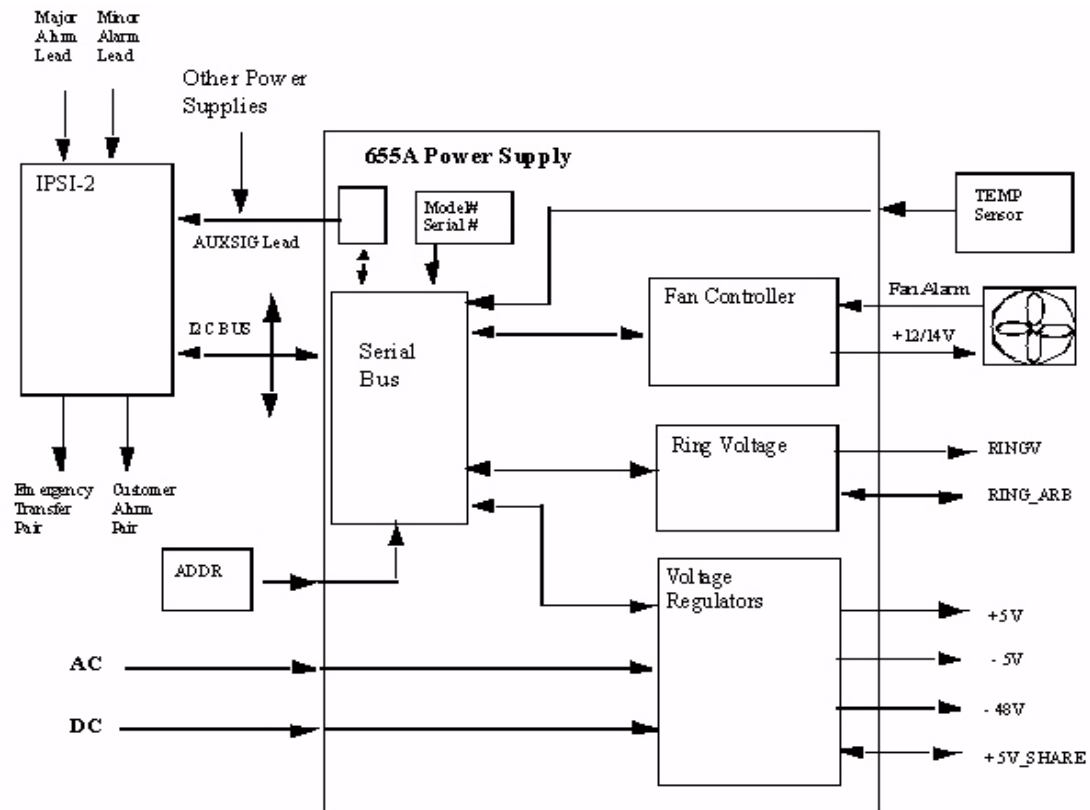
Figure 115: G650 Cabinet Environmental Hardware Components

[Figure 115: G650 Cabinet Environmental Hardware Components](#) on page 1989 illustrates these components.

Refer to [Figure 115: G650 Cabinet Environmental Hardware Components](#) on page 1989 for further information.

A TN2312BP IPSI, in a G650 with a carrier address set to A, has two alarm ports that connect to external devices. An example of an external device is an uninterruptible power supply (UPS). Refer to [Figure 115: G650 Cabinet Environmental Hardware Components](#) on page 1989 for further information.

There is one instance of this MO for each 655A power supply equipped in a G650 stack. Refer to [Figure 115: G650 Cabinet Environmental Hardware Components](#) on page 1989 for further information.

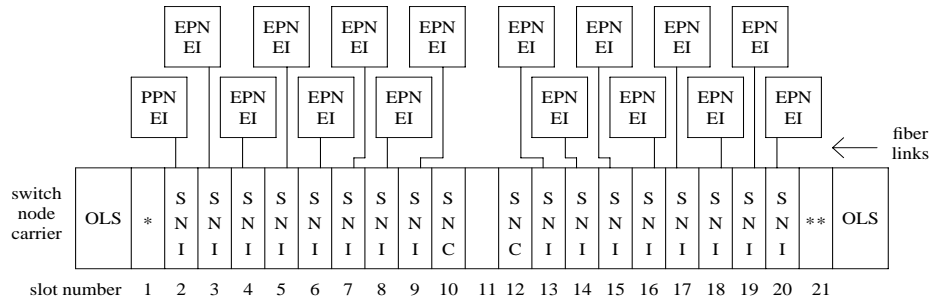
Figure 116: A Center Stage Switch Configuration

* = An EI or a DS1C circuit pack may reside in this slot
 ** = A DS1C circuit pack may reside in this slot

- Switch Node Clock (SNC) TN572
- Switch Node Interface (SNI) TN573
- Expansion Interface (EI) TN570
- DS1 Converter (DS1C) TN574
- Online Switcher (OLS) power supply

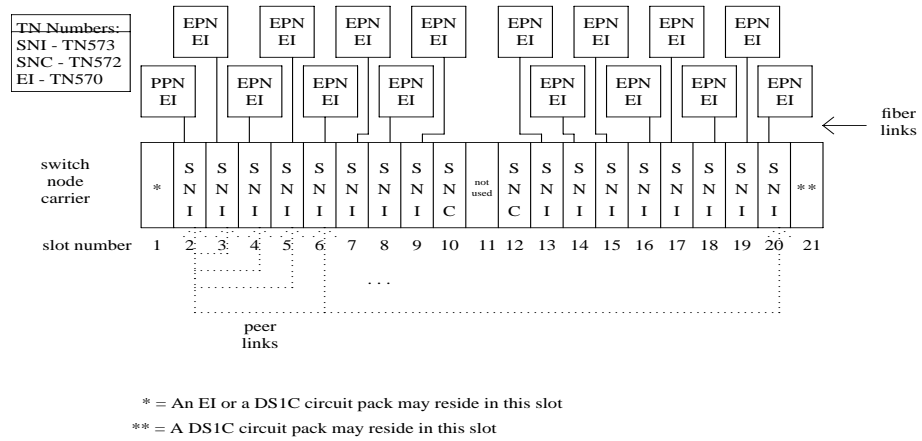
Figure 118: CSS Configuration with Unduplicated PNC and 1 Switch Node Carrier

[Figure 118: CSS Configuration with Unduplicated PNC and 1 Switch Node Carrier](#) on page 2076 shows an unduplicated CSS with one switch node. A single switch node can accommodate up to 16 port networks. A system with two switch nodes can accommodate up to 22 port networks. [Figure 119: CSS Configuration with Duplicated PNC and 4 Switch Node Carriers](#) on page 2077 shows a two-switch node CSS with duplicated PNC (four switch node carriers). In this configuration, each PNC (A and B) contains two switch nodes. The cabinet numbers for the switch node carriers are typical cabinet numbers. The PNs on the top half of the figure (PNC A) are the same as the PNs on the bottom half of the figure (PNC B).

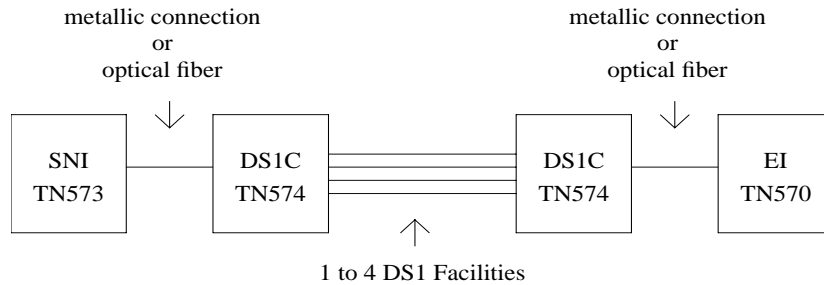
Figure 120: Fiber Link over a DS1 Converter Complex

A DS1 converter complex can be used to provide connectivity to a remotely located port network. The DS1 converter complex consists of two TN574 DS1 converter (DS1C) circuit packs connected by 1 to 4 DS1 facilities. The DS1C complex is administered as a fiber link.

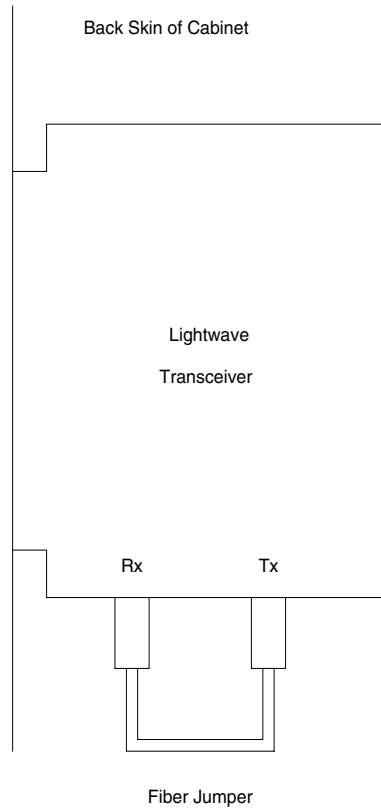
Figure 121: Interconnection of Lightwave Transceiver Transmit/Receive Jacks

3. Using a spare fiber jumper cable, interconnect the transmit and receive jacks of the lightwave transceiver as shown in [Figure 121: Interconnection of Lightwave Transceiver Transmit/Receive Jacks](#) on page 2084.

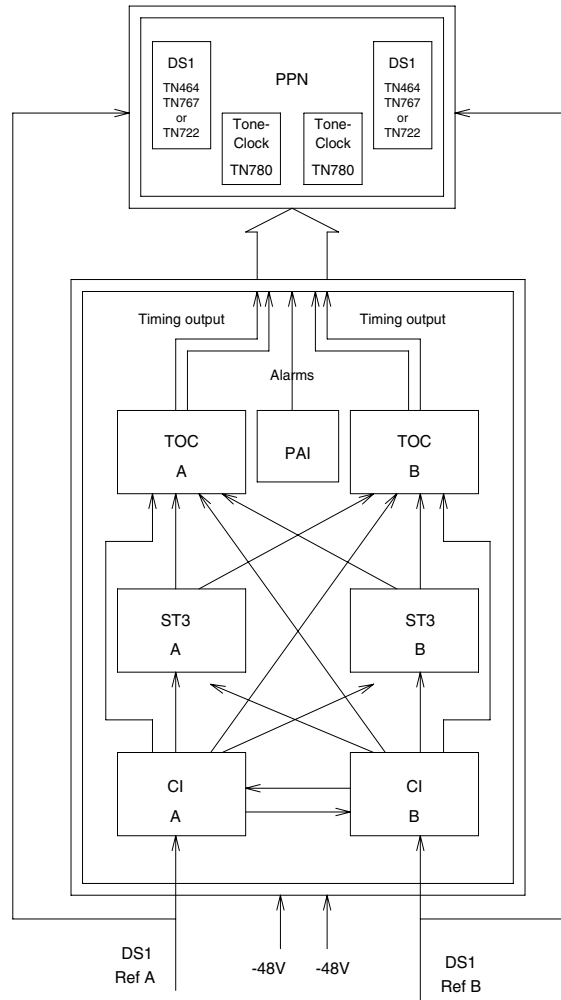
Figure 122: Stratum-3 Clock Hardware Configuration

In the system, the Stratum-3 clock has been implemented as an external which follows the specification in PUB 60110 for Stratum 3. The only external Stratum-3 clock that is supported is the Telecom Solutions Digital Clock Distributor for Customer Premise Timing (DCD-CPT) Stratum-3 clock. [Figure 122: Stratum-3 Clock Hardware Configuration](#) on page 2156 shows how the Stratum-3 hardware configuration provides clock and alarm signals to the TN780 Tone-Clock circuit pack(s). The reference DS1 facilities connect directly to the Stratum-3 clock for timing purposes, but the DS1 data may be routed into the switch by using a Y connector (H-600-274 G1 for the 50-pin DS1 end or H-600-274 G2 for the 15-pin DS1 end).

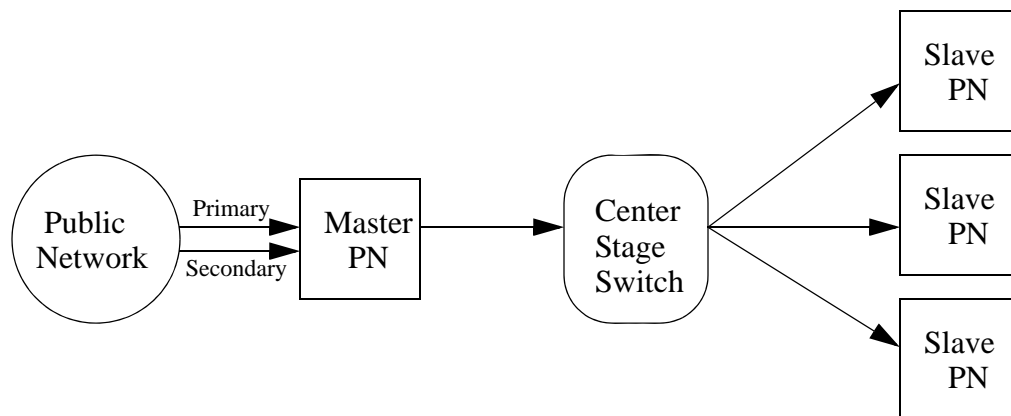
Figure 123: Traditional Sync Operation

This creates a hierarchy where the master PN receives timing from the public network, and every other PN derives its timing from the master through the CSS. See [Figure 123: Traditional Sync Operation](#).

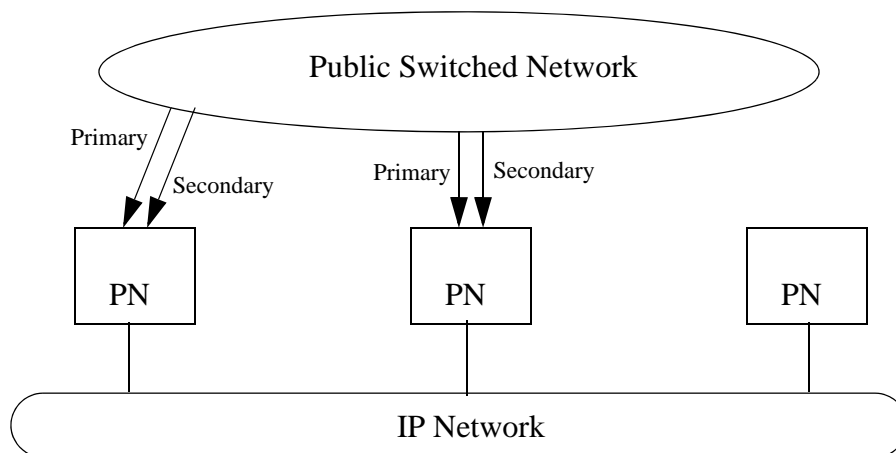
Figure 124: S8700 Media Server IP-PNC Sync Operation

A typical S8700 IP-PNC configuration is shown in [Figure 124: S8700 Media Server IP-PNC Sync Operation](#).

This figure also shows the far-right S8700 IP-PNC system's PN without public-network digital interface. A PN without public-network connectivity runs off of its local IPSI circuit pack's Tone-Clock circuit.

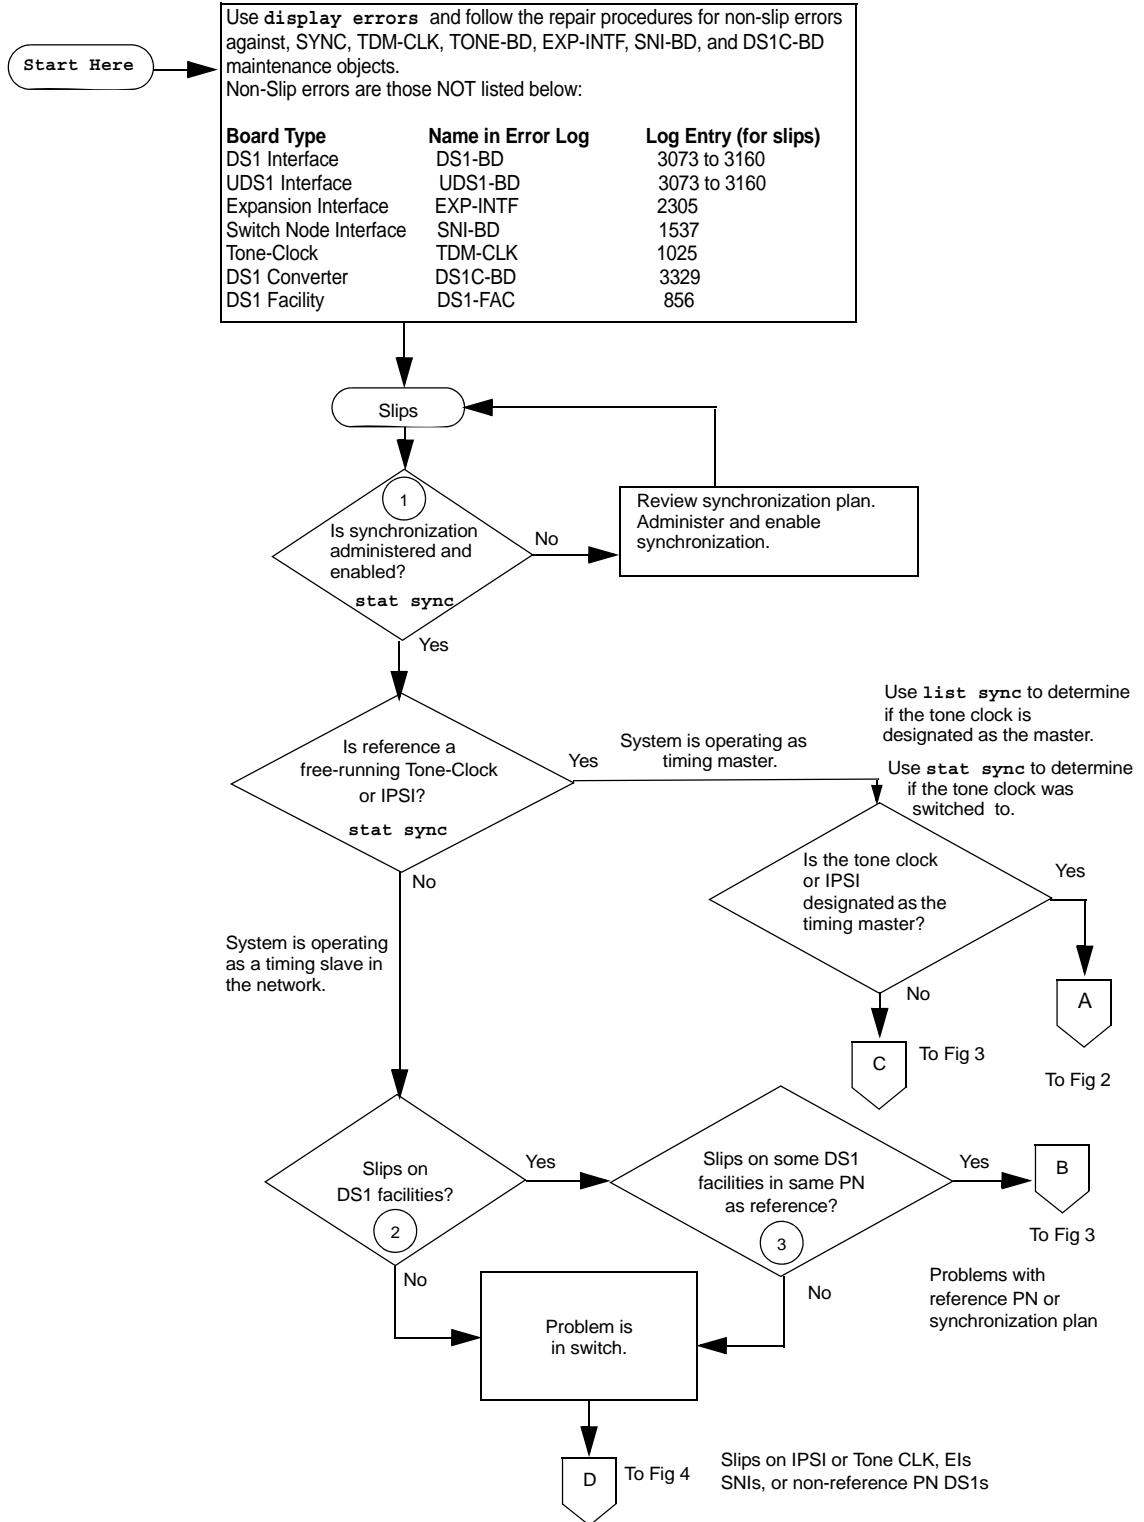
Figure 125: Synchronization Troubleshooting, Fig. 1 of 5

The following flow chart presents a logical approach to troubleshooting synchronization problems in conjunction with the previous background information. Explanatory notes follow the charts.

Notes for Sheet 1 through Sheet 5 flowcharts. (When checking for slip errors, use the previous [Table 756: Error Log Entries for Slip Errors](#) on page 2175.
