Maintenance Alarms for Avaya Communication Manager 3.1.x, Media Gateways and Servers

03-300430
Issue 2.1
June 2006

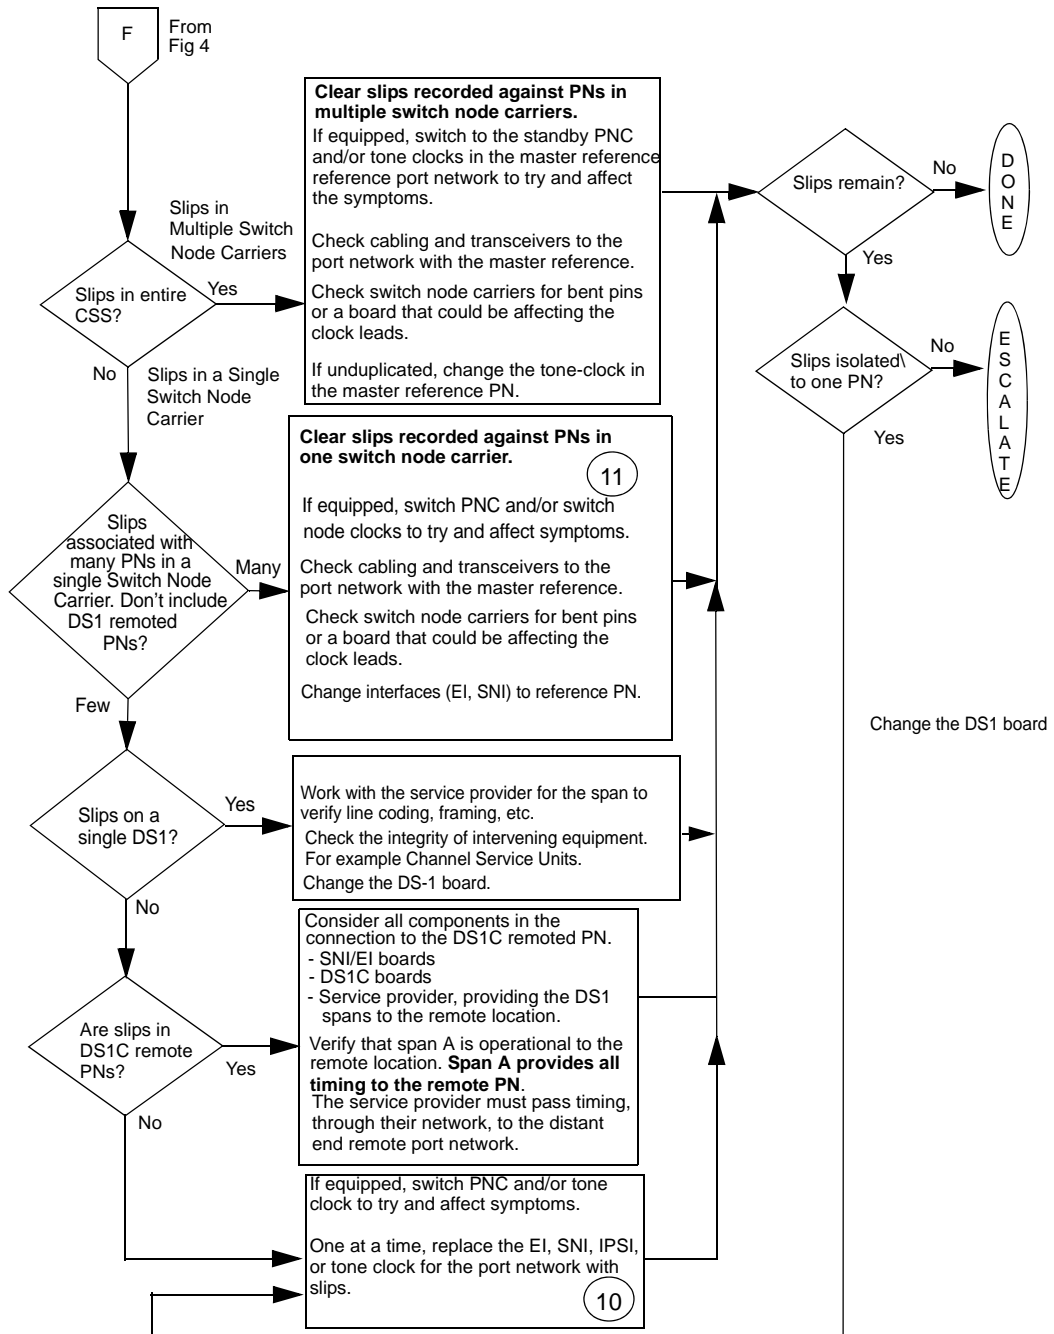
Figure 129: Synchronization Troubleshooting, Fig 5 of 5

The synchronization issue covers a large portion of the system. The problem is in a center stage switch (CSS), IPSI or Tone-Clock, EI, SNI, or DS1 spans in port networks (PN) other than the timing master PN.
 This procedure attempts to isolate the problem.
 When instructed to do so, perform the steps indicated while slips remain.

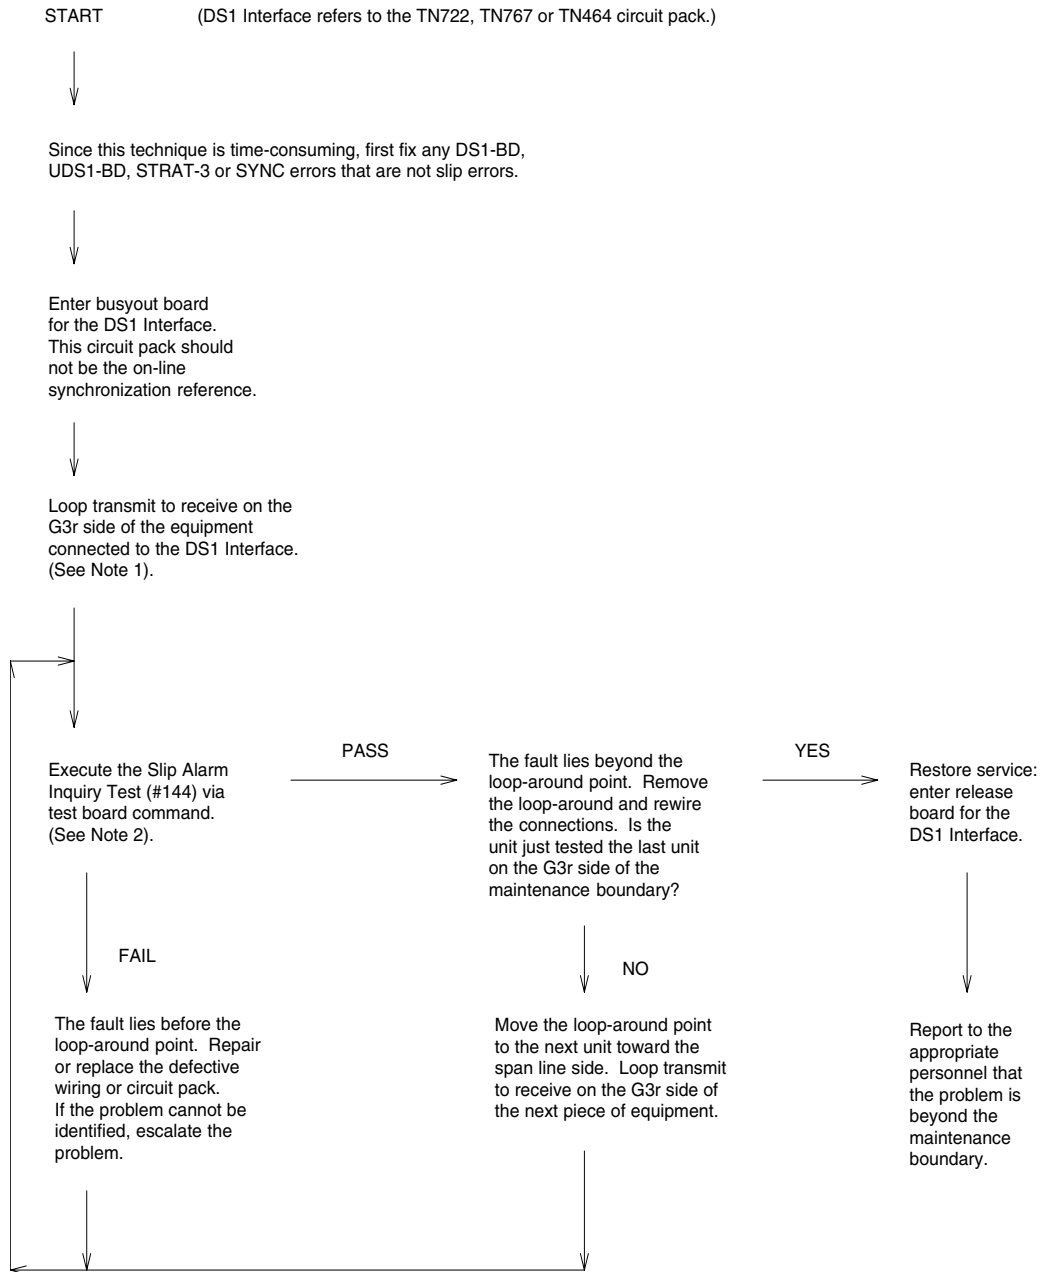
Figure 135: Facility Fault Sectionalization

Notes to Facility Fault Sectionalization Flowchart

1. Loop transmit to receive on the system side.

The flowchart in [Figure 135: Facility Fault Sectionalization](#) on page 2190 gives an overview of the facility fault sectionalization technique. It is important that you know the configuration and wiring of the equipment for the problem facility in order to support this technique.

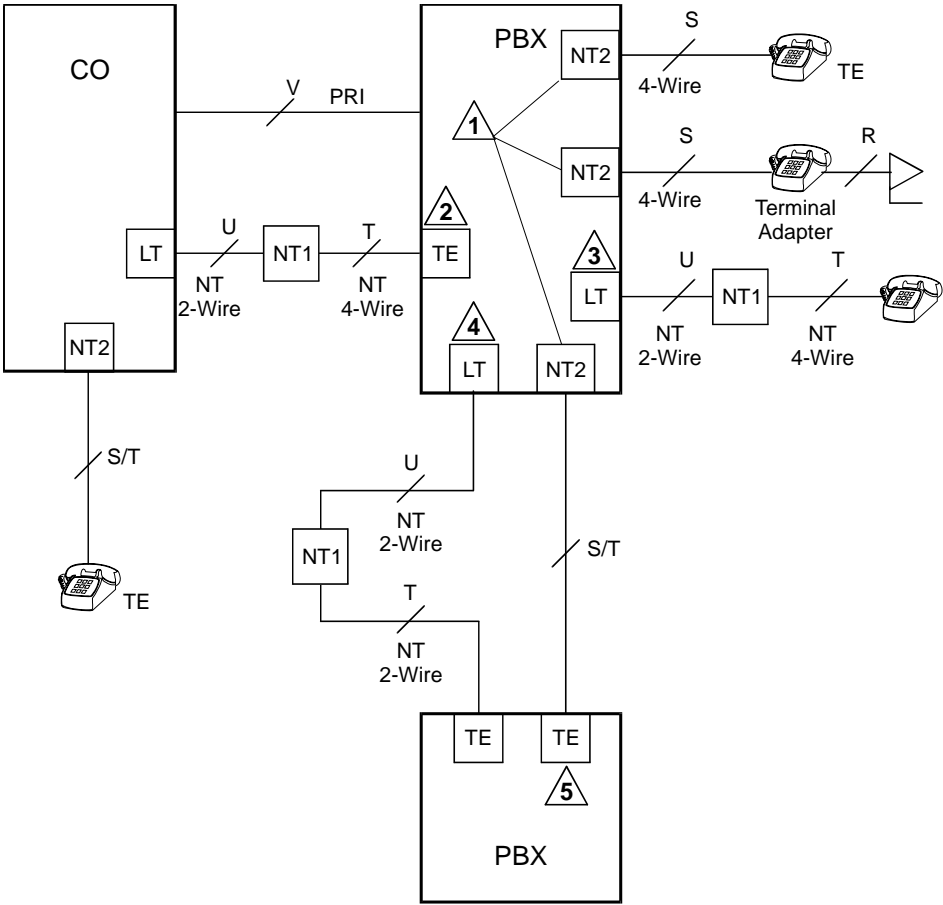
Figure 136: Integrated Trunk-Side BRI, ISDN Interface Reference Points

ISDN Interface Reference Points

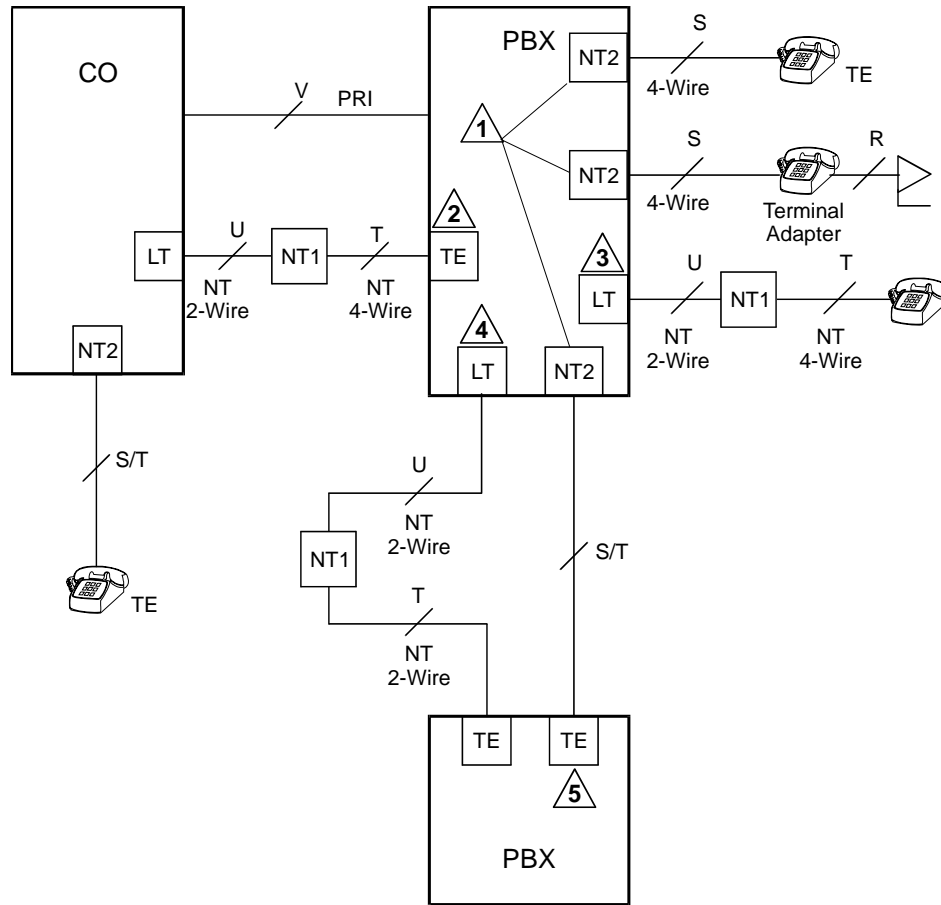
Figure 137: Integrated Trunk-Side BRI, ISDN Interface Reference points

ISDN Interface Reference Points

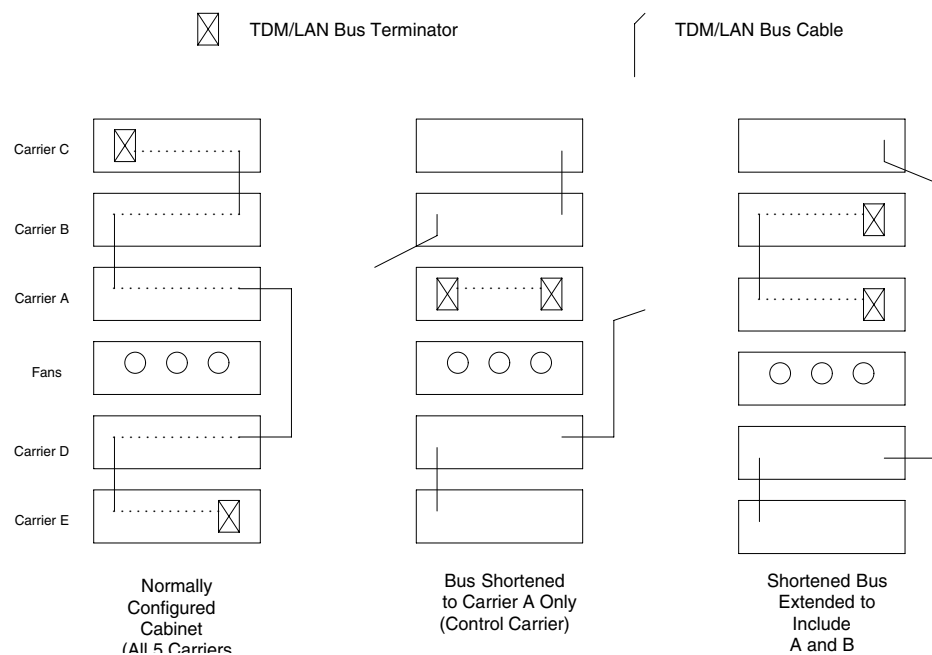
Figure 138: Carrier Rewiring Example — Rear View of 5-Carrier Cabinet

If replacement does not resolve the TDM-bus fault, the cabinet is reconfigured so that certain carriers are disconnected from the TDM bus. This is done by moving the TDM/LAN bus terminators (ZAHF4) on the carrier's backplane. To terminate a TDM bus at the end of a particular carrier, the TDM bus cable that connects the carrier to the next carrier should be unplugged and replaced with a TDM/LAN bus terminator (see [Figure 138](#)). As the length of a TDM bus is *modified*, any essential circuit packs to the system's operation and TDM-bus maintenance (for example, Tone-Clock), must still be connected to the *shortened* TDM bus.

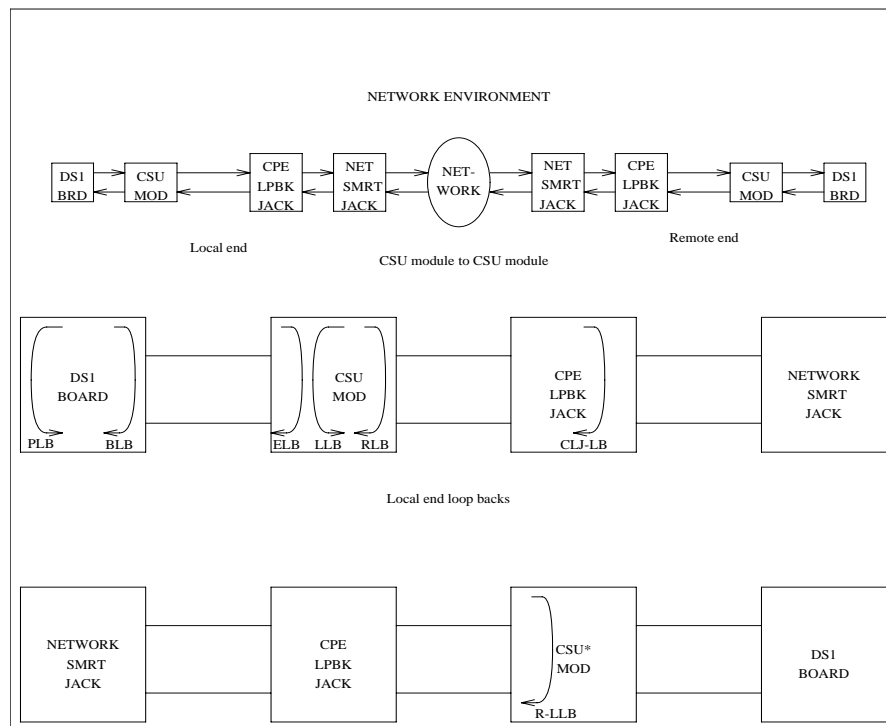
Figure 143: High Level Overview Of Loopback Points

The following list of acronym definitions are for the [Figure 143: High Level Overview Of Loopback Points](#):

These loop-back tests are explained in detail later in this UDS1-BD MO, but [Figure 143](#) gives a high level overview of the loop-back points.

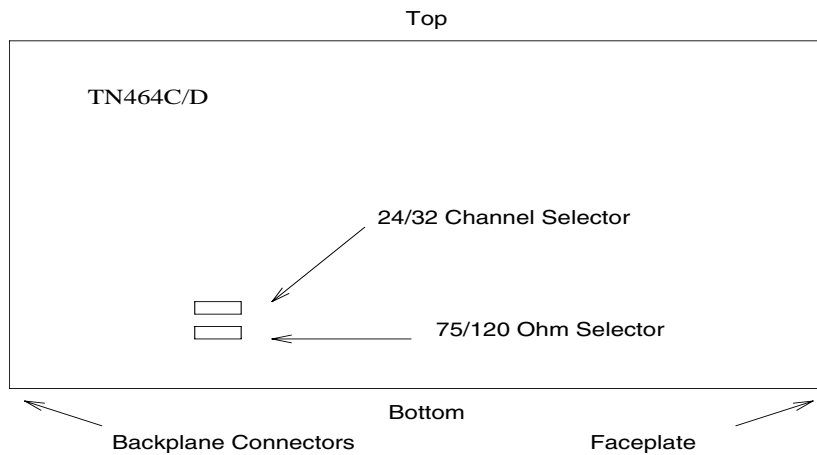
Figure 146: TN464C/D DS1 Option Jumpers

Two option jumpers located on the side of the TN464C/D circuit pack must be installed correctly. The figures on the following page show how to configure the circuit pack for 24- or 32-channel DS1, and for 75*W (coaxial) or 120*W trunk connections. The channel selection must match the parameters administered on the corresponding DS1 Circuit Pack screen. (US applications use 24 Channels.)

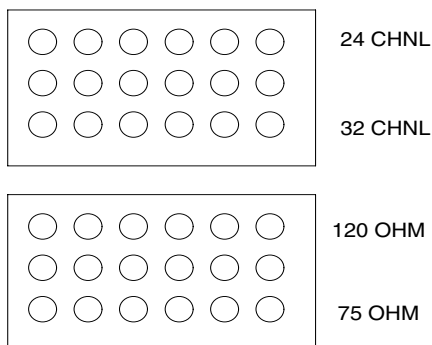
Figure 147: TN464C/D DS1 Option Jumpers (cont'd)

Insert the jumpers into the blocks so as to join the center row of pins and the row designating the desired options.

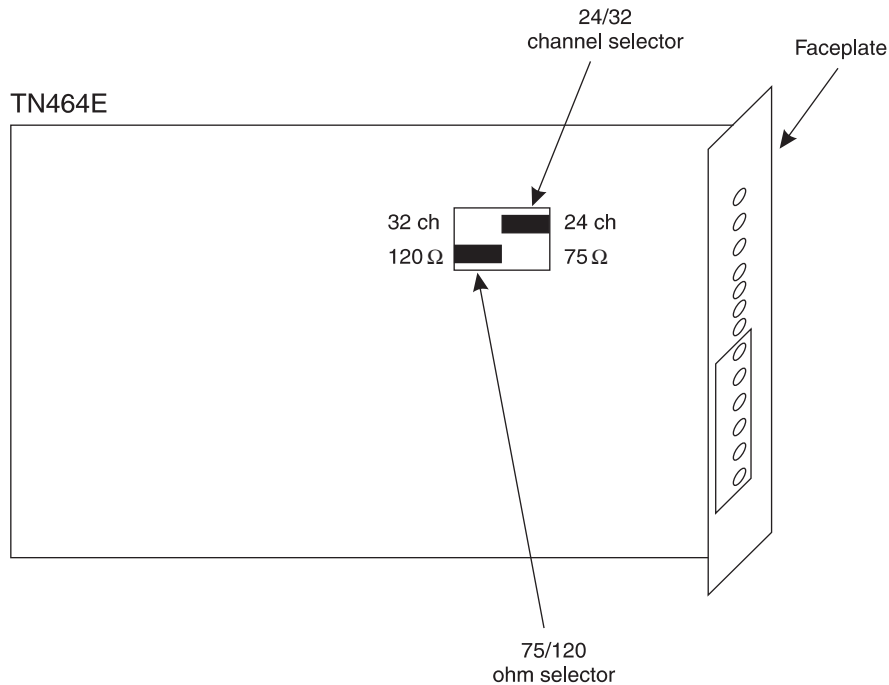
Figure 148: TN464E/F DS1 Option switches

The option switch located on the component side of the TN464E/F circuit pack must be set correctly. [Figure 148: TN464E/F DS1 Option switches](#) on page 2402 shows how to configure the circuit pack for 24-channel or 32-channel DS1. The channel selection must match the parameters administered on the corresponding DS1 Circuit Pack screen. (US applications use 24 Channels.)

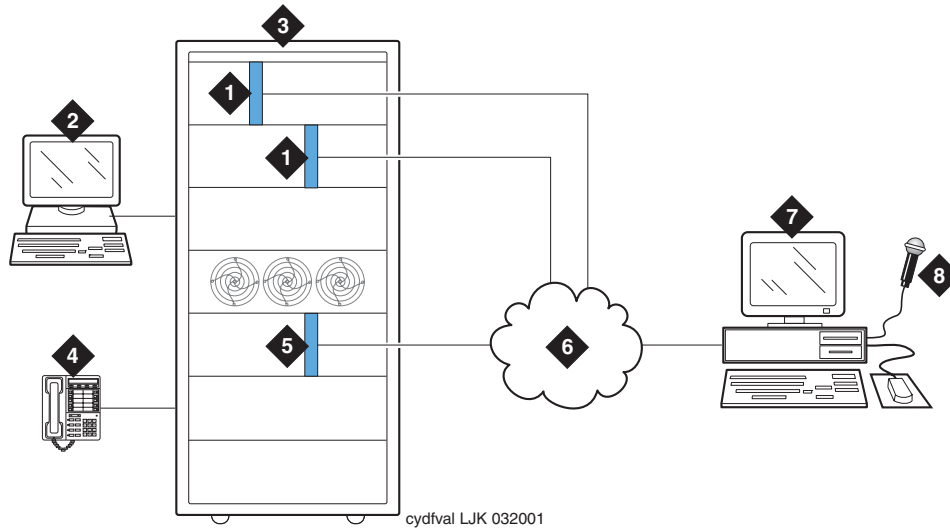
Figure 149: VAL configuration options

[Figure 149](#) shows the configuration options for the TN2501AP (VAL) circuit pack within a system.

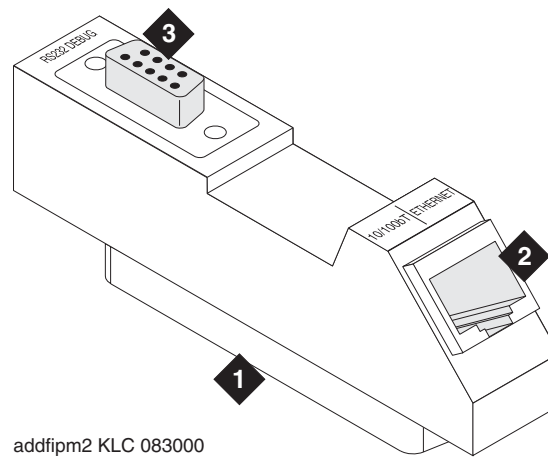
Figure 151: Backplane Adapter

The following figure shows the Backplane Adapter (label reads IP Media Processor).

- 1. Amphenol connector attaches to the back of the switch cabinet, corresponding to the TN2501AP circuit pack's slot.**
 - 2. RJ-45 LAN cable connection**
 - 10 Mbps uses Category 3 cable
 - 100 Mbps uses Category 5 cableThis connector is not used for VAL.
-

Ethernet connection speed	Cable	Connection description
10 Mbps	Category 3	Connects through the RJ45 jack (note #2 in Figure 151),
100 Mbps	Category 5	Connects through the RJ45 jack (note #2 in Figure 151),

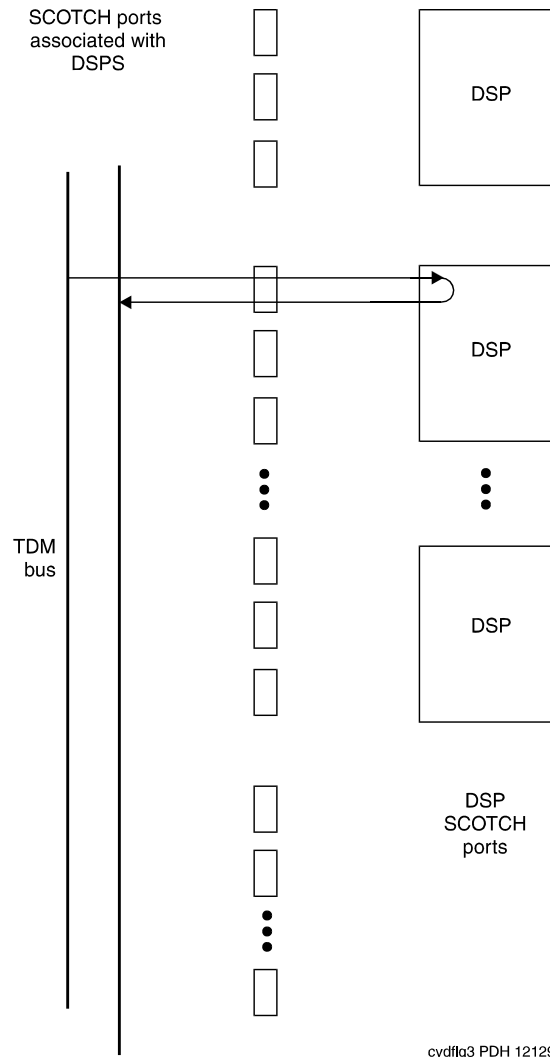
Figure 153: VC Circuit pack DSP Port DSP Loop-Around Test

This test verifies the connectivity of a VC-DSPPT across the TDM bus. It aborts if calls associated with the port are in progress. Failure of this test indicates an on-board fault associated with the port hardware on the circuit pack.

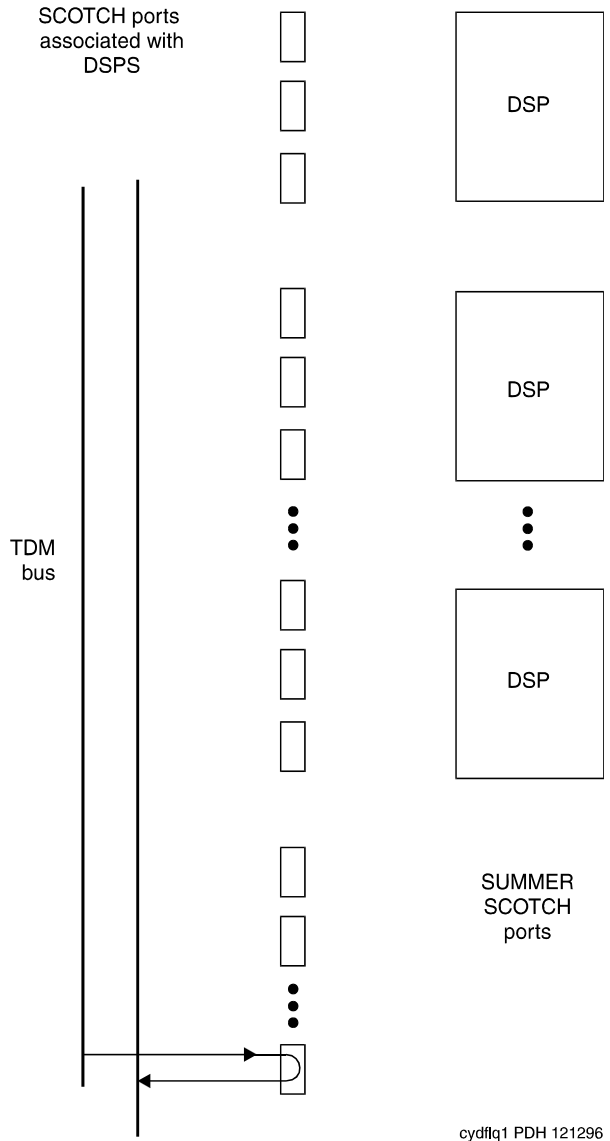
Figure 154: VC Circuit Pack Summer Port Loop-Back Test

The tests are run in the above order. If the first test fails, the switch returns an Error Code, and the second test is not executed.
